**Star
Home
Inspection Services**

Home Inspection Report

16 NW Main St, Lees Summit, MO 64063

Report Number: 06182009-1A

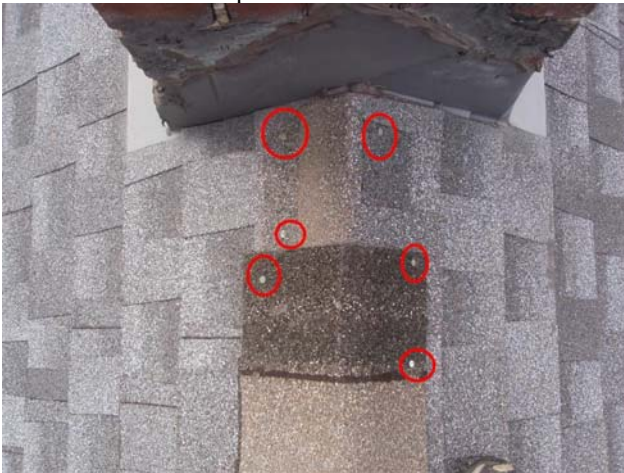
Sloped Roofing

- **Repair:** Exposed nail heads were observed in the roofing shingles and/or ridge caps. All exposed nail heads should be caulked to reduce the potential of leaks.

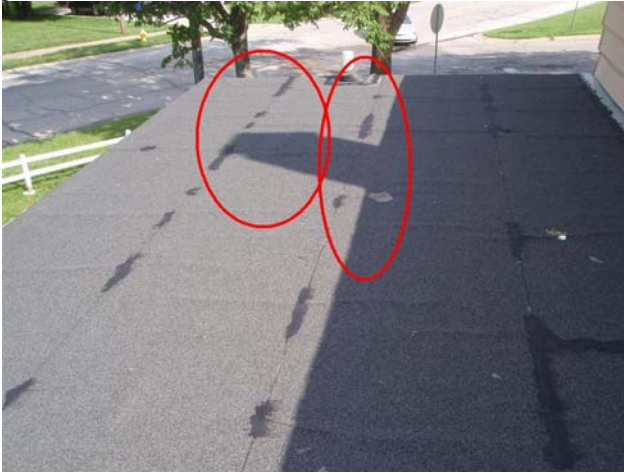
Flat Roofing

- **Note:** Rolled roofing is prone to leaking and requires close monitoring and higher than normal maintenance.
- **Monitor:** Prior repairs to the roll roofing are evident. This would suggest that problems have been experienced in the past. This area should be monitored.

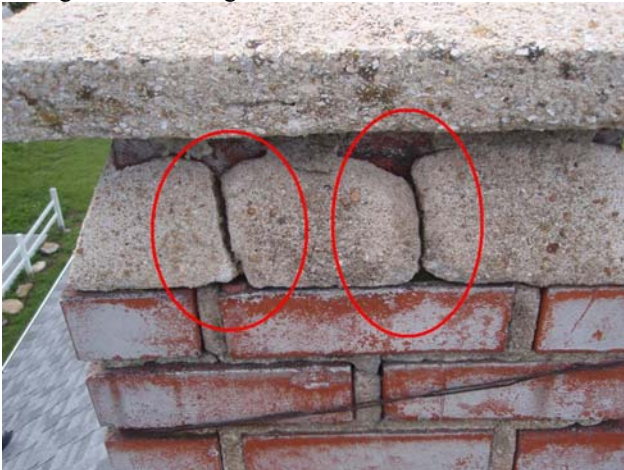
Chimneys

- **Repair:** The cap of the masonry chimney is cracked. These cracks should be sealed or caulked before winter to prevent damage from freezing water.

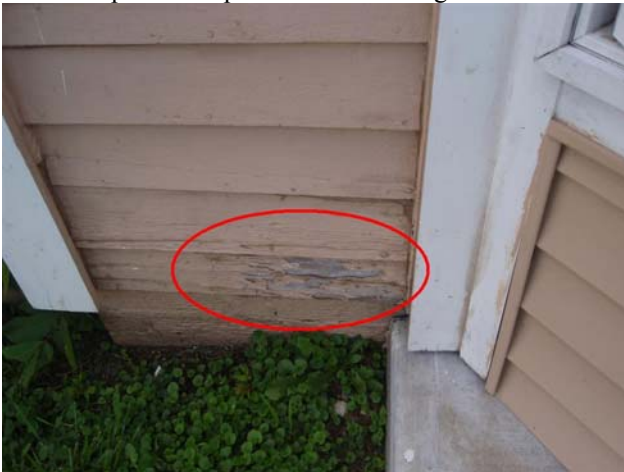
- **Repair:** The exterior siding paint is peeling and/or worn thin in localized areas (example at west building). These areas should be painted to prevent water damage or rot in the future.

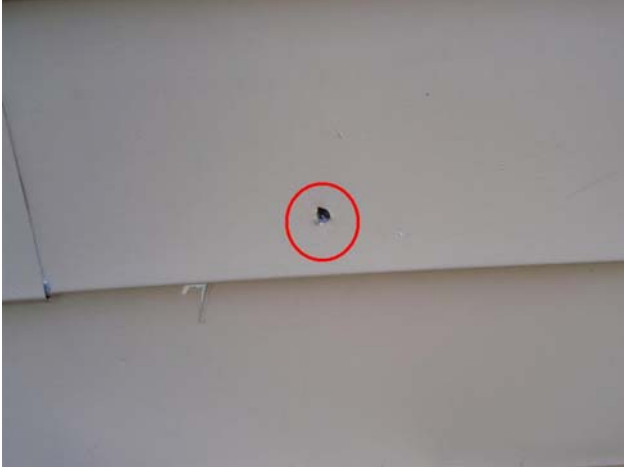
- **Repair:** Any openings in the exterior siding should be sealed (example at north side of home). Caulking is needed.

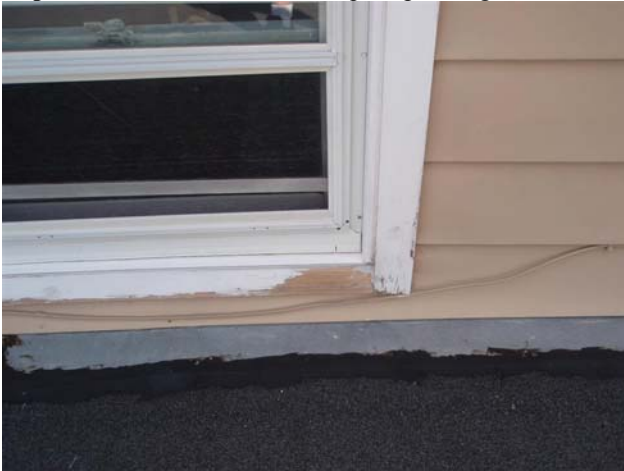
Windows

- **Repair:** The window frames require painting and caulking.

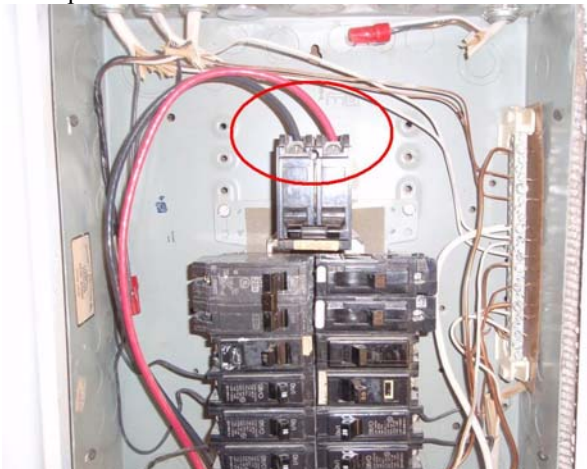
Auxiliary Panel(s)

- **Repair:** The oversized auxiliary panel main breaker should be replaced. The wire rating for this panel is a maximum of 60 amps.

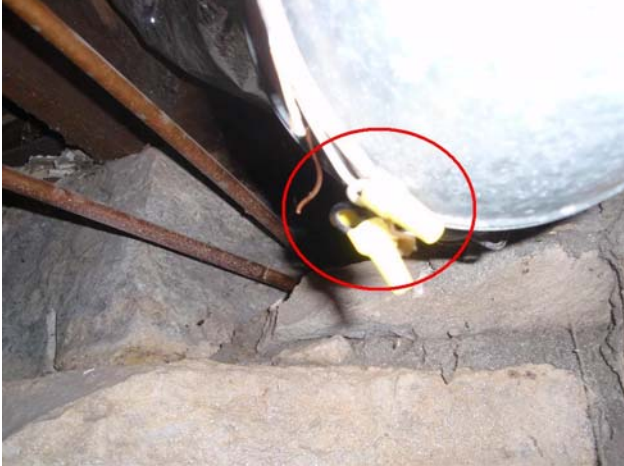
Distribution Wiring

- **Repair:** Improper electrical connections should be repaired (example at furnace room). All electrical connections should be made inside junction boxes fitted with cover plates.

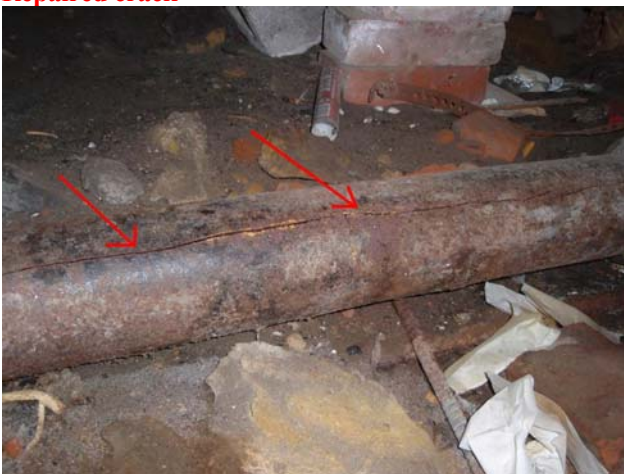
Waste / Vent

- **Monitor:** The waste piping at the south crawl spaced shows evidence of deterioration (crack at top of waste piping).
Repaired crack
