Star Home Inspection Services

Home Inspection Report

1603 NE 78th St, Kansas City, MO 64118

Inspection Date: 08/12/2009

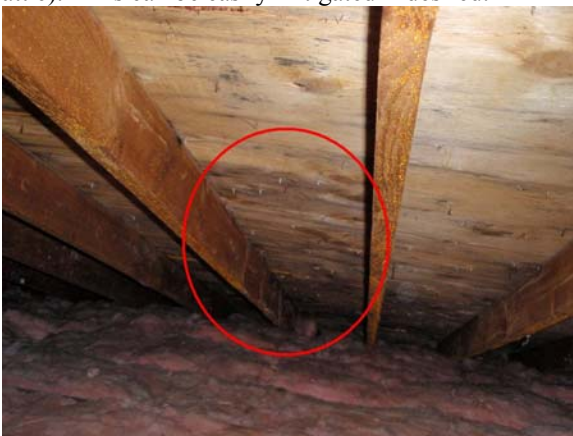
- **Monitor:** Some of the northeast corner rafters of the roof structure show evidence of sagging. Strengthening the roof structure would resist further movement. This improvement is not priority unless the roof is likely to be subjected to heavy loads such as from snow or additional layers of roofing material whose weight could cause further damage. Additional support can often be added easily.
- **Monitor:** Some roof sheathing sags were noted. This should be investigated when re-roofing. **The roofers did not feel that there needed to be any replacement, they re-secured the sheathing as needed.**
- **Monitor:** Possible dormant mildew/mold was visible on some roof sheathing (i.e. small area at northeast corner of attic). This can be easily mitigated if desired.

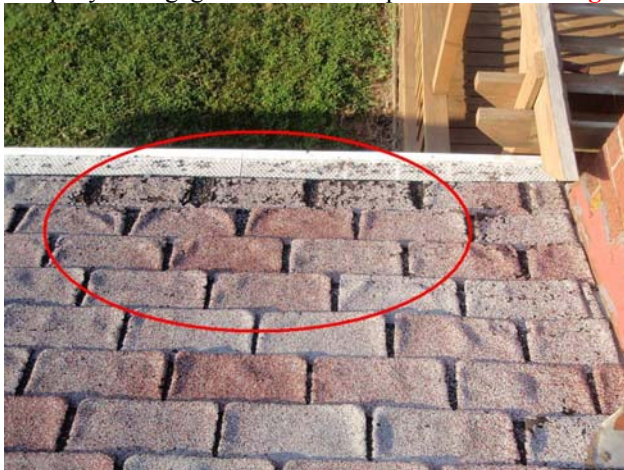
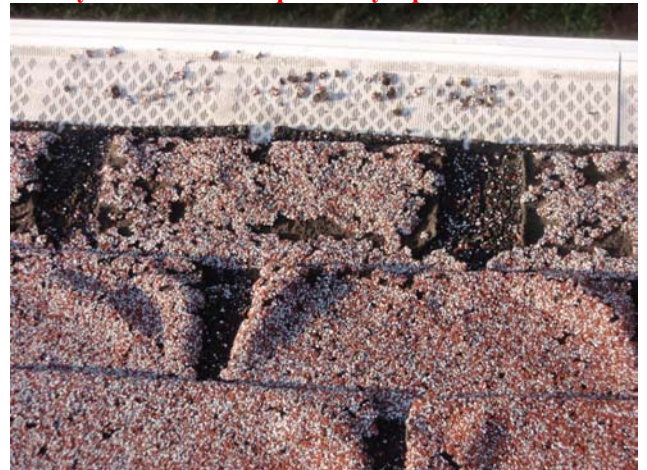
- **Major Concern, Repair:** The roofing is at end of life and should be replaced soon. Recommend a professional roofing company be engaged for a second opinion. **The roofing was totally removed and replaced by a professional roofer**

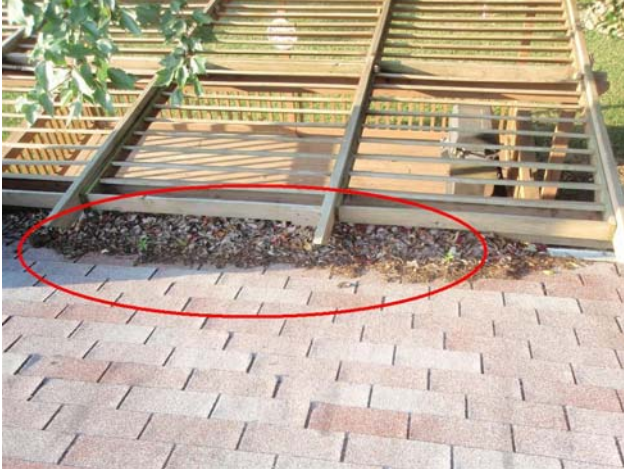
- **Improve:** Debris should be removed from the roofing to reduce risk of leaks and early roof wear. **Repaired**

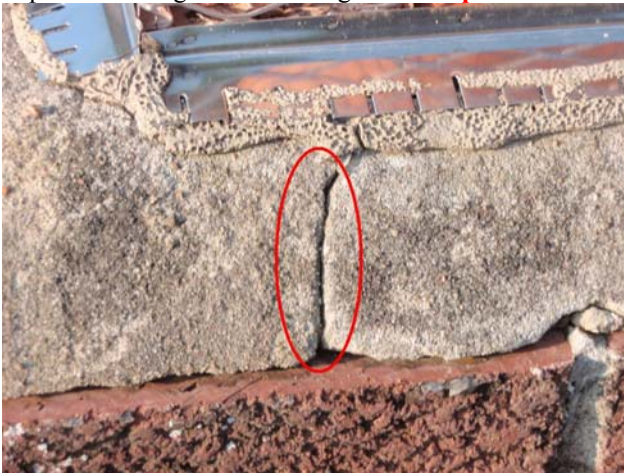
- **Monitor, Repair:** The cap of the masonry chimney is cracked. These cracks should be sealed or caulked before winter to prevent damage from freezing water. **Repaired**

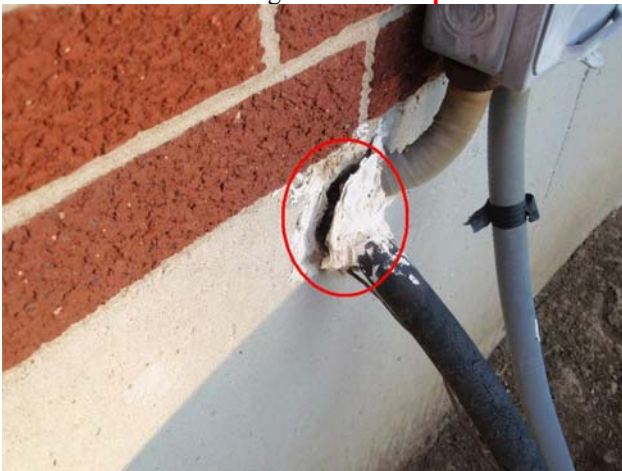
- **Repair:** Any openings in the exterior siding should be sealed. An example is where the air conditioner refrigerant lines enter the house. Caulking is needed. **Repaired**

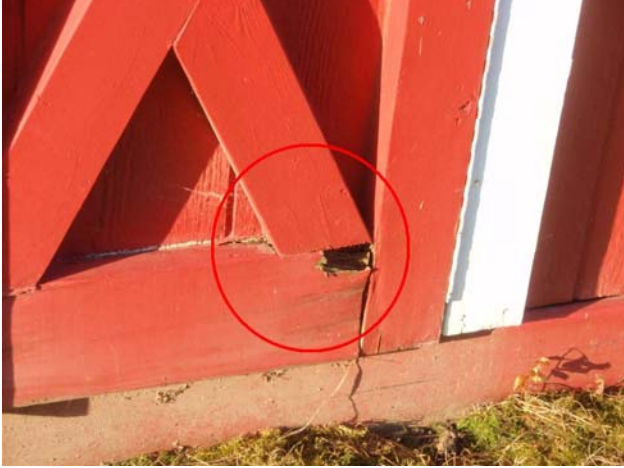
- **Repair:** Localized rot was observed in the trim around the siding at the storage building. Following repair of the damaged areas (which should be combined with exterior painting/maintenance) proper maintenance of the siding and control of water from roof or surface runoff can avoid further damage. **Storage building is excluded**

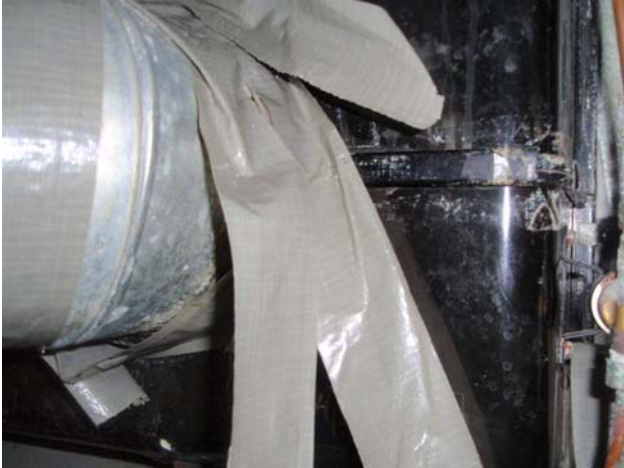
- **Repair:** Loose fitting joints sealed with duct tape and/or openings in the ductwork should be improved. Duct tape is not appropriate material for this use, despite its name. **Repaired**
