**Star
Home
Inspection Services**

Home Inspection Report

16114 S Bradley Dr, Olathe, KS 66062

Inspection Date: 11/05/2008

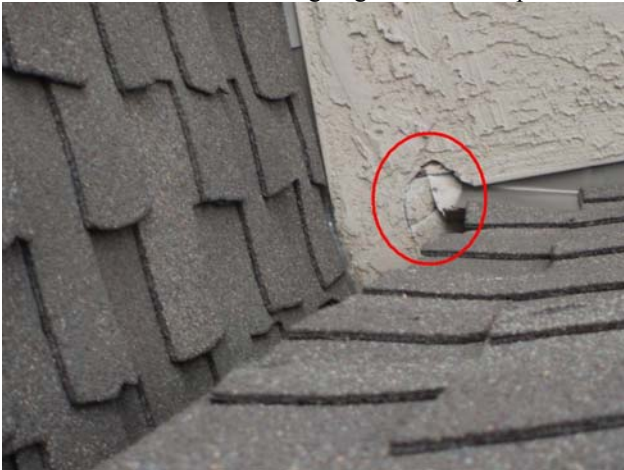
- **Monitor, Repair:** Localized damage of the stucco exterior wall near the bottom edge of south side of roof over porch where it meets the roof over garage should be repaired. There is extra risk of hidden damage in such areas.

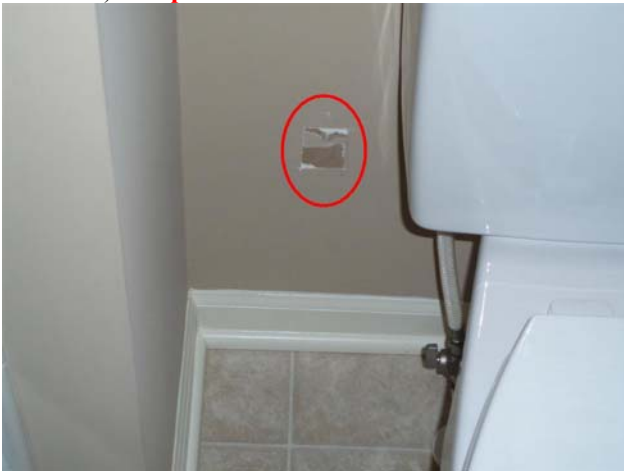
- **Monitor:** Water staining was noted at garage ceiling.
- **Monitor:** Damage to the interior finish was observed (minor area at wall near toilet in upstairs west middle bedroom bathroom). **Repaired**
