**Star
Home
Inspection Services**

Home Inspection Report

16412 Riggs, Stilwell, KS 66085

Report Number: 04282008-2L

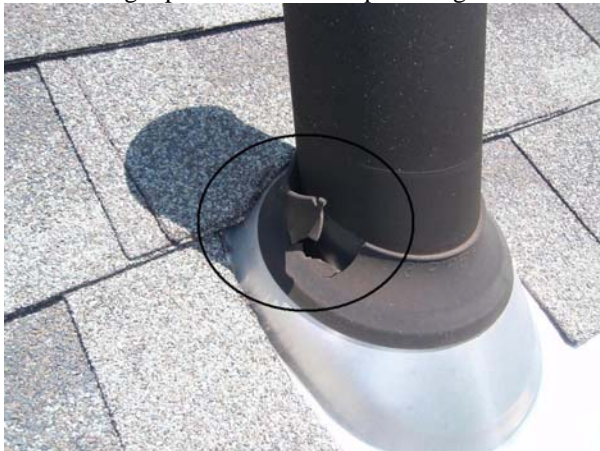
- **Repair:** The plumbing vent flashing boot is split making it vulnerable to leaks. The boot should be caulked or the flashing replaced. The other plumbing vent boot should also be inspected as it was not accessible.

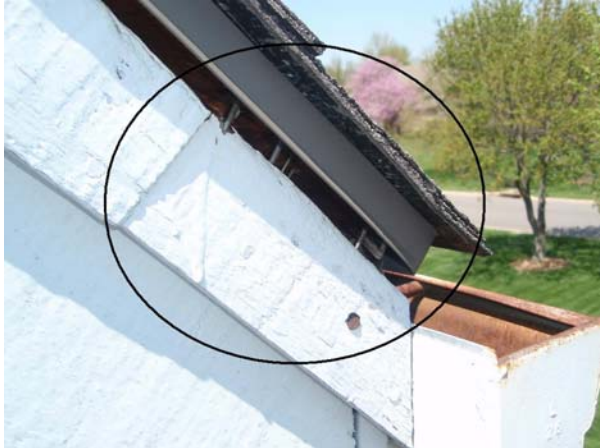
- **Repair:** The roof sheathing has pulled up on the corner of the roof of the front northeast bedroom.

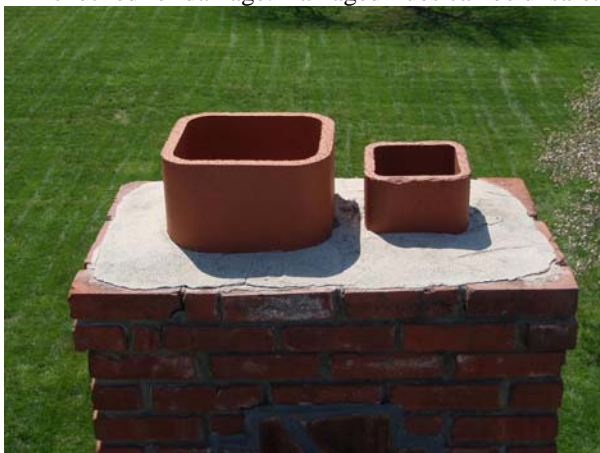
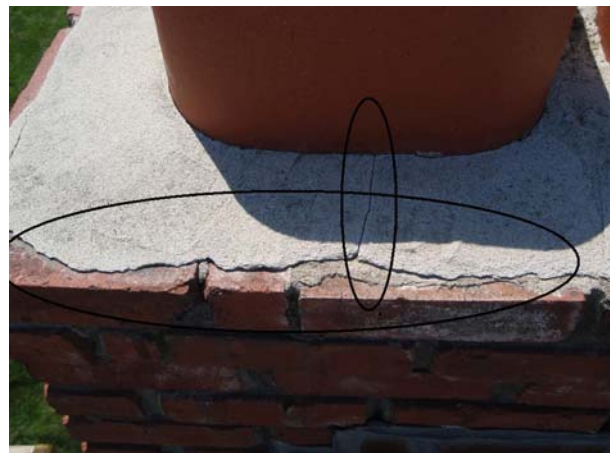
- **Monitor:** The masonry chimney shows evidence of spalling (surface deterioration of the masonry). Repair is not necessary at this time but this condition should be monitored.
- **Monitor, Repair:** The cap of the masonry chimney is cracked. These cracks should be sealed or caulked before winter to prevent damage from freezing water.
- **Repair:** A rain cap and vermin screen should be installed on the masonry chimney and the chimney flue should be checked for damage. Damaged flues can be unsafe.

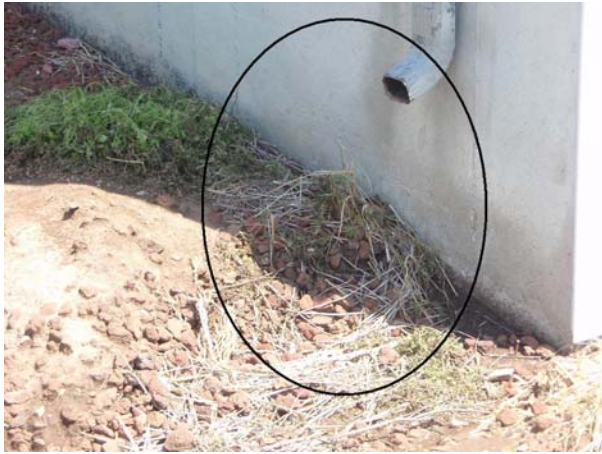
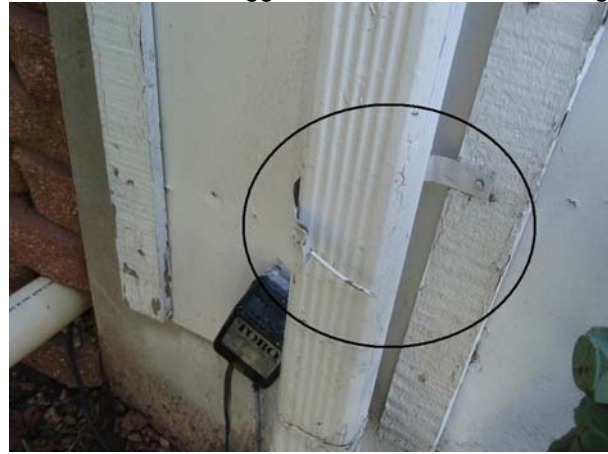
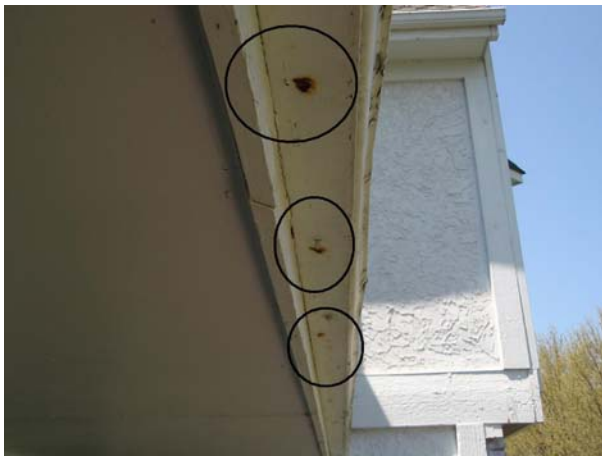
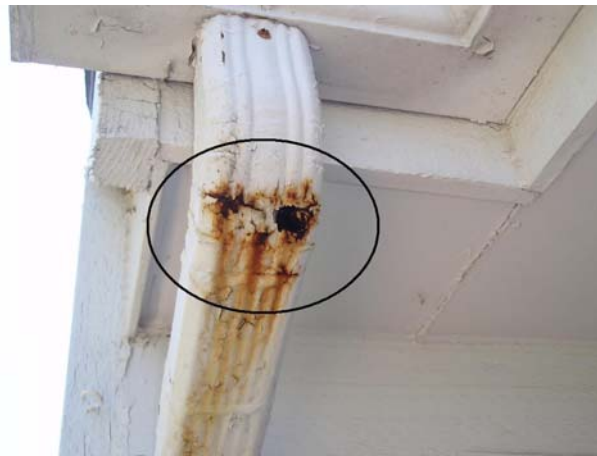
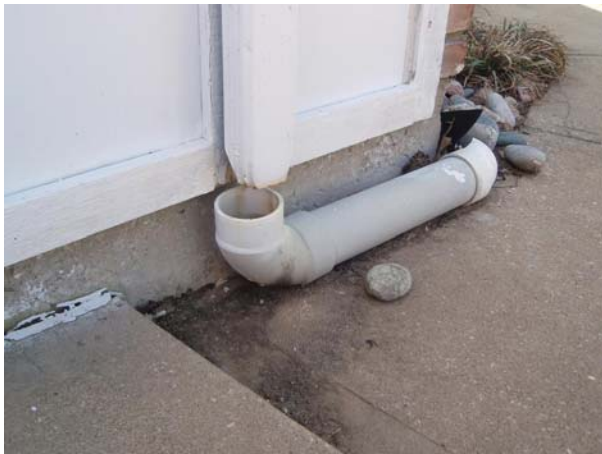
- **Repair:** Minor leaks in the gutters should be repaired and rusted gutters replaced.
- **Repair:** The downspout(s) should discharge water at least five (5) feet from the house. Storm water should be encouraged to flow away from the building at the point of discharge.
- **Repair:** Loose downspout(s) should be repaired.

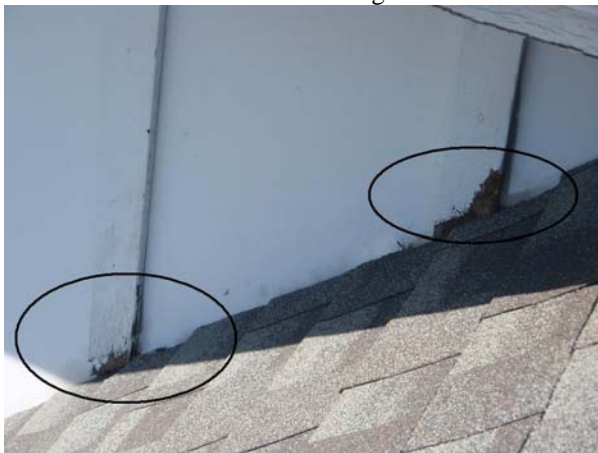
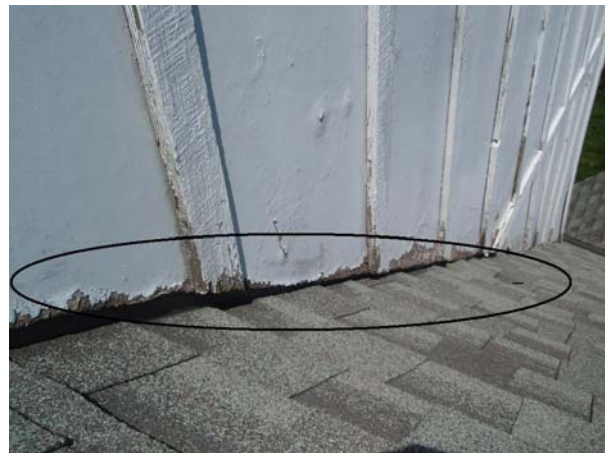
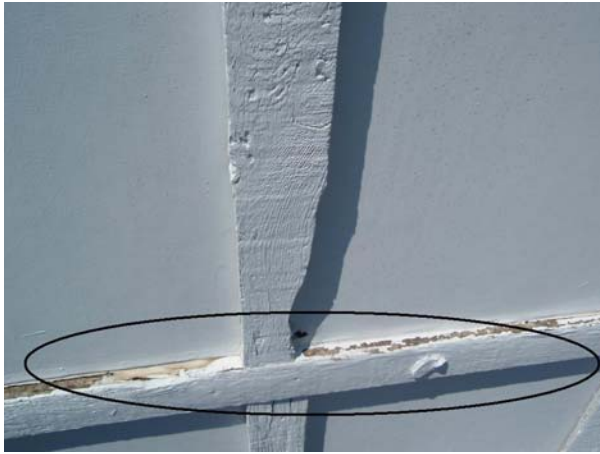
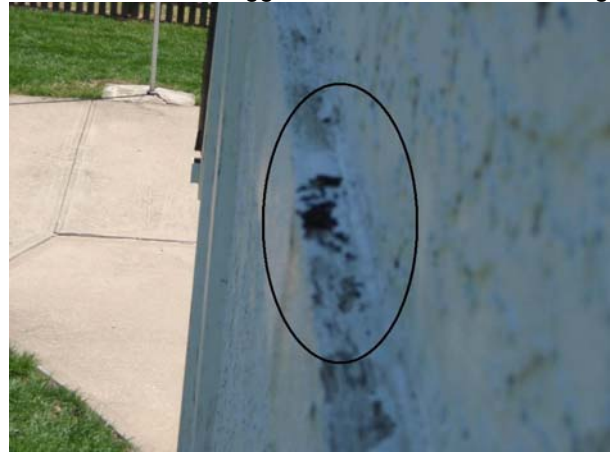
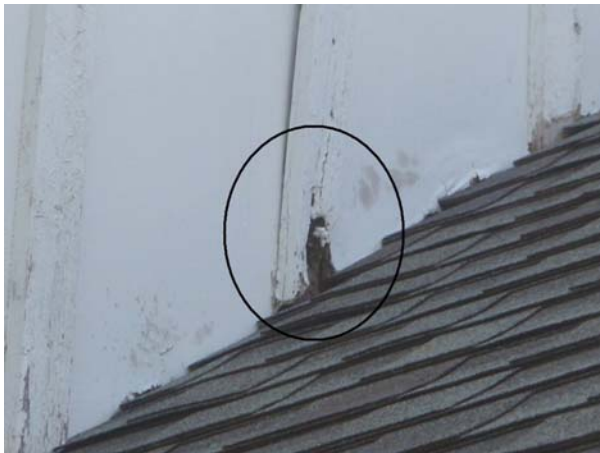
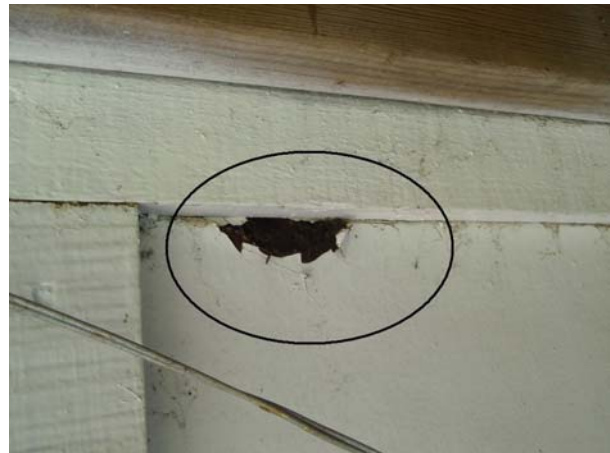
- **Repair:** The exterior of the house needs to be painted.
- **Repair:** Localized rot was observed in the siding. Following repair of the damaged areas (which should be combined with exterior painting/maintenance) proper maintenance of the siding and control of water from roof or surface runoff can avoid further damage.
- **Repair:** Localized rot was observed in the trim around siding. Following repair of the damaged areas (which should be combined with exterior painting/maintenance) proper maintenance of the siding and control of water from roof or surface runoff can avoid further damage.

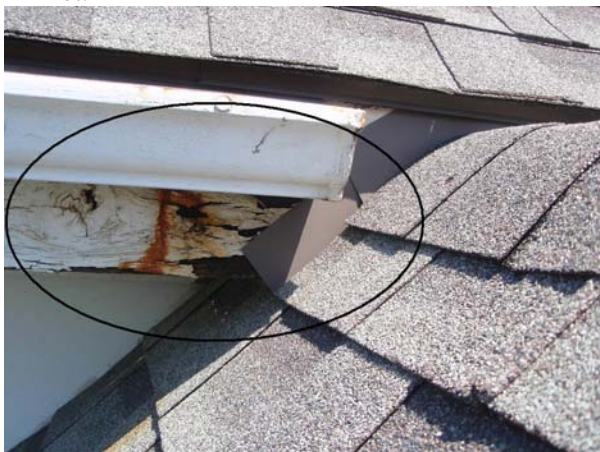
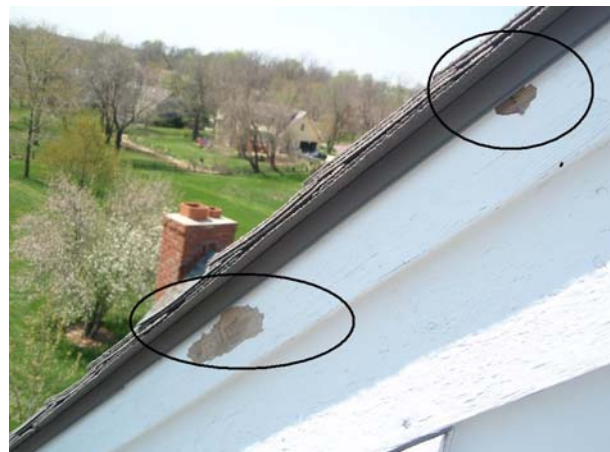
- **Monitor:** Localized rot was observed in the fascia (the wooden board to which the gutter is typically fastened). Improvement is not necessary at present, although this condition should be repaired when exterior painting or maintenance are planned.
- **Repair:** The eaves and fascias are peeling in localized areas and they should be painted to prevent water damage and rot.

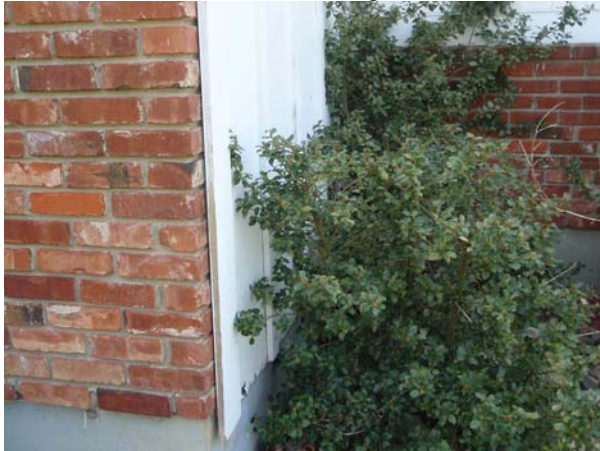
- **Repair:** Shrubs, bushes and/or vines growing on exterior walls should be kept trimmed away from the structure to reduce the risk of water damage and insect infestation.

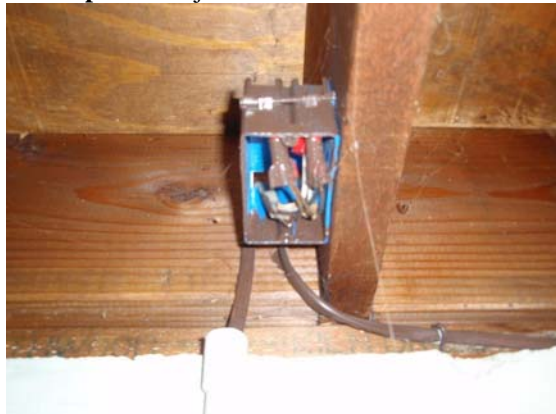
- **Repair:** All junction boxes in the basement should be fitted with cover plates, in order to protect the wire connections.

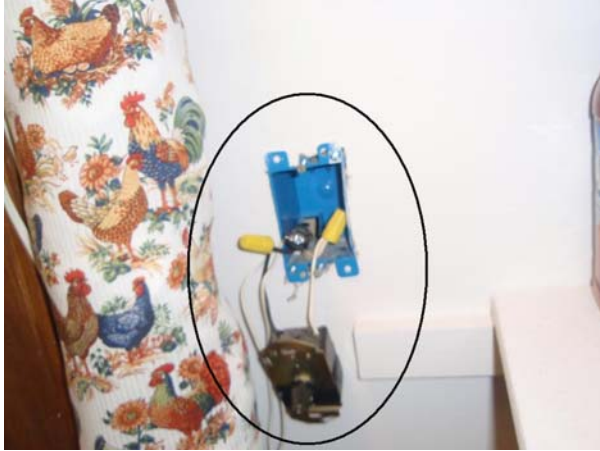
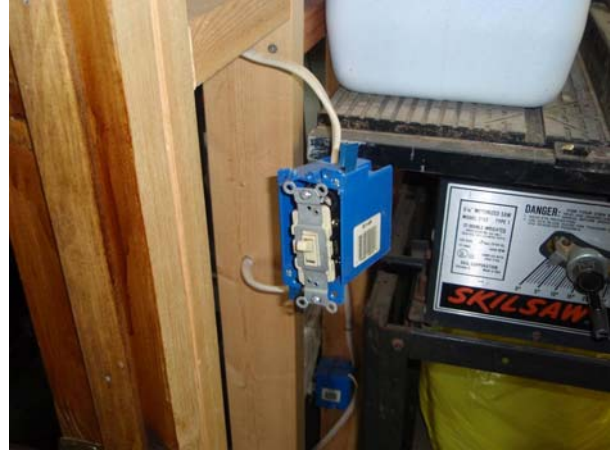
- **Repair:** The loose light switches in the kitchen pantry and basement should be secured.
- **Repair:** Missing switch cover plates in the basement should be replaced to avoid a shock hazard.

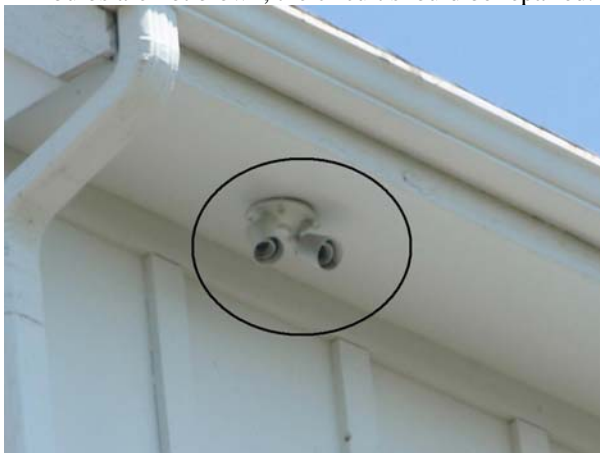
- **Repair:** A couple of florescent lights in the basement and the flood lights on the southwest corner are inoperative. If the bulbs are not blown, the circuit should be repaired.
