# Star Home Inspection Services

## *Home Inspection Report*

**1829 W Fredrickson Dr, Olathe, KS 66061**

**Inspection Date: 12/1/2008**

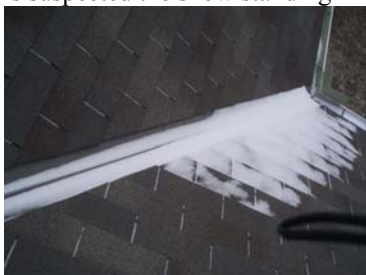
- **Repair:** The flashing should be caulked to avoid leaks (example at valley flashings at back southeast corner of house). It is suspected the snow standing in the valley flashings is causing moisture at kitchen ceiling when snow melts.

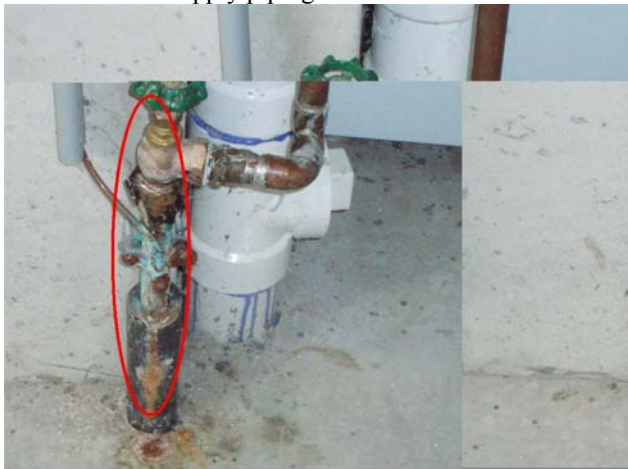
- **Monitor:** The supply piping main shutoff shows evidence of previous leakage.
