Home Inspection Report

1841 E 152nd Ct Olathe, KS 66062

Inspection Date: 09/03/2010

Report Number: 09032010-2L

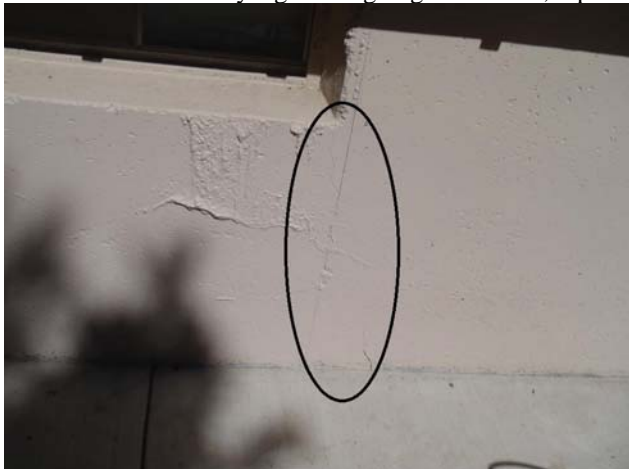
Foundation

- **Monitor:** Common minor settlement cracks were observed in the foundation walls. This implies that some structural movement of the building has occurred. Cracks of this type should be watched for any sign of additional movement. In the absence of any sign of ongoing movement, repair should not be necessary. **Cracks have been sealed**

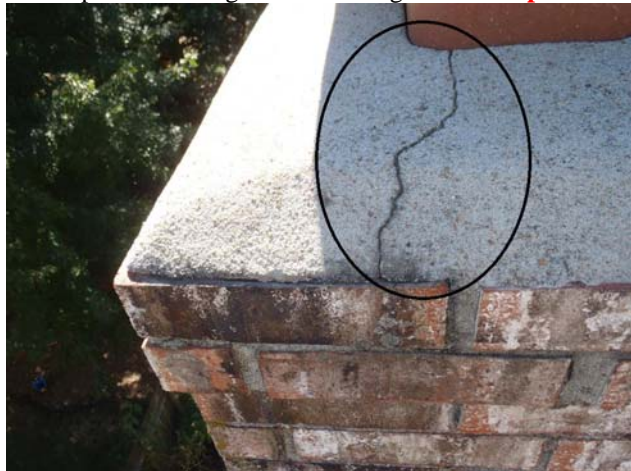
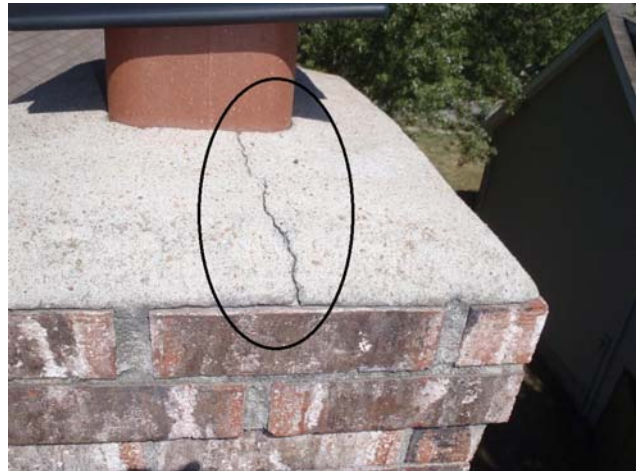
Chimneys

- **Monitor, Repair:** The cap of the masonry chimney is cracked. These cracks should be sealed or caulked before winter to prevent damage from freezing water. **Repaired**

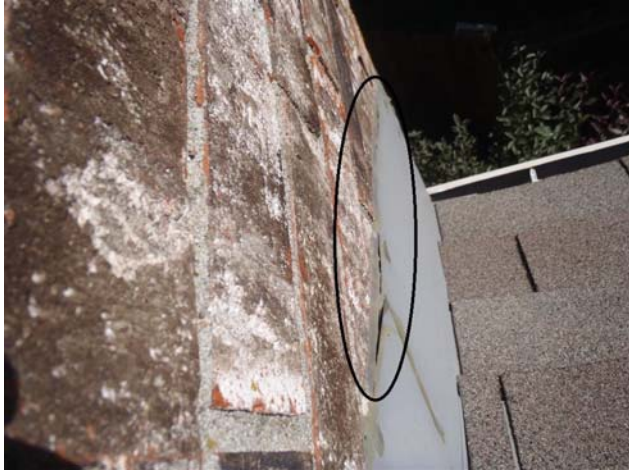
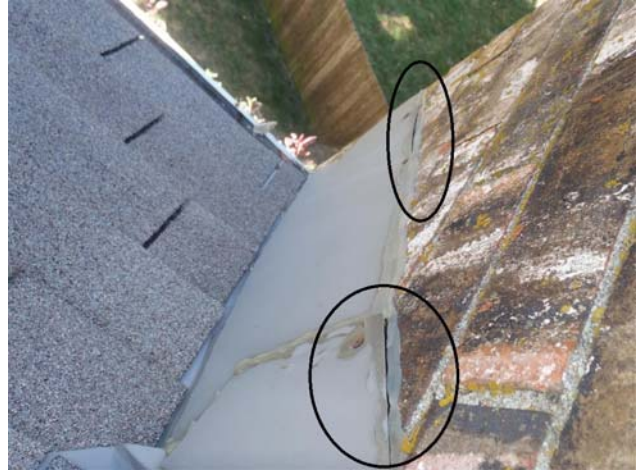
Flashings

- **Repair:** The flashing should be caulked to avoid leaks. **Repaired**

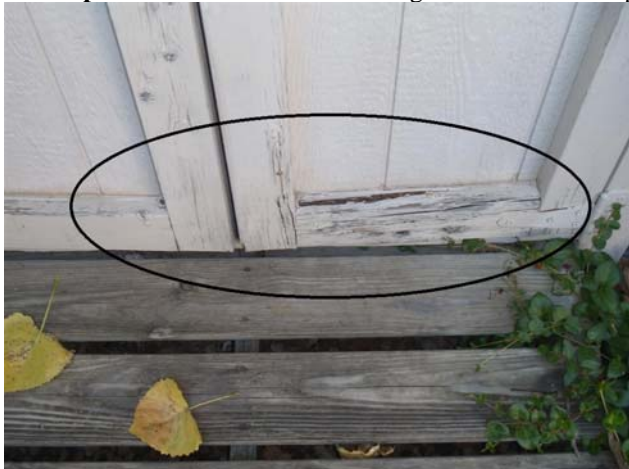
- **Repair:** The exterior of the storage shed needs to be painted and the rot in the door repaired.

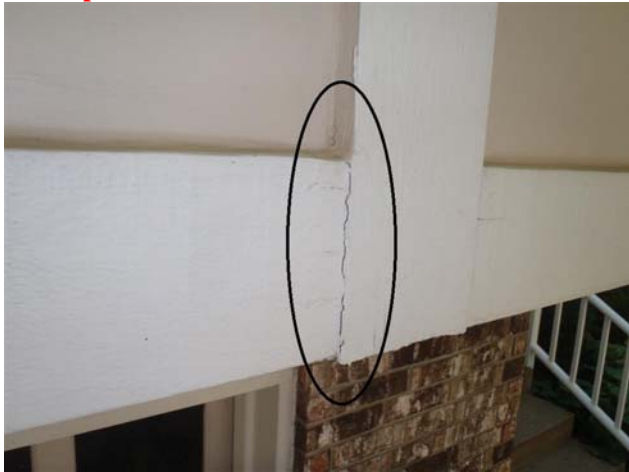
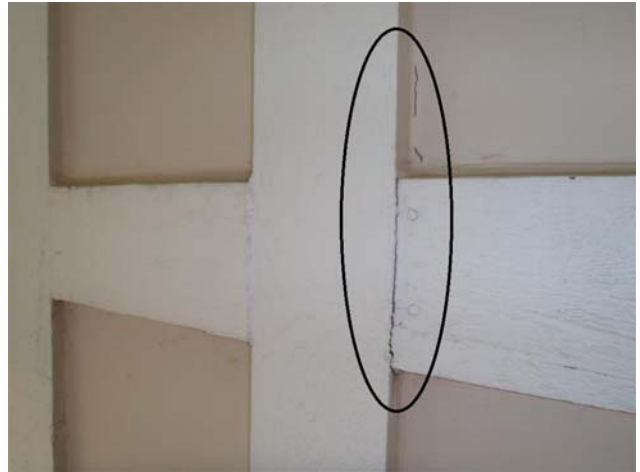
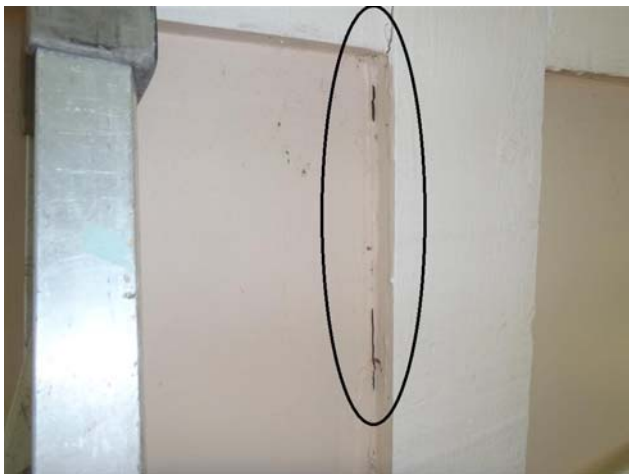
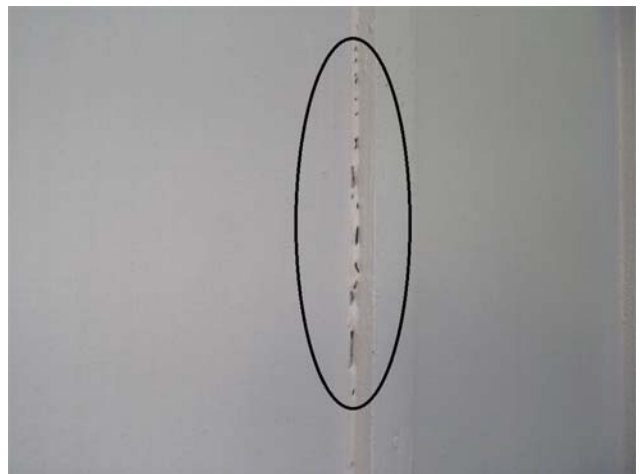
- **Repair:** The siding trim needs minor caulking improvements in localized areas to prevent water damage and rot.
Repaired

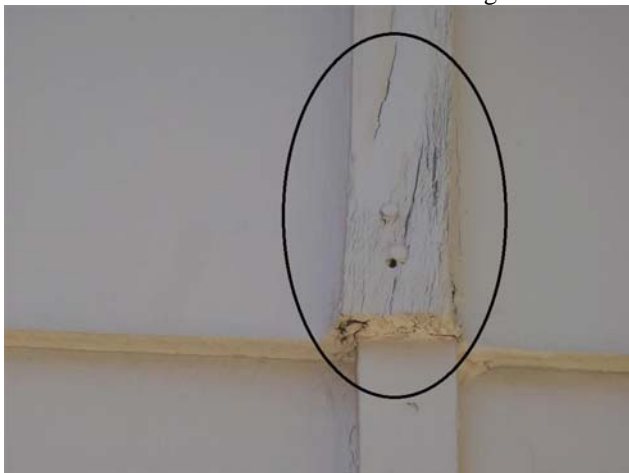
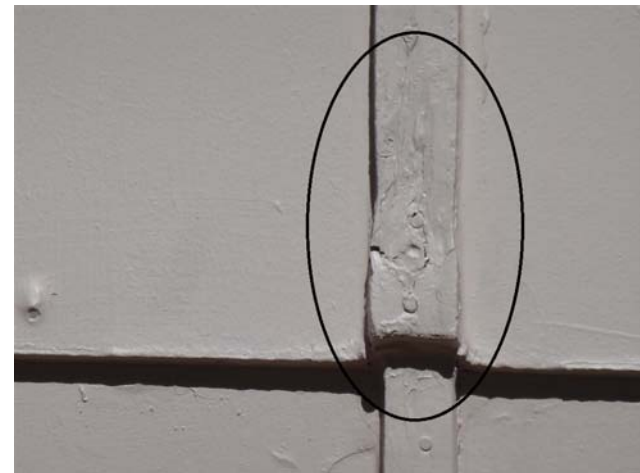
- **Repair:** Localized minor rot was observed in the trim around the siding. Following repair of the damaged areas (which should be combined with exterior painting/maintenance) proper maintenance of the siding and control of water from roof or surface runoff can avoid further damage.

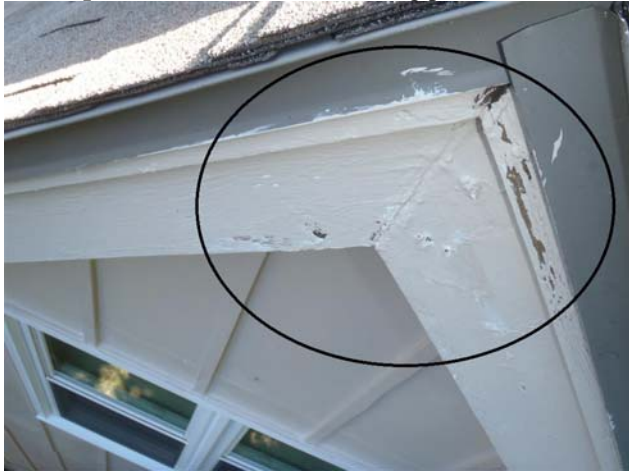
Exterior Eaves

- **Repair:** The north eave is lacking paint and should be painted to prevent water damage and rot. **Repaired**

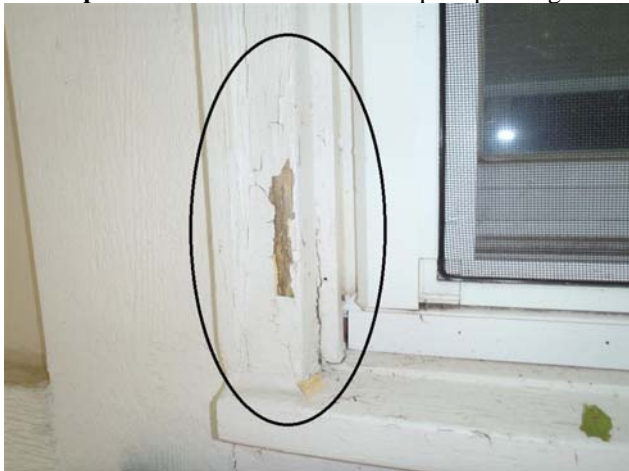
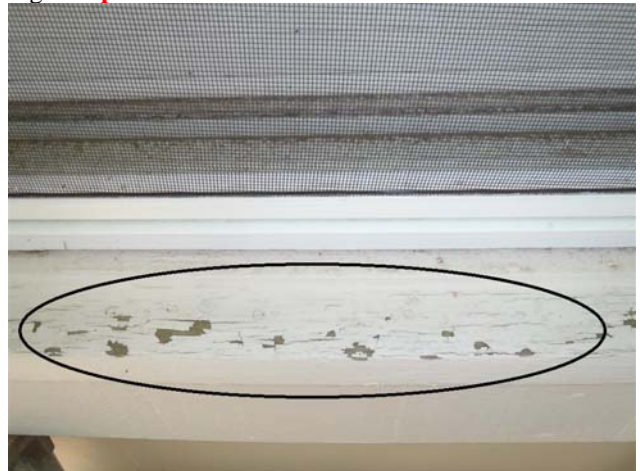
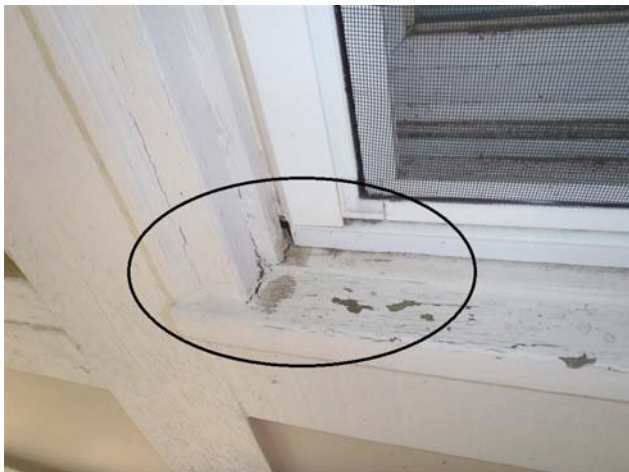
- **Repair:** Some window frames require painting and caulking. **Repaired**

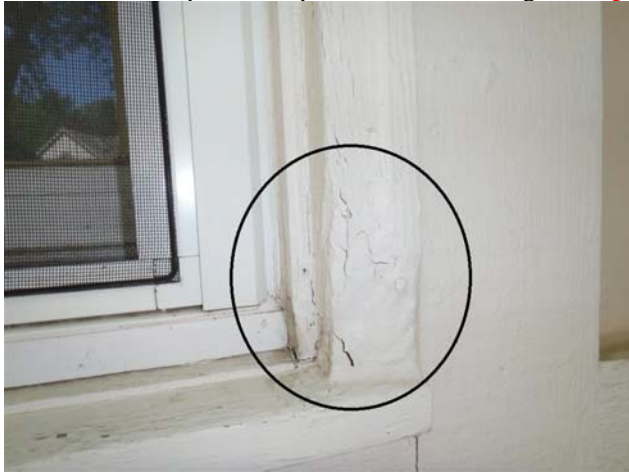
- **Monitor:** There appears to be some minor rot repairs to window trim/frames. These areas are currently protected with paint and do not need immediate attention. It is recommended, however, that these areas be monitored closely and kept caulked and painted to prevent further damaged. **Repaired**

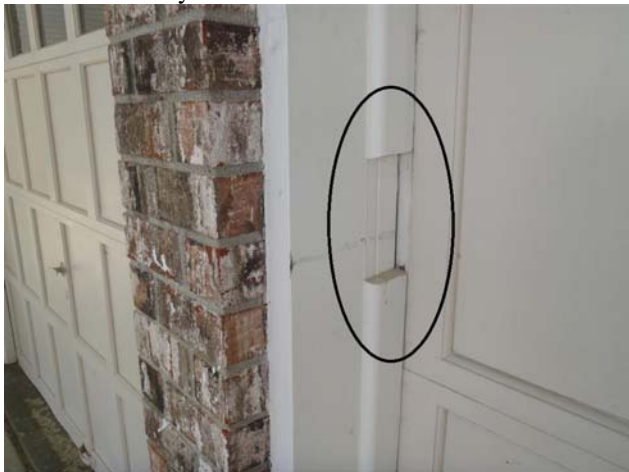
Garage

- **Monitor, Repair:** The north garage door trim has been cut out to give clearance for the mirrors on the SUV. Repair is discretionary

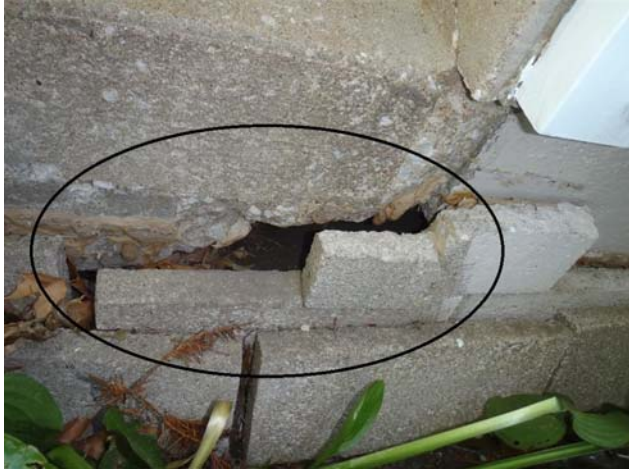
Porch

- **Monitor, Repair:** The steps serving the porch have settled and there is an absence of soil underneath due to settlement and/or erosion or vermin activity. It's recommended the cavity be filled to help prevent further settlement. **Repaired**

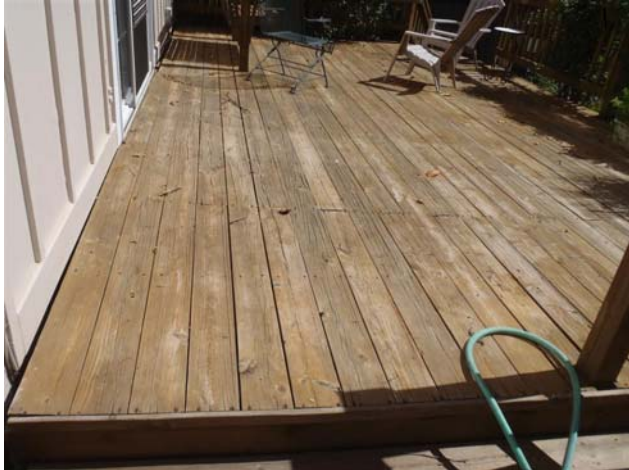
- **Recommend:** The deck is in fair condition and it's recommended it be stained or painted to prolong its life.

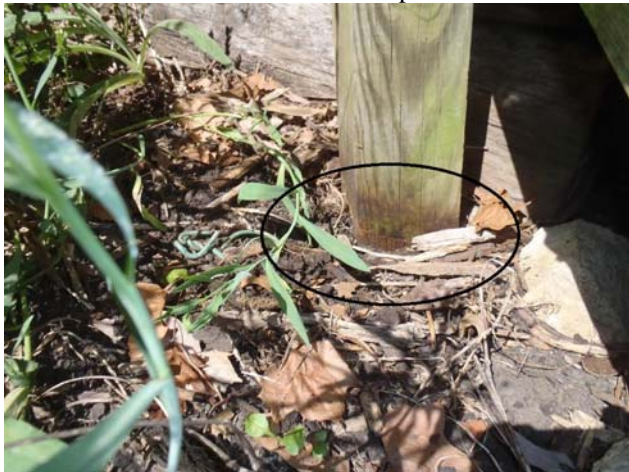
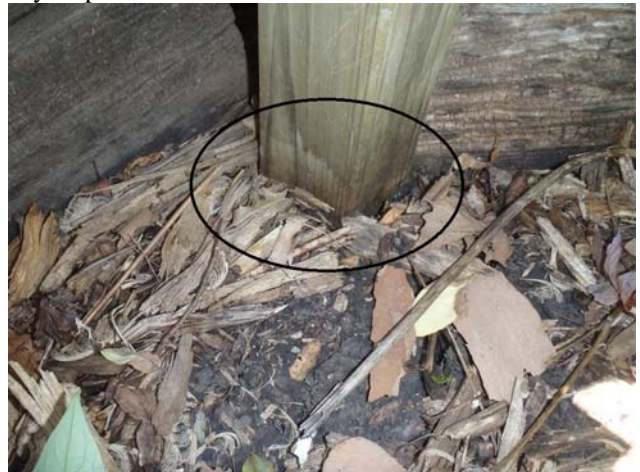
- **Monitor, Repair:** The support posts for the deck are below the soil. This configuration is prone to rot. Rising above soil level is recommended. The potential of rot could already be present.

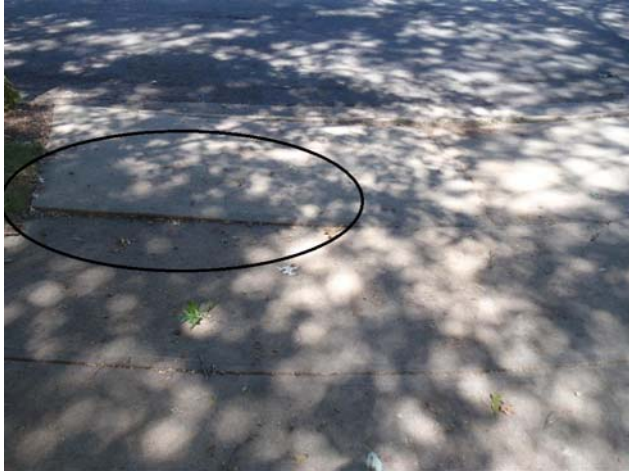
Driveway

- **Monitor:** The soil below the driveway has settled and/or heaved resulting in an uneven surface and cracks. Persisting movement may result in the need for resurfacing.

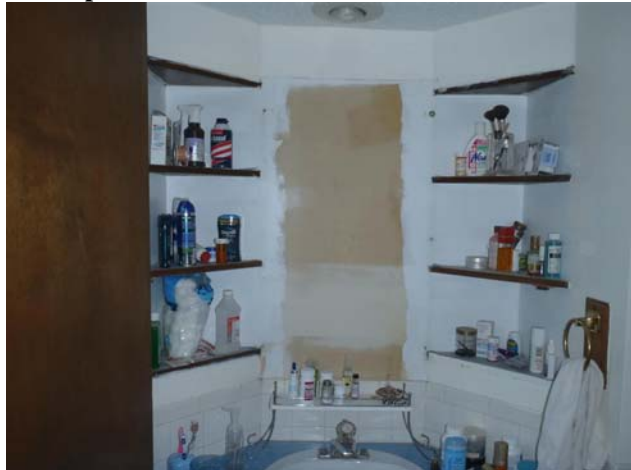
- **Repair:** The mirror has been removed from the master bedroom bath. **Repaired**

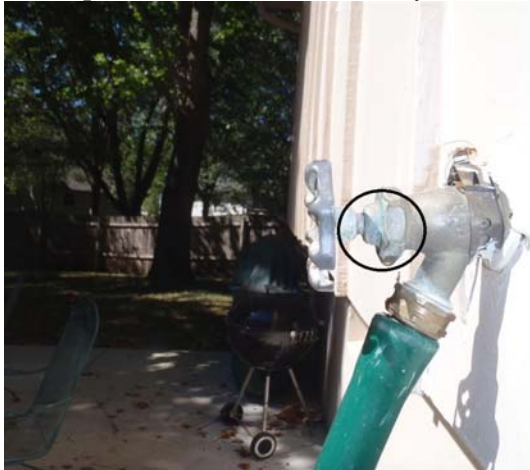
- **Repair:** The rear hose bib is leaky when the water is on.(very minor)

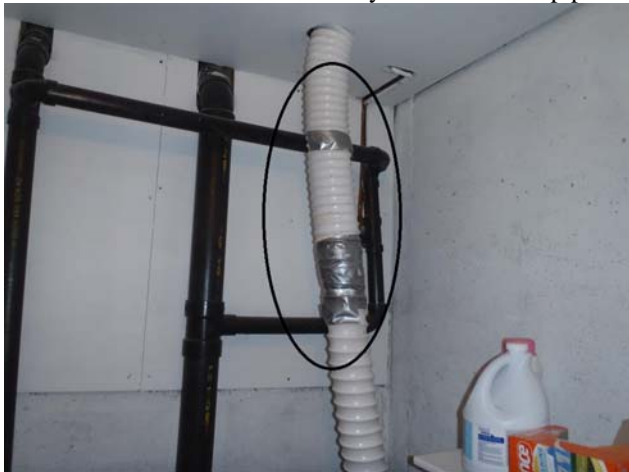
Clothes Dryer

- **Recommend:** The clothes dryer exhaust vent pipe is duct taped. Improvement is recommended.

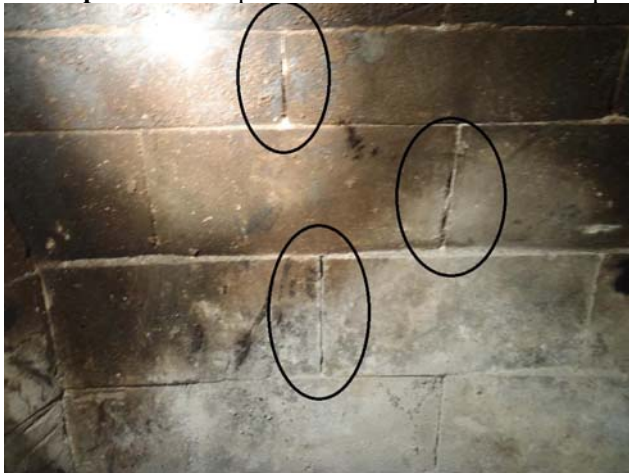
- **Repair:** The fireplace firebox mortar should be repaired. **Repaired**
