**Star
Home
Inspection Services**

Home Inspection Report

18908 34th St, Independence, MO 64057

Report Number: 01172008-1A

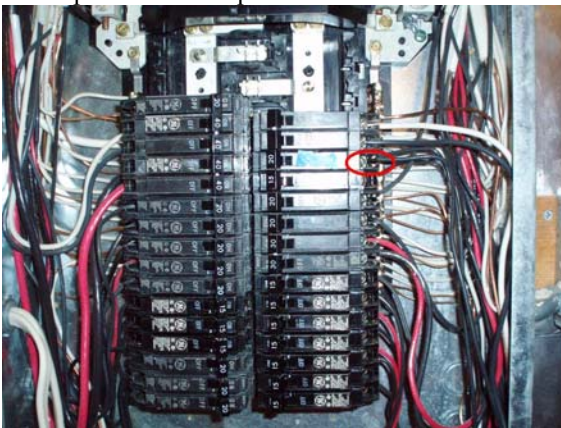
- **Repair:** Circuits within the main distribution panel that are doubled up (referred to as "double taps") and marked with blue tape should be separated. Each circuit should be served by a separate fuse or breaker.
