**Star
Home
Inspection Services**

Home Inspection Report

19133 E 15th St North, Independence, MO 64056

Inspection Date: 4/27/2009

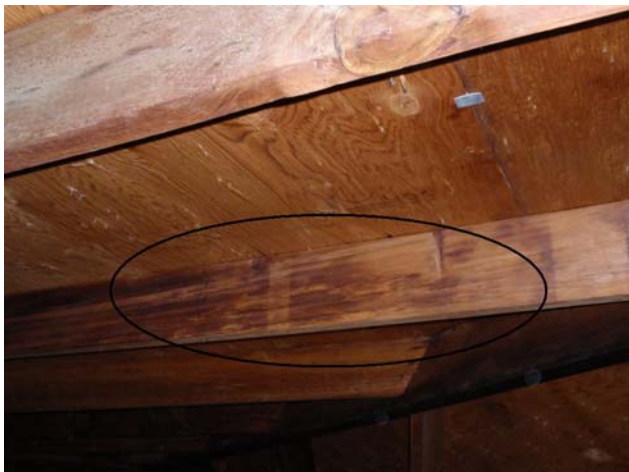
- **Monitor:** Construction mold was visible on some roof rafters. This is mold that grows on the lumber while lying in the weather during construction as evidenced by the strap marks. Most homes have some level of this mold and it goes dormant once removed from the elements and normally does not present any problems. **AS IS**

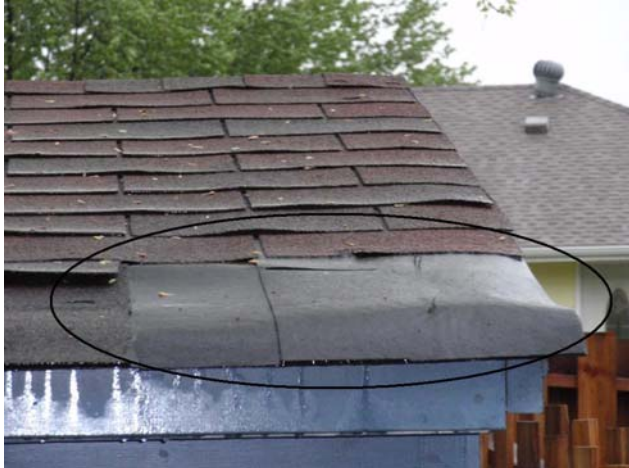
- **Monitor, Repair:** Missing shingles was observed on the corner of the storage shed. Replacement is recommended

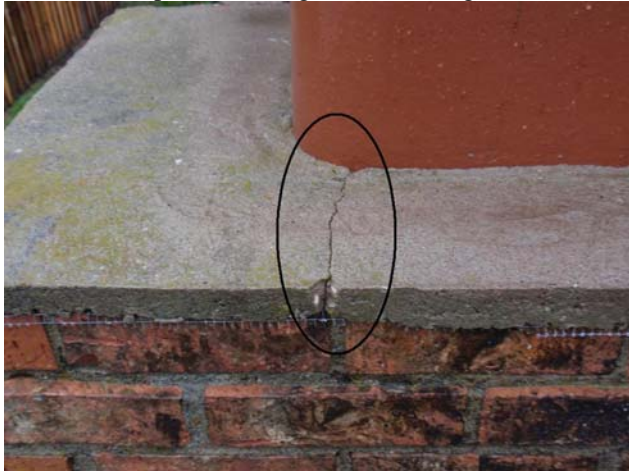
- **Monitor, Repair:** The cap of the masonry chimney is cracked. These cracks should be sealed or caulked before next winter to prevent damage from freezing water. **Will repair**

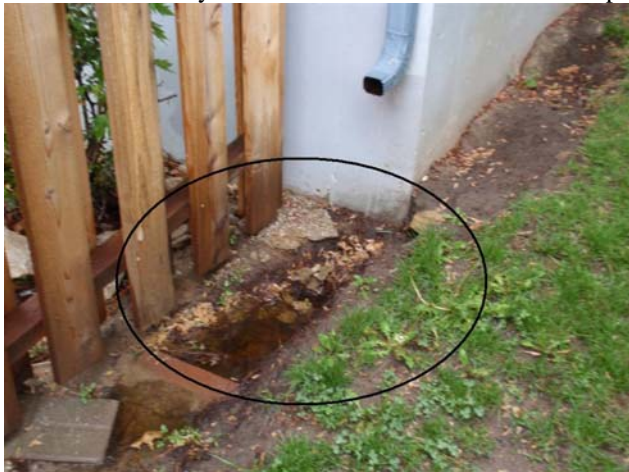
- **Repair:** The downspout(s) should discharge water at least five (5) feet from the house. Storm water should be encouraged to flow away from the building at the point of discharge. The one on the southwest corner needs to be extended away from the foundation and fence to stop the erosion. **Will repair**

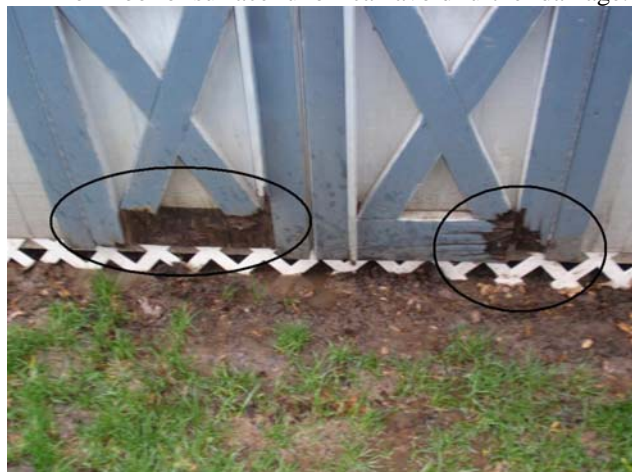
- **Repair:** The exterior of the house needs to be painted. **Full exterior painting and repairs will be completed**
- **Repair:** Localized rot was observed in the siding and trim of the storage shed. Following repair of the damaged areas (which should be combined with exterior painting/maintenance) proper maintenance of the siding and control of water from roof or surface runoff can avoid further damage. **Will repair with painting**

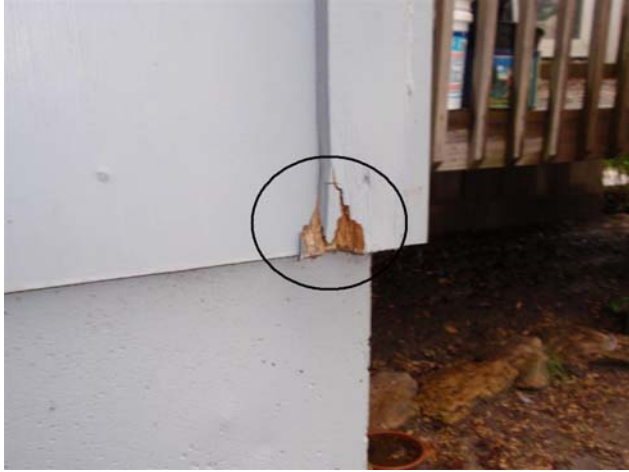
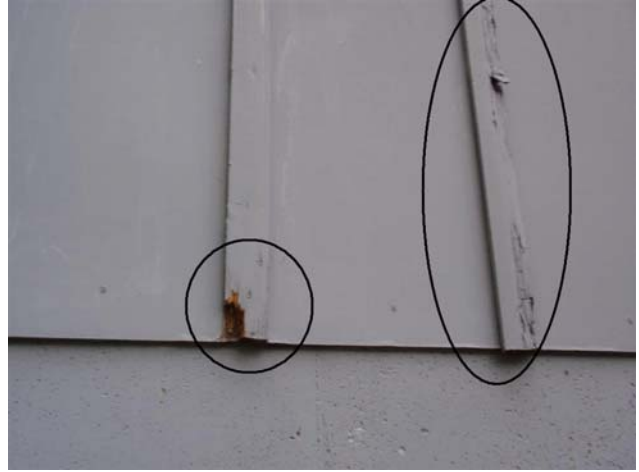
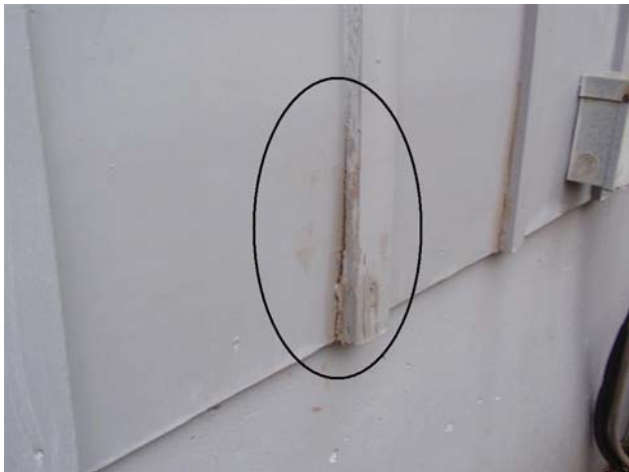
- **Repair:** Localized rot was observed in the bat trim around siding and caulking is needed. Following repair of the damaged areas (which should be combined with exterior painting/maintenance) proper maintenance of the siding and control of water from roof or surface runoff can avoid further damage. **Will repair with painting**

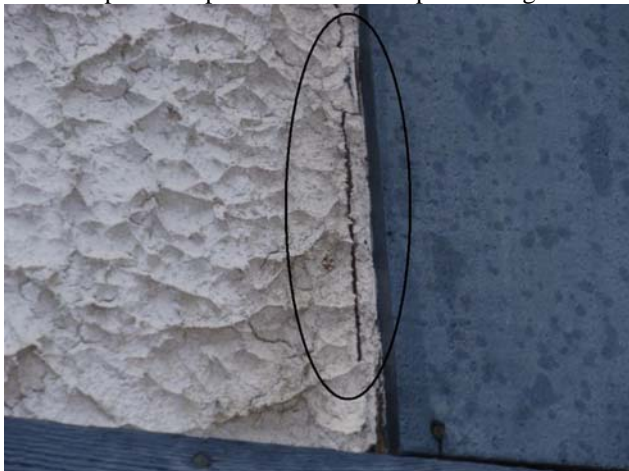
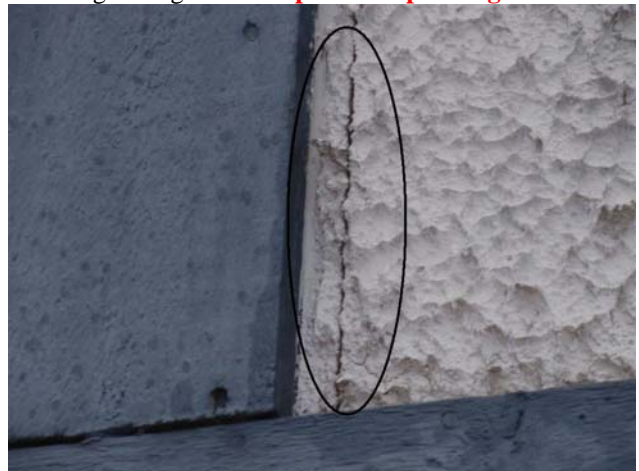
- **Repair:** Cracks were observed in the exterior staccato board/stucco walls on the front of the house. These cracks should be repaired to prevent water from penetrating the wall and causing damage. **Will repair with painting**

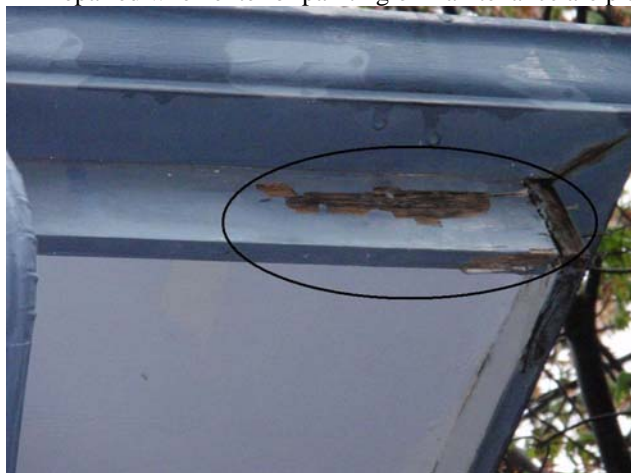
- **Monitor:** Localized rot and/or vermin damage was observed in the fascia (the wooden board to which the gutter is typically fastened) on the southwest corner. Improvement is not necessary at present, although this condition should be repaired when exterior painting or maintenance are planned.

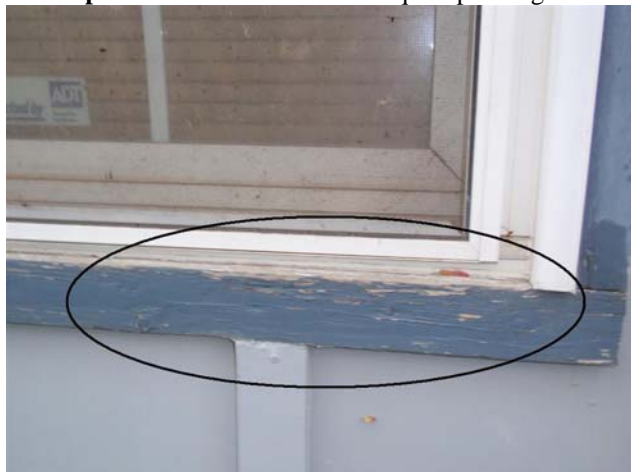
- **Repair:** The window frames require painting and caulking.

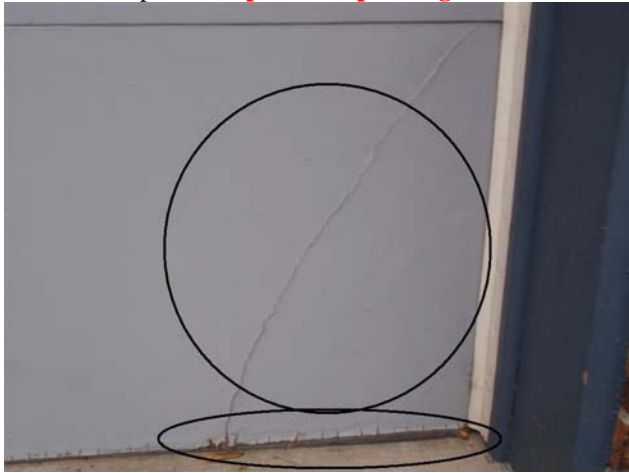
- **Monitor, Repair:** The west overhead garage door lower panel shows evidence of minor water damage and is cracked. These areas should be monitored closely. Maintain with a good coat of paint and keeping any cracks or open areas closed up. **Will repair with painting**

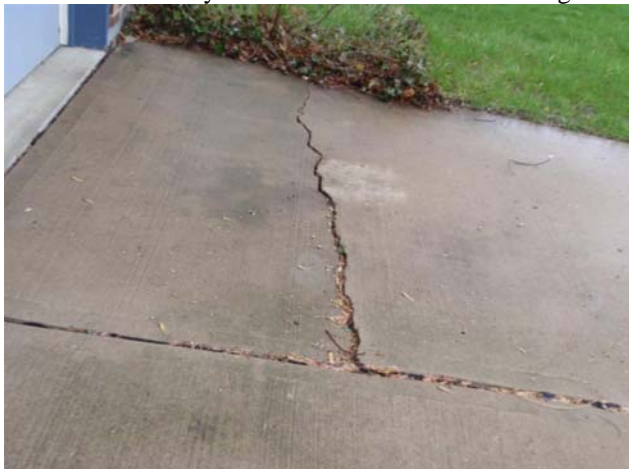
- **Monitor:** The soil below the driveway has settled and/or heaved resulting in more than typical cracking. Persisting movement may result in the need for resurfacing. **AS IS**

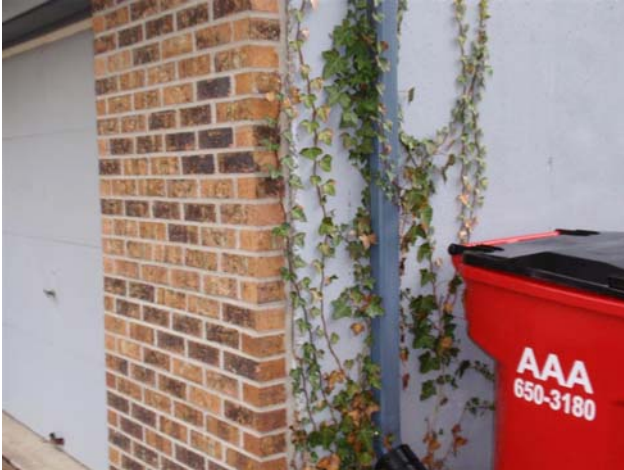
- **Repair:** Shrubs, bushes and/or vines growing on exterior walls need to be trimmed away from the structure to reduce the risk of water damage and insect infestation. **Repaired**

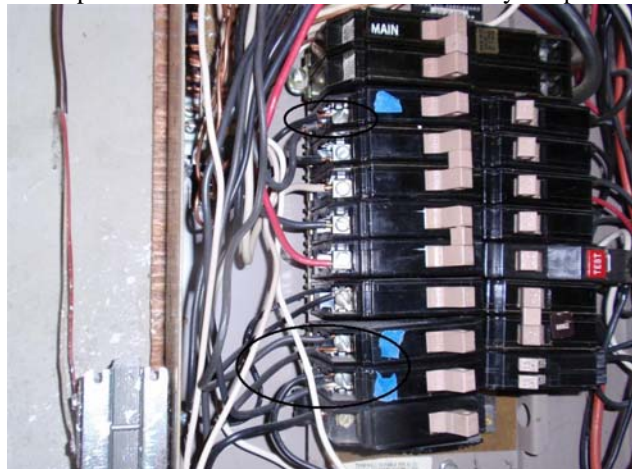
- **Repair:** Circuits within the main distribution panel that are doubled up (referred to as "double taps") should be separated. Each circuit should be served by a separate fuse or breaker. **Will Repair**

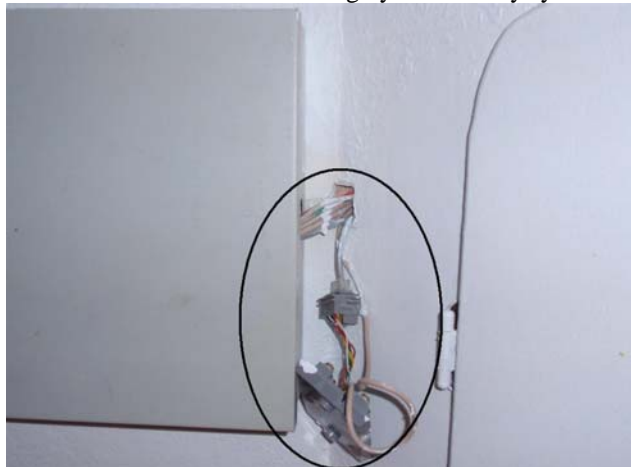
- **Recommend:** Loose wiring by the security system main panel should be secured. **Will Repair**

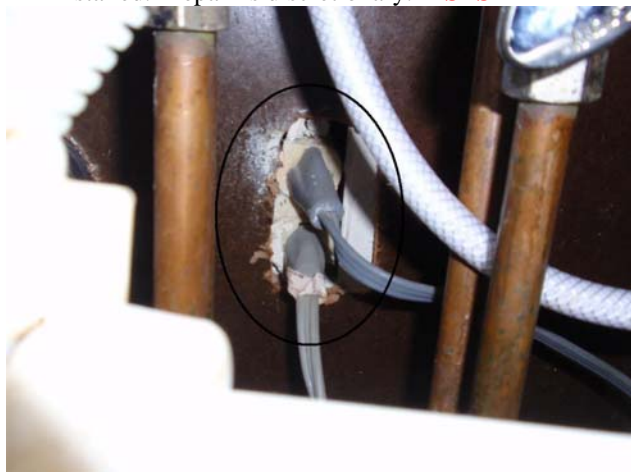
- **Repair:** Ungrounded 3-prong outlet in the basement bathroom should be repaired. In some cases a ground wire may be present in the electrical box and simply needs to be connected. **Will repair**
- **Monitor, Repair:** The cover is missing on the disposal outlet. The cabinet may need to be modified before one can be installed. Repair is discretionary. **AS IS**

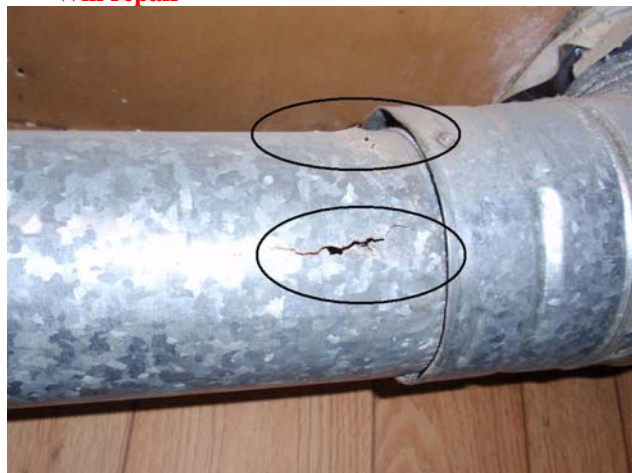
- **Repair, Safety Issue:** *Poor exhaust flue in the garage is rusted.* Holes due to rust risk flue gas and carbon monoxide leakage or other unsafe conditions. This should be repaired and the entire flue checked by a qualified HVAC technician.
Will repair

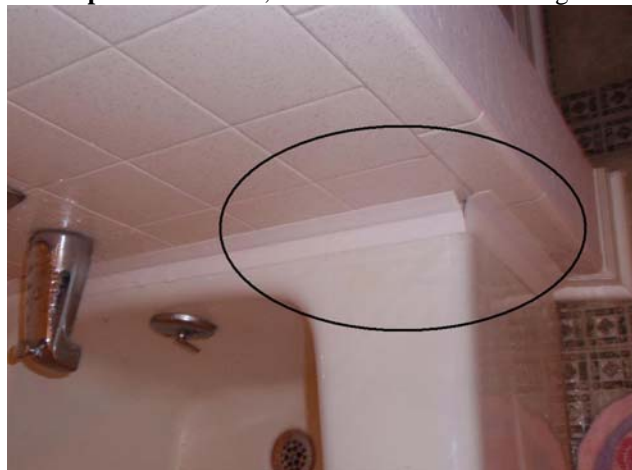
- **Repair:** The hallway bathroom sink drain plug is inoperative or missing and needs repair. **AS IS**
- **Improve:** Cracked, deteriorated and/or missing bathtub enclosure caulk could be improved. **AS IS**

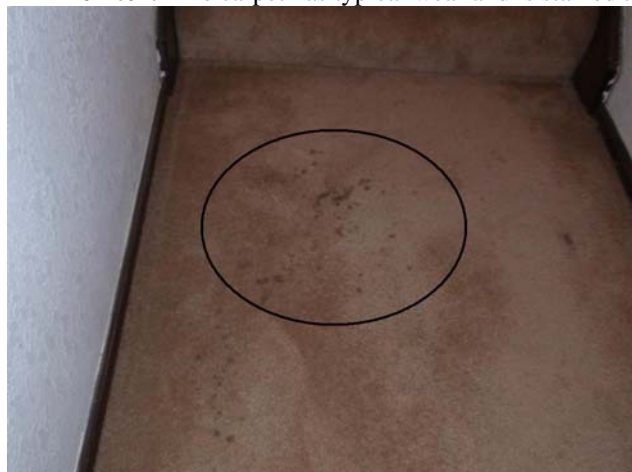
- **Monitor:** The carpet has typical wear and is stained at the bottom of the basement stairway. **AS IS**

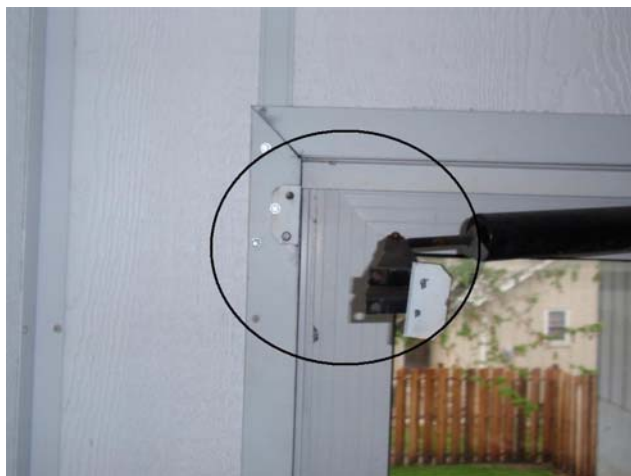
- **Monitor, Repair:** Doors to the furnace room and northeast bedroom should be adjusted as necessary to latch properly. **AS IS**
- **Repair:** The damaged and/or loose auto closer on the rear storm doors needs repair. **Will repair**

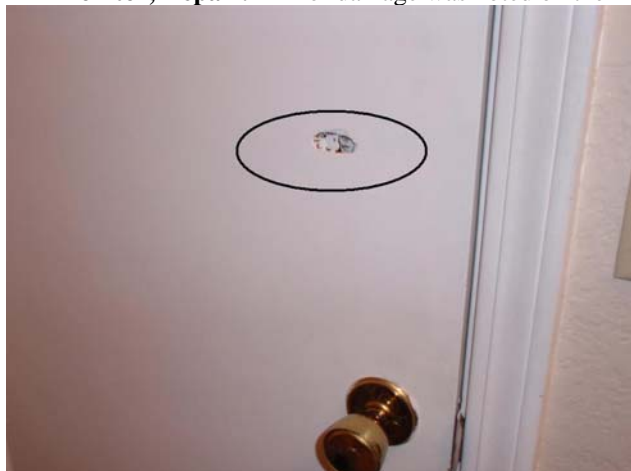
- **Monitor, Repair:** Minor damage was noted on the master bedroom bath door. Repair is discretionary **AS IS**

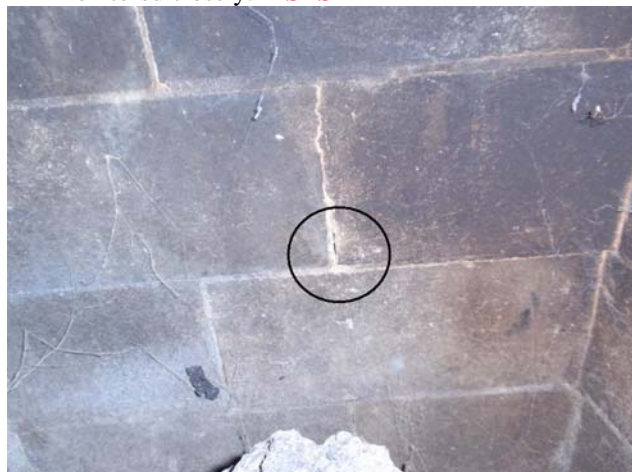
- **Monitor:** The fireplace firebox mortar is showing signs of wear. Repair is not necessary at this time but it should be monitored closely. **AS IS**
