**Star
Home
Inspection Services**

Home Inspection Report

200 Cherry Hill Ct, Belton, MO 64012

Inspection Date: 11/11/2008

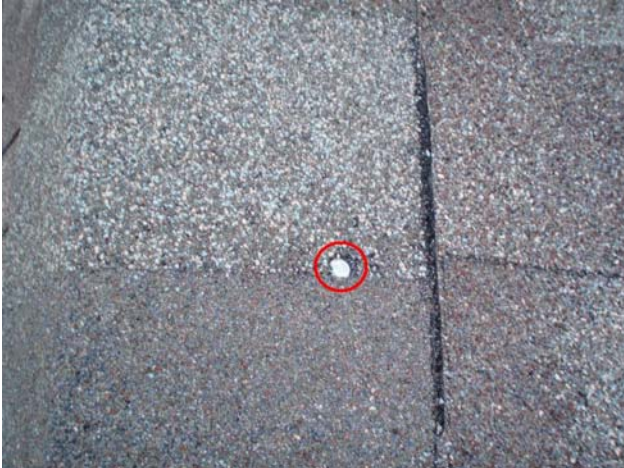
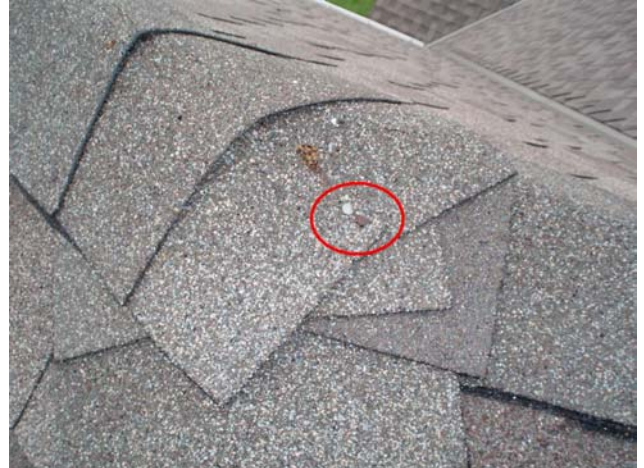
Sloped Roofing

- **Repair:** Nail heads are exposed at the ridge cap. They should be sealed to reduce risk of leaks.

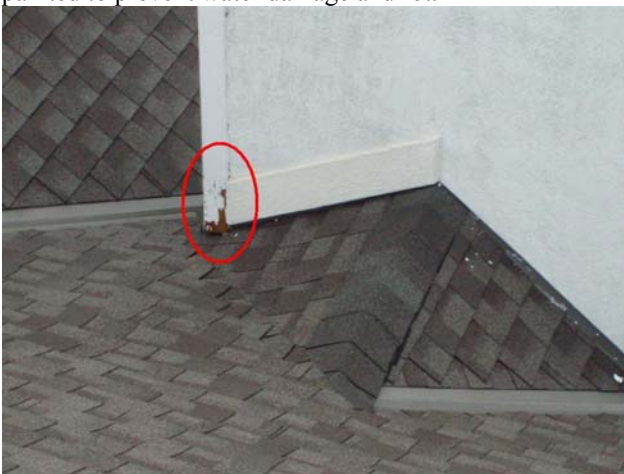
- **Repair:** The paint on the trim around the siding, windows, doors, and chimney is peeling. These areas should be painted to prevent water damage and rot.

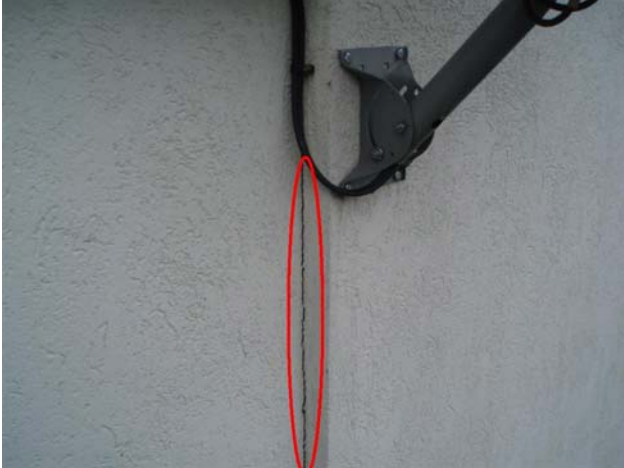
- **Monitor, Repair:** Cracks were observed in the exterior stucco walls. Repair is not critical at this time but these cracks should be filled or repaired when exterior painting is planned. There is risk of damage if water can penetrate the walls.

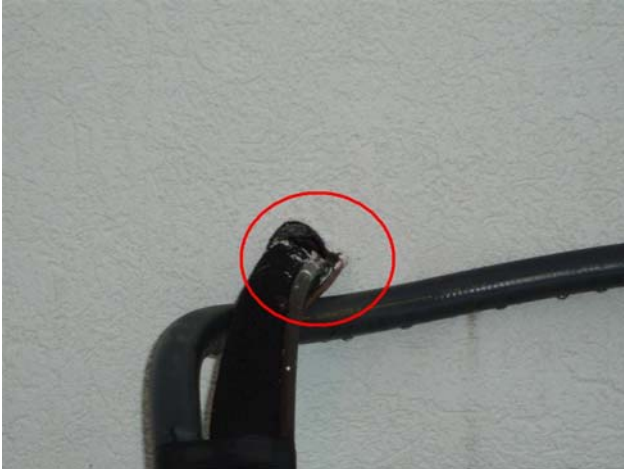
- **Improve:** Opening where heat pump lines enter home at siding should be sealed.

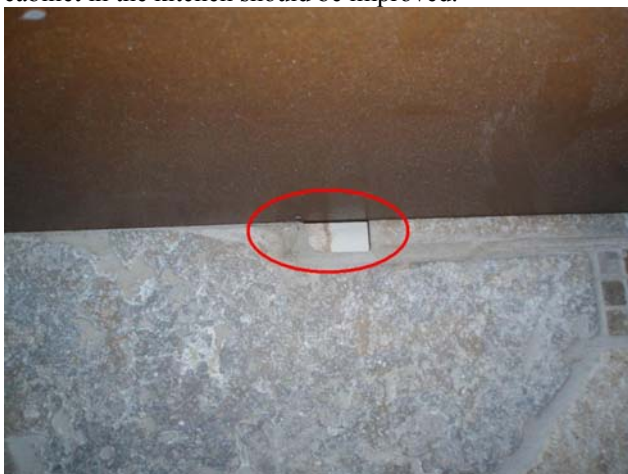
Kitchen Counters

- **Repair:** Damaged, missing or loose grouting of the tile countertops backsplash and back wall near bottom of upper cabinet in the kitchen should be improved.
