**Star
Home
Inspection Services**

Home Inspection Report

20012 S Stockman Rd Belton, MO 64012

Inspection Date: 01/21/2010

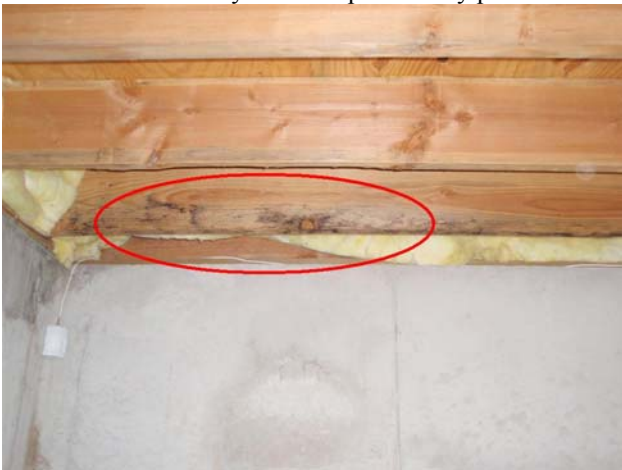
- **Monitor:** Construction mold was visible on some floor joists. This is mold that grows on the lumber while lying in the weather during construction. Most homes have some level of this mold and it goes dormant once removed from the elements and normally does not present any problems.

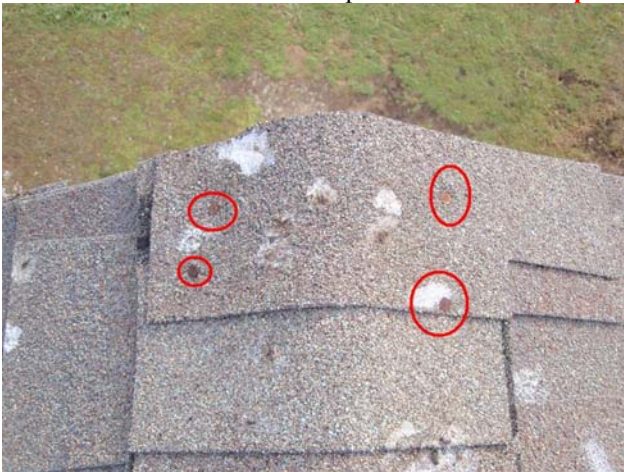
- **Recommend:** Exposed nail heads were observed in the roofing shingles and/or ridge caps. All exposed nail heads should be caulked to reduce the potential of leaks. **Repaired**

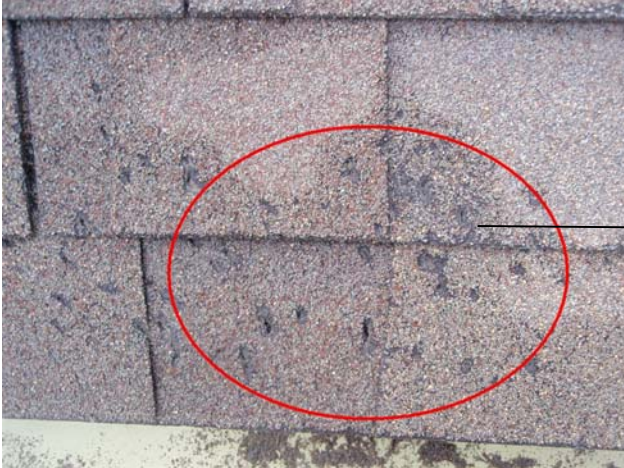
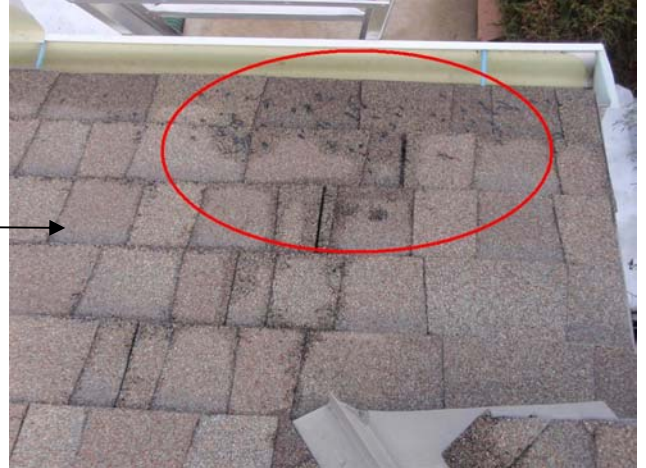
- **Repair:** Minor repairs to the roofing are needed. Damaged or missing roofing material should be repaired. All roof penetrations should be examined and sealed as necessary. **Repaired**

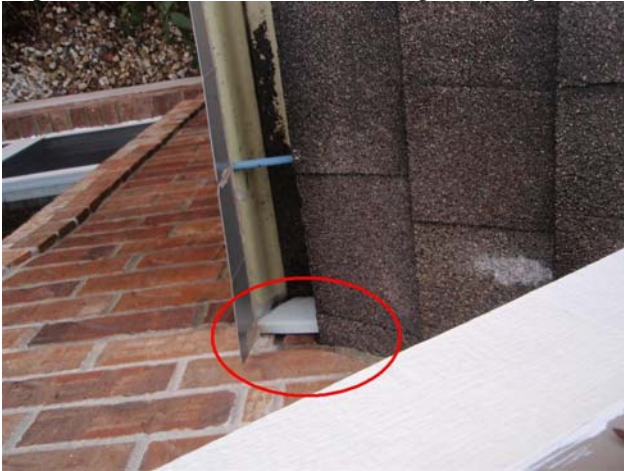
- **Repair:** The installation of the flashing is incomplete and should be repaired to avoid leaks. **Repaired**

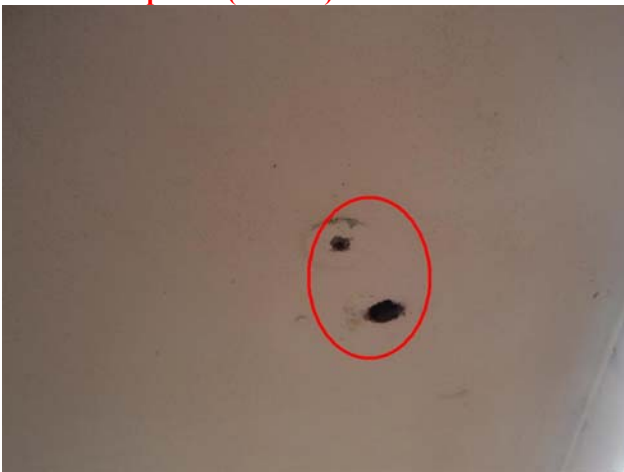
- **Repair:** Siding of this type requires considerable monitoring and maintenance. It has a tendency to pop out past nail heads creating a space where two panels join together. Re-securing and caulking the seams and nail holes is standard maintenance for this type of siding.
- **Repair:** The exterior siding paint is peeling and/or worn thin in localized areas (i.e. bottom edge of siding). These areas should be painted to prevent water damage or rot in the future.
- **Repair:** Any openings in the exterior siding should be sealed. An example is at the soffit over the back deck. Caulking is needed. **Repaired (caulked)**

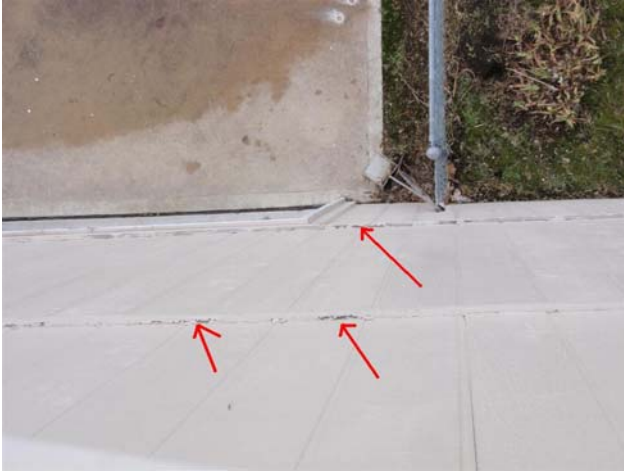
- **Repair:** Localized rot was observed in the siding. Following repair of the damaged areas (which should be combined with exterior painting/maintenance) proper maintenance of the siding and control of water from roof or surface runoff can avoid further damage.
- **Repair:** The siding trim needs caulking improvements in localized areas to prevent water damage and rot.
- **Repair:** The paint on the trim around the siding and shed is peeling. These areas should be painted to prevent water damage and rot.

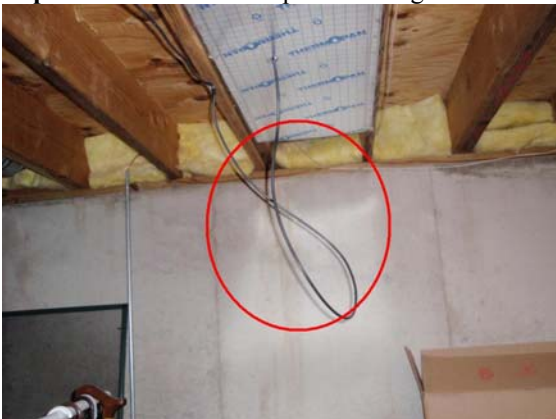
- **Repair:** Loose cable and phone wiring in the basement should be secured.

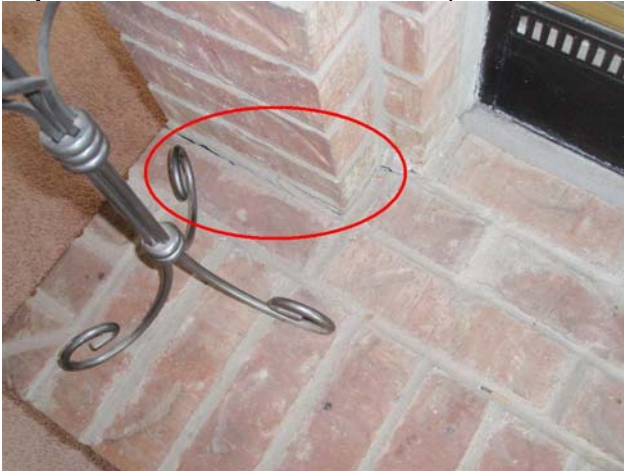
- **Improve:** Mortar deterioration at the fireplace hearth was observed. Repairs are discretionary.
