**Star  
Home  
Inspection Services**

*Home Inspection Report*

**2020 W 48th Terr, Westwood, KS 66205**

**Report Number: 08072008-1G**

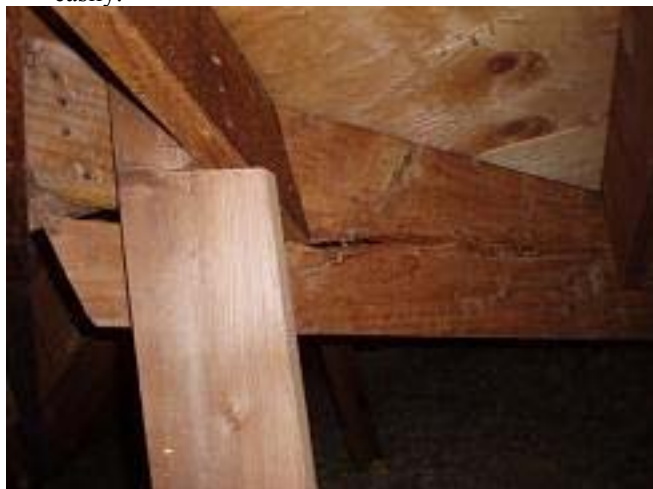
#### Roof

- **Monitor:** One of the rafters of the roof structure is cracked. Strengthening the roof structure would resist further movement. This improvement is not priority unless the roof is likely to be subjected to heavy loads such as from snow or additional layers of roofing material whose weight could cause further damage. Additional support can often be added easily.

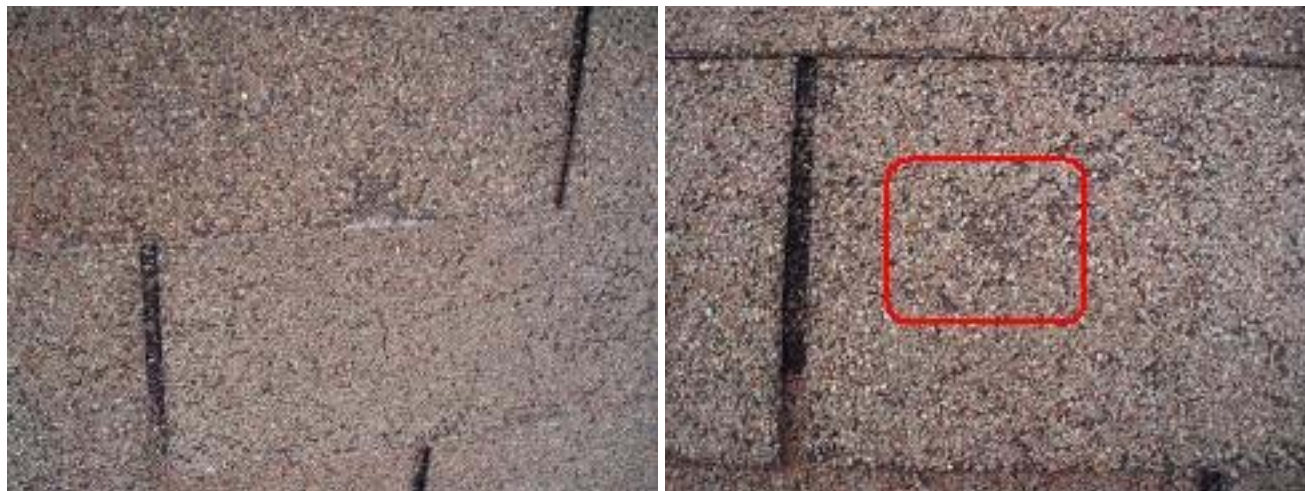
#### Sloped Roofing

- **Repair:** Repairs to the roofing are needed (suspected storm damage). Damaged or missing roofing material should be repaired. All roof penetrations should be examined and sealed as necessary. The roofing materials are older and approaching the end of their useful life.

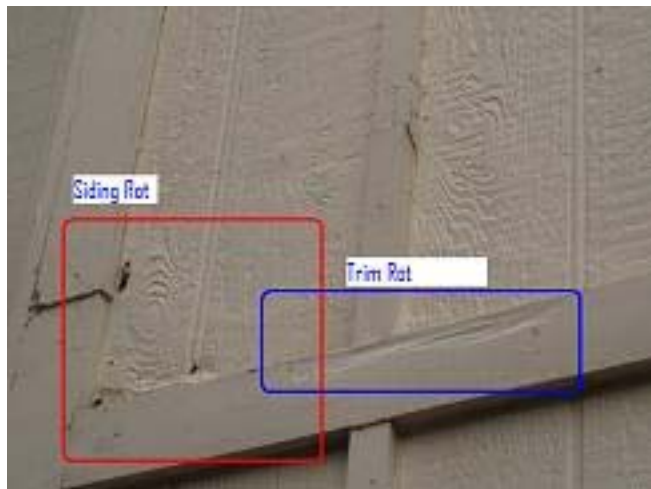
#### Exterior Walls

- **Repair:** Localized rot was observed in the siding. Following repair of the damaged areas (which should be combined with exterior painting/maintenance) proper maintenance of the siding and control of water from roof or surface runoff can avoid further damage.
- **Repair:** The paint on trim around siding is peeling. These areas should be painted to prevent water damage and rot.
- **Repair:** Localized rot was observed in the trim around siding. Following repair of the damaged areas (which should be combined with exterior painting/maintenance) proper maintenance of the siding and control of water from roof or surface runoff can avoid further damage.

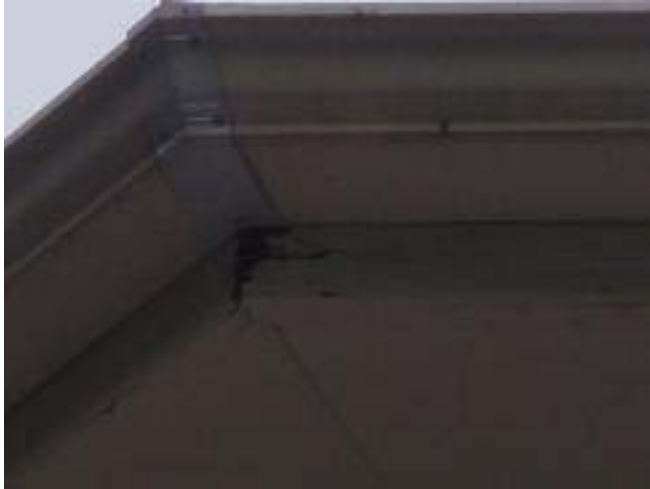
### Exterior Eaves

- **Monitor:** Localized rot was observed in the fascia (the wooden board to which the gutter is typically fastened). Improvement is not necessary at present, although this condition should be repaired when exterior painting or maintenance are planned.
