Home Inspection Report

204 E 74th St, Kansas City, MO 64114

Inspection Date: 06/30/2009

Report Number: 06302009-1A

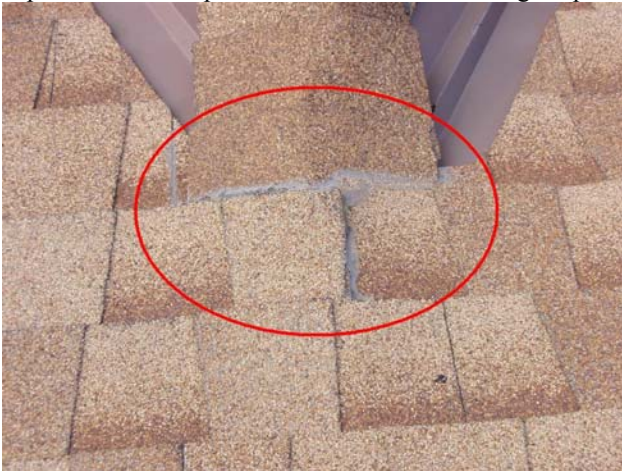
- **Monitor:** Prior minor repairs to the roofing are evident (caulking). This would suggest that problems have been experienced in the past. This area at the back ridge cap should be monitored.

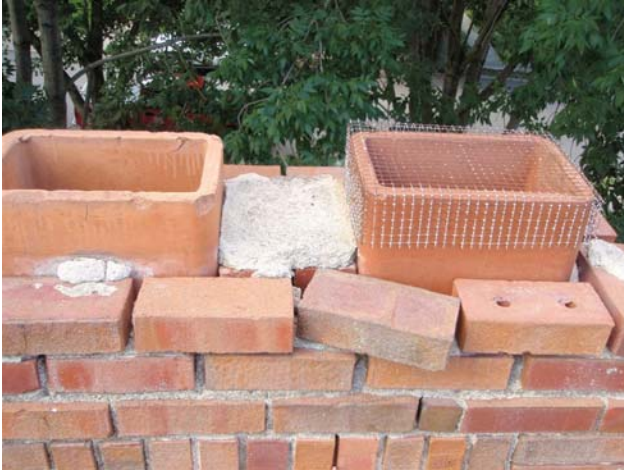
- **Repair:** The cap of the masonry chimney should be replaced and the chimney flue should be checked for damage. Damaged flues can be unsafe.
- **Repair:** A rain cap and vermin screen should be installed on the masonry chimney and the chimney flue should be checked for damage. Damaged flues can be unsafe.

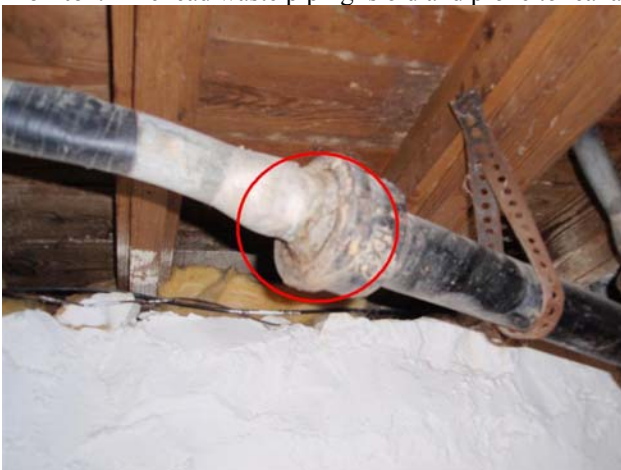
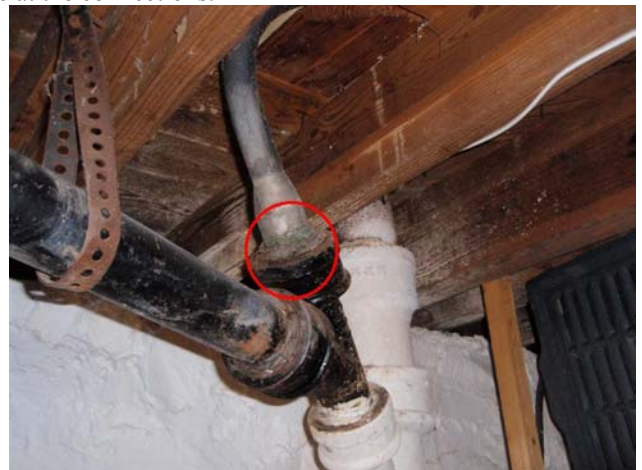
- **Monitor:** The lead waste piping is old and prone to leakage at the connections.
