**Star  
Home  
Inspection Services**

*Home Inspection Report*

**20926 W 117th St, Olathe, KS 66061**

**Report Number: 01232009-2A**

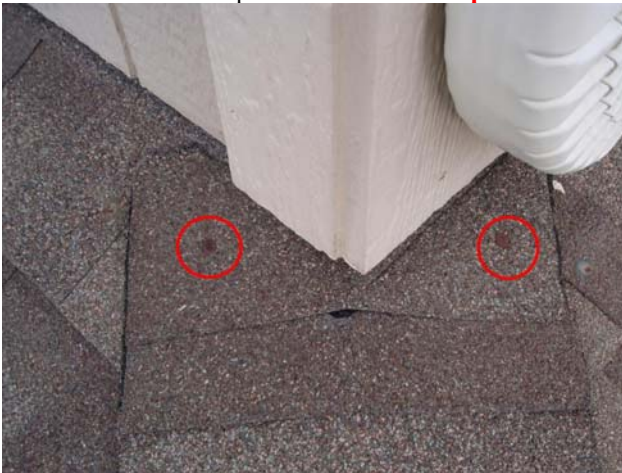
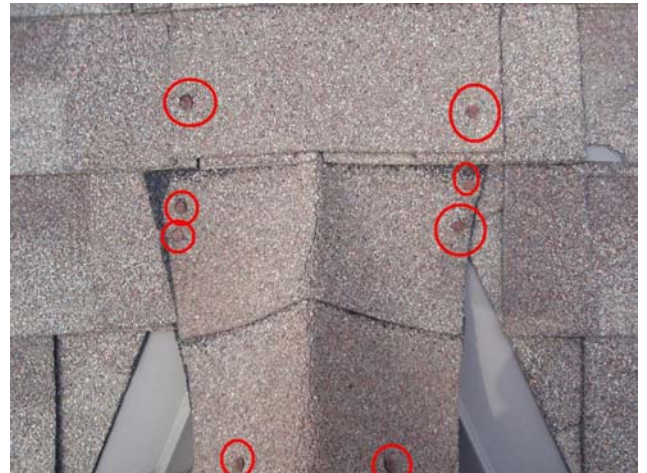
- **Repair:** Exposed nail heads were observed in the roofing shingles and/or ridge caps. All exposed nail heads should be caulked to reduce the potential of leaks. **Repaired**

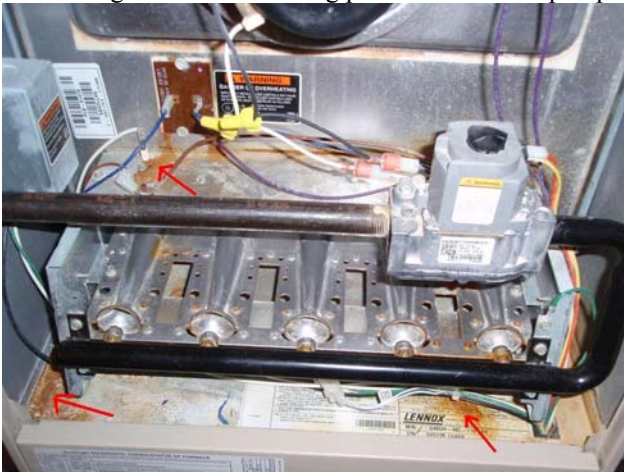
- **Monitor:** Minor surface rust was observed inside the furnace housing, suggesting the condensate line leading from the furnace may be dirty and may need to be cleaned to avoid blockage and possible improper operation of the equipment when using the air conditioning portion of the heat pump when the weather changes in the spring/summer.

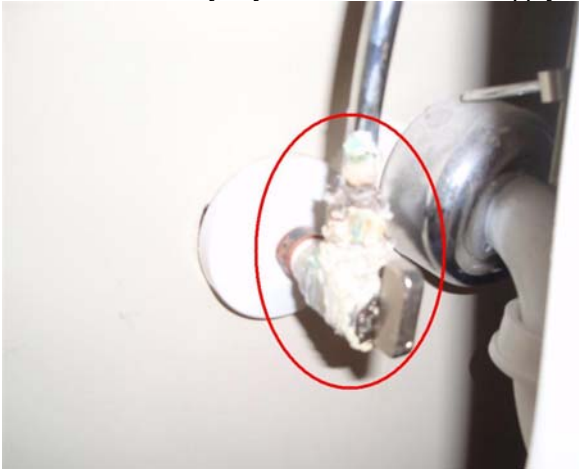
- **Monitor:** The entryway bathroom hot water supply line shows evidence of prior leakage.

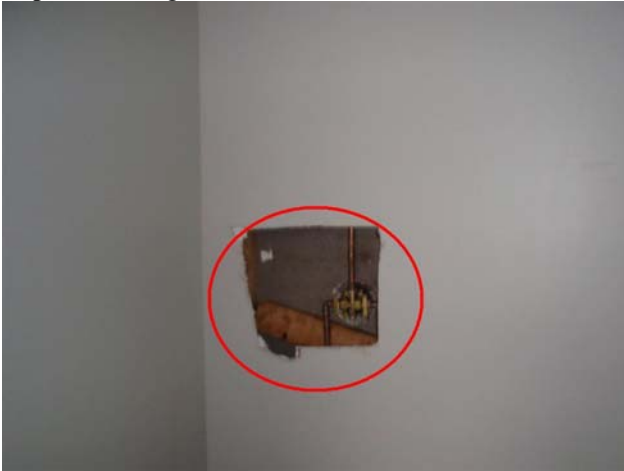
- **Repair:** Damage to the interior finish was observed at the master bedroom wall behind the shower. **Repaired**
