Home Inspection Report

211 W Sierra Dr Raymore, MO 64083

Inspection Date: 11/18/2009

Report Number: 11182009-1A

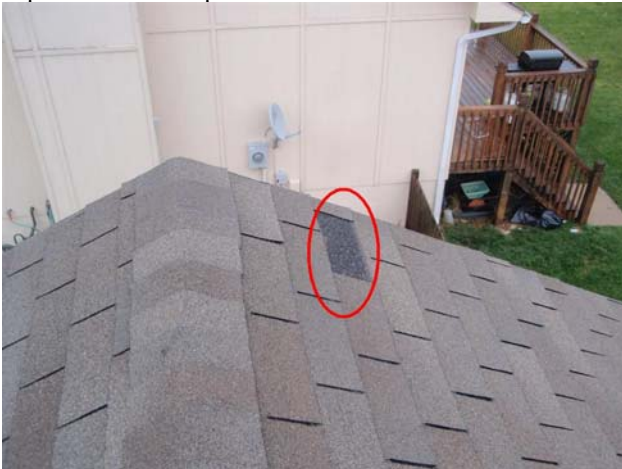
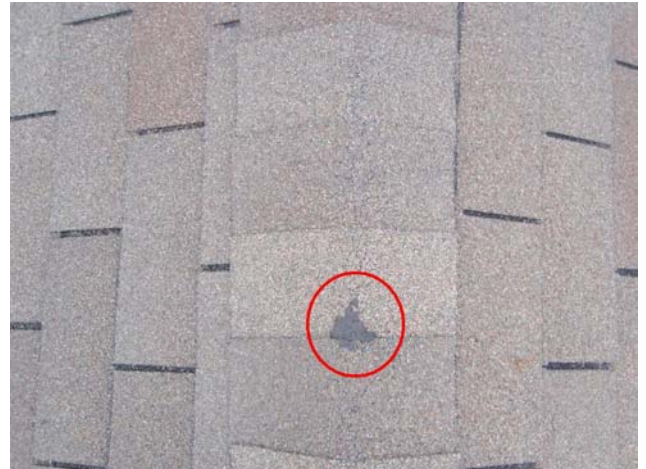
Sloped Roofing

- **Monitor, Repair:** Missing tab was observed. This area should be monitored closely, especially after instances of high wind.
- **Monitor:** Prior minor repair to the roofing ridge cap is evident. This would suggest that problems have been experienced in the past. This area should be monitored.

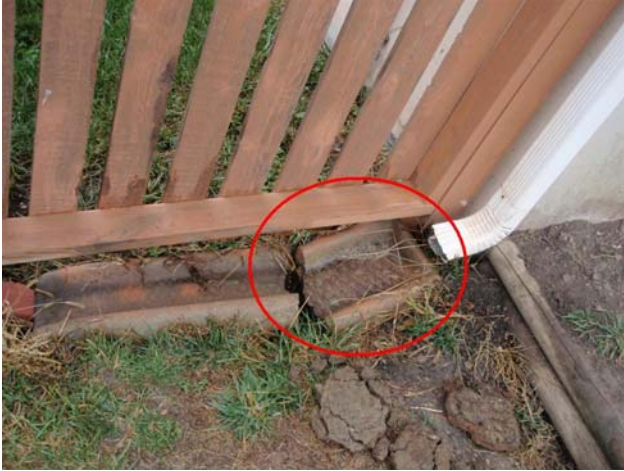
Gutters & Downspouts

- **Recommend:** The downspout(s) should discharge water at least five (5) feet from the house. Storm water should be encouraged to flow away from the building at the point of discharge.
- **Repair:** Damaged downspout splash pans should be replaced.

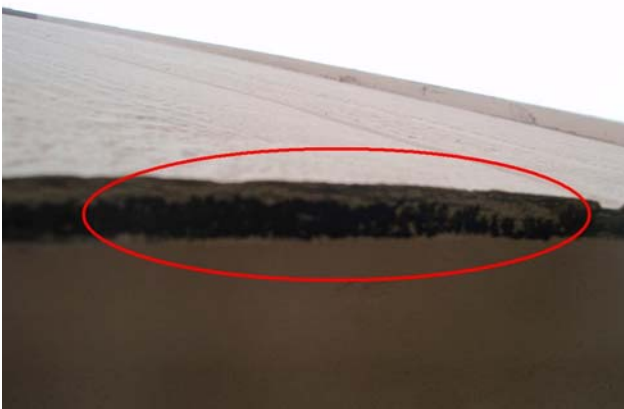
- **Repair:** The exterior siding paint is peeling and/or worn thin in localized areas (i.e. bottom edge of siding). These areas should be painted to prevent water damage or rot in the future.

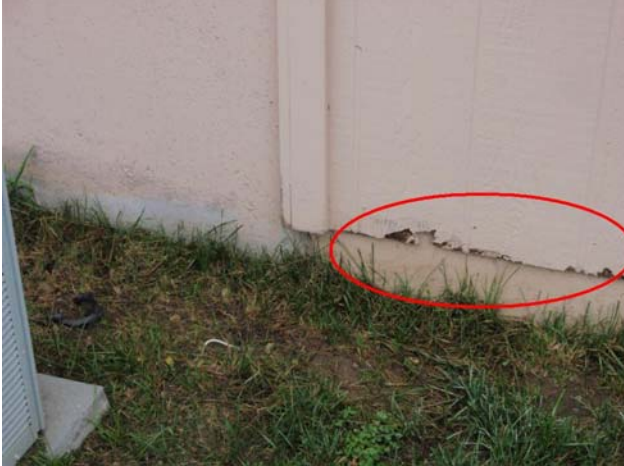
- **Repair:** Localized minor rot was observed in the siding (i.e. east side near air conditioner). Following repair of the damaged areas (which should be combined with exterior painting/maintenance) proper maintenance of the siding and control of water from roof or surface runoff can avoid further damage.
