Star Home Inspection Services

Home Inspection Report

2115 E 153rd Terr, Olathe, KS 66062

Report Number: 10152008-2A

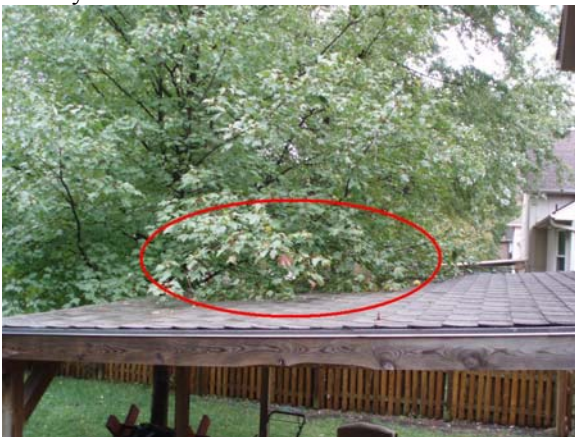
Trim away tree branches close to the roof.

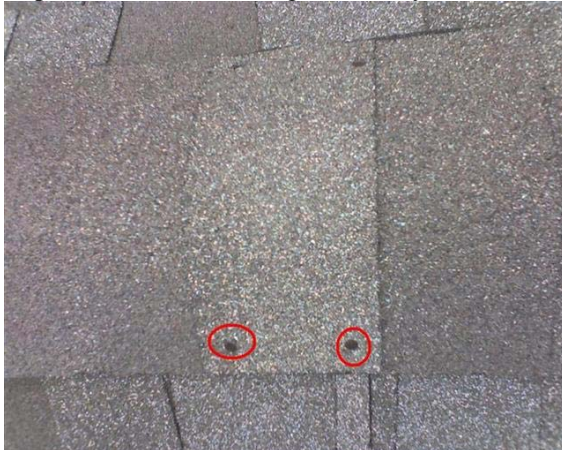
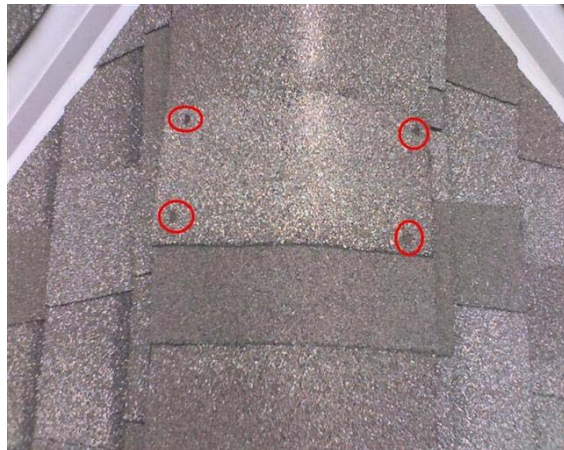
Sloped Roofing

- **Repair:** Nail heads are exposed. They should be sealed to reduce risk of leaks.

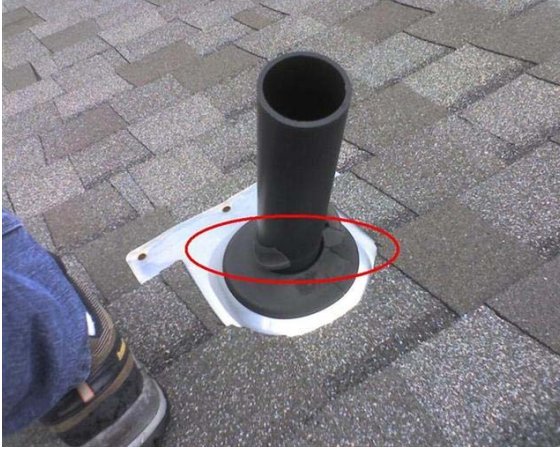
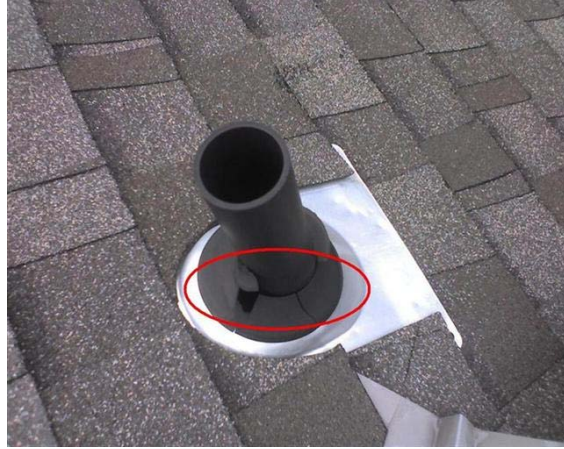
Flashings

- **Repair:** The plumbing vent flashing boot(s) are split making them (4) vulnerable to leaks. It's recommended that the boots be caulked or the flashing replaced.

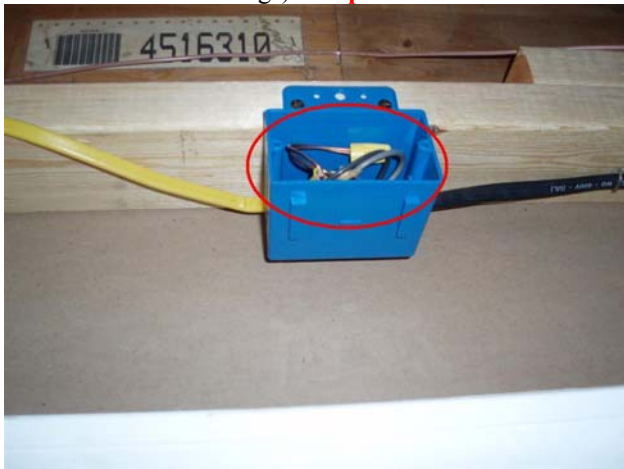
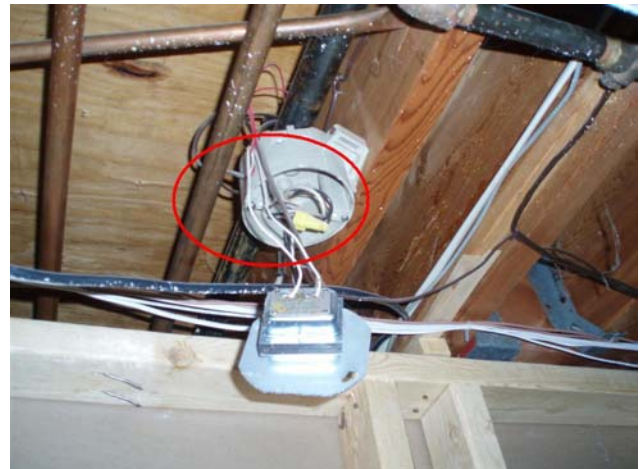
Distribution Wiring

- **Repair:** All junction boxes should be fitted with cover plates, in order to protect the wire connections (main panel room and furnace room ceilings). **Repaired**

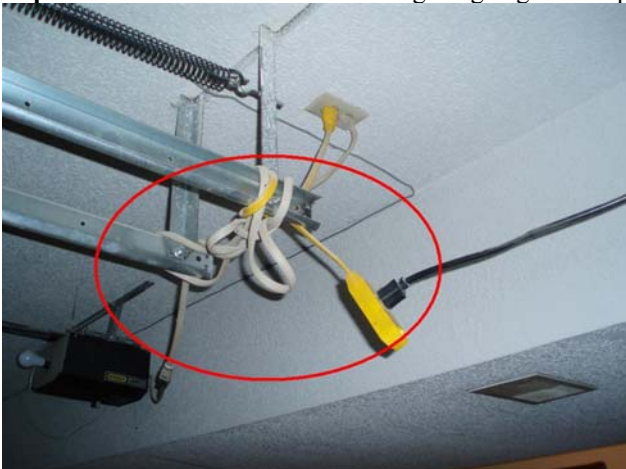
- **Repair:** Amateur installation of wiring for garage door openers.
