Star Home Inspection Services

Home Inspection Report

2119 W 47th Terr Westwood, KS 66205

Inspection Date: 03/24/2010

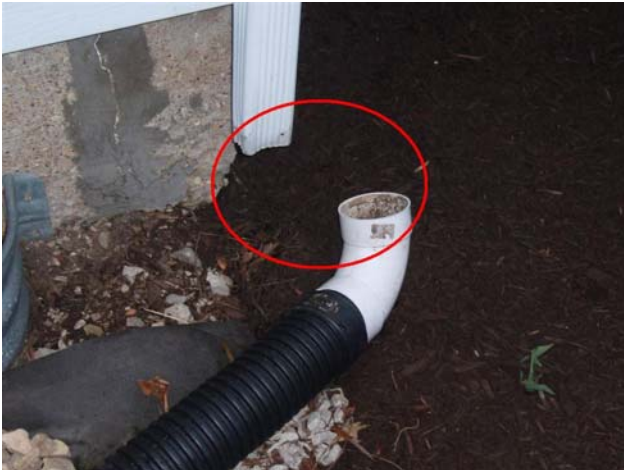
Gutters & Downspouts

- Repair:** The gutters require cleaning to avoid spilling roof runoff around the building – a potential source of water entry or water damage. **REPAIRED**
- Repair:** The downspout(s) should discharge water at least five (5) feet from the house (i.e. disconnected downspout at front northeast corner.) Storm water should be encouraged to flow away from the building at the point of discharge. **REPAIRED**

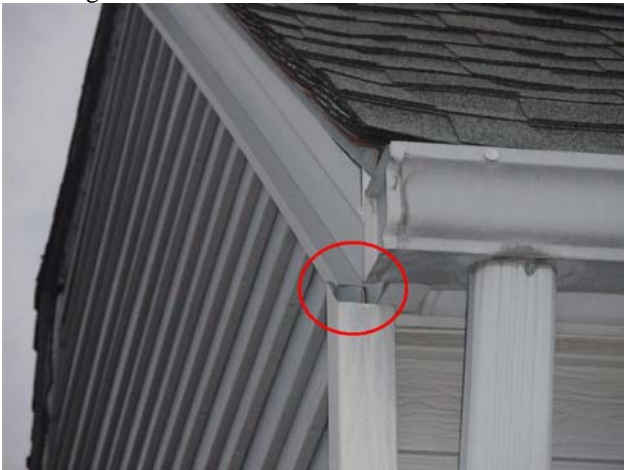
- **Repair:** Any openings in the exterior siding should be sealed. An example is at the top corners of the metal siding. Caulking is needed.

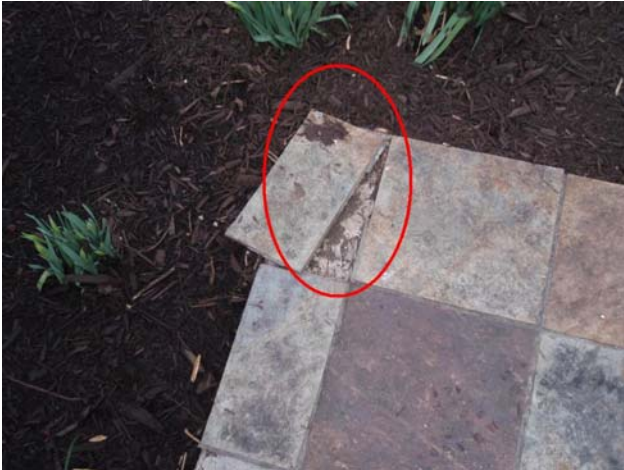
- **Monitor, Repair:** Patio loose tile was observed.

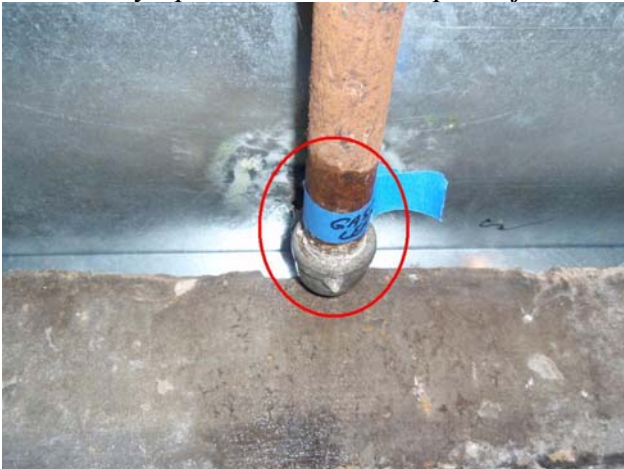
Gas Piping

- **Repair, Safety Issue:** *A gas leak was detected (at the front basement ceiling and marked "GAS LEAK" with blue tape) with a TIF 8800 gas/carbon monoxide detector and confirmed with soapy water. This is a serious safety concern. It is recommended that the gas utility, HVAC company or plumber be engaged as soon as possible to make the necessary repairs. The current occupants of the home should also be notified. **REPAIRED***
