**Star
Home
Inspection Services**

Home Inspection Report

21315 Nall Ave Bucyrus, KS 66013

Report Number: 05312011-2A

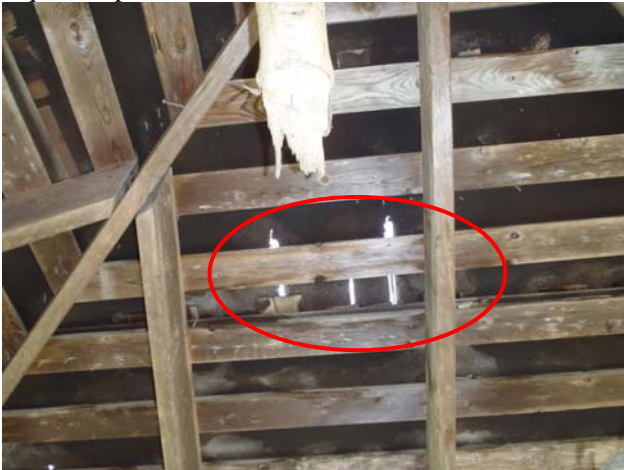
- **Repair:** Light was visible below the gazebo roof. Repair is needed. The life expectancy of wood roofs is generally 15 to 20 years with tune-ups normally needed around the 10th year. This will depend on several factors such as the quality of shingle or shake, the slope of the roof (steeper is better), the amount of exposed shingle, and the amount of sun or shade. As with all roofs, annual maintenance is needed. Cracked, curled, or displaced shingles or shakes should be repaired. As a rule of thumb, replacement of the entire roof covering may be logical if more than ten percent of the wood roof requires repair.

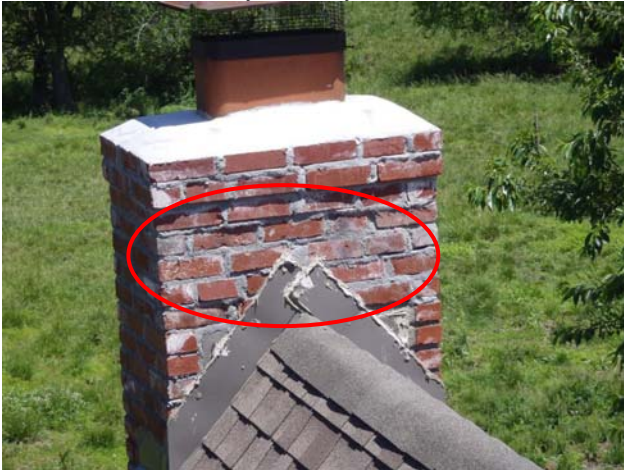
- **Monitor:** The masonry chimney shows evidence of prior repair.

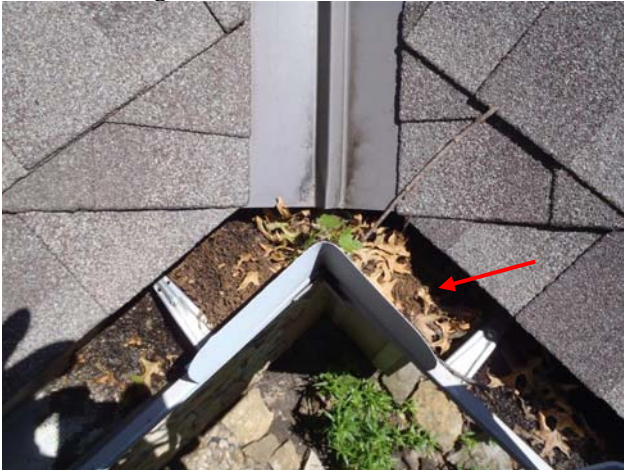
- **Repair:** The gutters require cleaning to avoid spilling roof runoff around the building – a potential source of water entry or water damage.

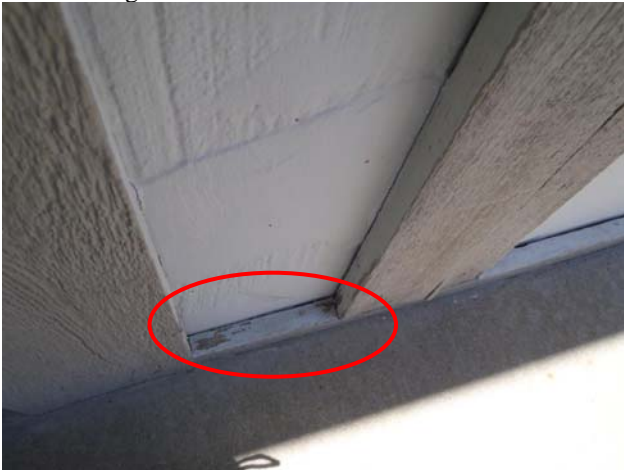
- **Repair:** The exterior siding paint is peeling and/or worn thin in localized areas (including bottom edge of siding.) These areas should be painted to prevent water damage or rot in the future.
- **Monitor, Repair:** Localized damage of the front exterior siding was observed
- **Repair:** The siding trim needs caulking improvements in localized areas to prevent water damage and rot.
- **Repair:** The paint on the trim around the siding is peeling in localized areas. These areas should be painted to prevent water damage and rot.

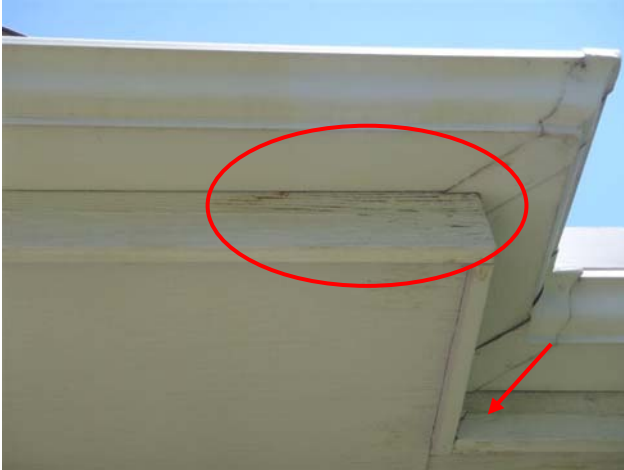
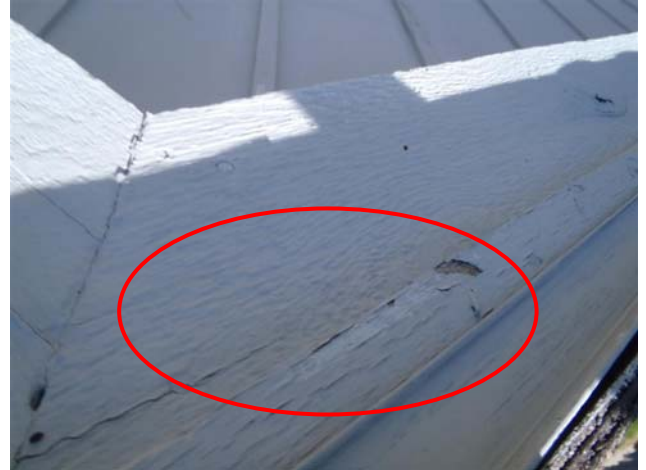
- **Repair:** Localized eave and fascia peeling was observed and they should be painted to prevent water damage and rot. Minor leaks in the gutter may be present in this area. Further investigation is required.

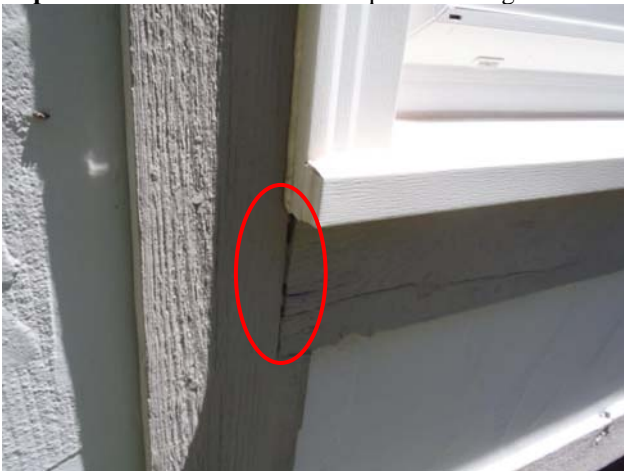
- **Repair:** Some of the windows require caulking.

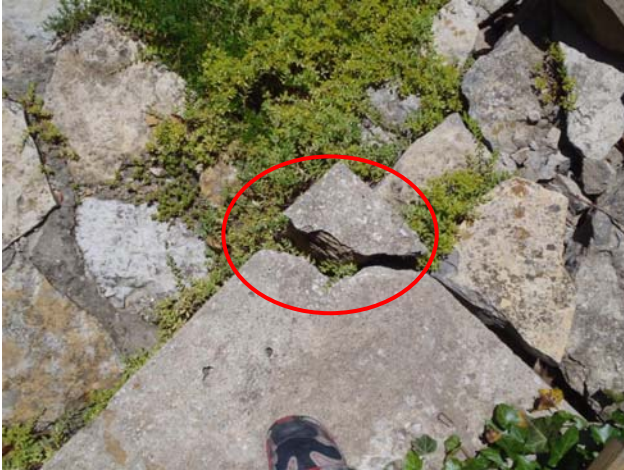
- **Monitor, Repair:** Patio surface deterioration was observed near the deck steps landing. Further deterioration may result in the need for repairs.

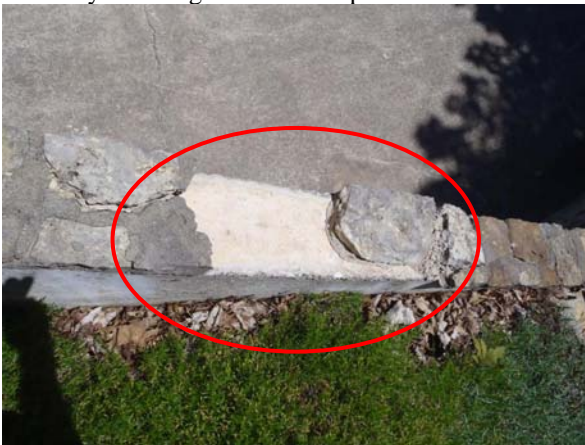
- **Monitor, Repair:** The south stone retaining wall shows evidence of movement. This condition should be monitored. It is impossible to determine the rate of movement during a one time visit to the house. The missing cap stones on the driveway retaining wall needs repair.

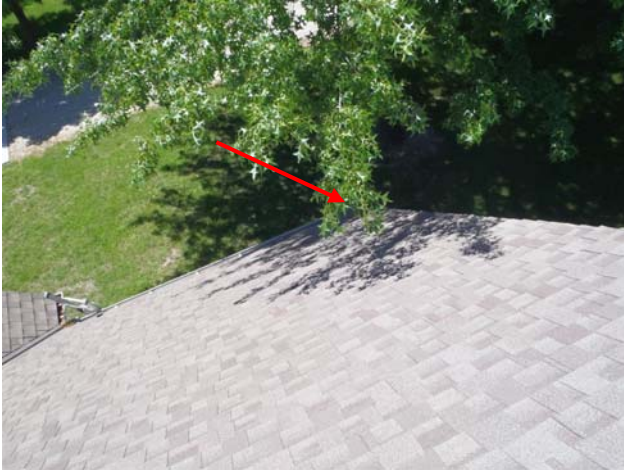
- **Monitor:** Tree branches should be kept trimmed away from the house to avoid damage to the building.

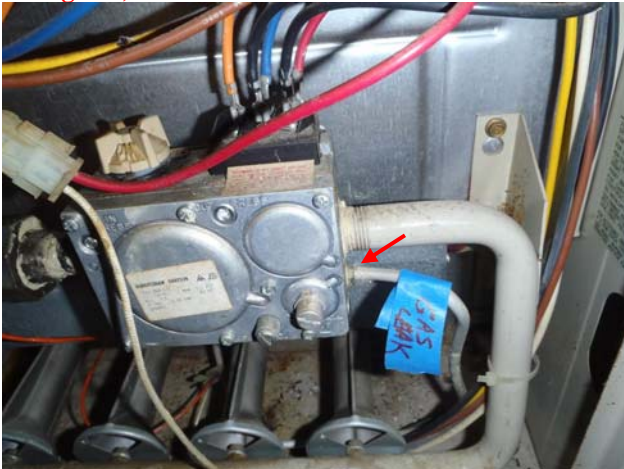
- **Repair, Safety Issue:** *A gas leak was detected at the control box inside the furnace housing marked "GAS LEAK" with blue tape, with a TIF 8800 gas/carbon monoxide detector and confirmed with soapy water. This is a serious safety concern. It is recommended that the gas utility, HVAC company or plumber be engaged as soon as possible to make the necessary repairs. The current occupants of the home should also be notified. **REPAIRED (NOTE: small gas leak was repaired on furnace. Gas company was also called to double check everything as a precaution and all is good.)***
