**Star
Home
Inspection Services**

Home Inspection Report

21700 W 71st St Shawnee, KS 66218

Inspection Date: 02/24/2010

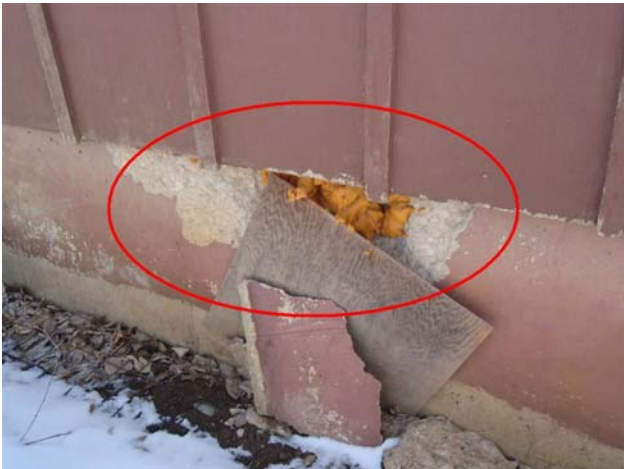
- **Repair:** Surface deterioration (spalling, crumbling material) was observed on foundation walls. Larger than typical foundation settlement cracking was observed. This condition is common in many old homes and does not usually represent a serious structural concern unless there is substantial loss of material. Recommend a qualified foundation specialist be engaged for a second opinion and estimate of the necessary repairs. Lot drainage improvements and elimination of water or roof runoff splashing against foundation walls as outlined in the Exterior section of this report are also recommended. **REPAIRED**

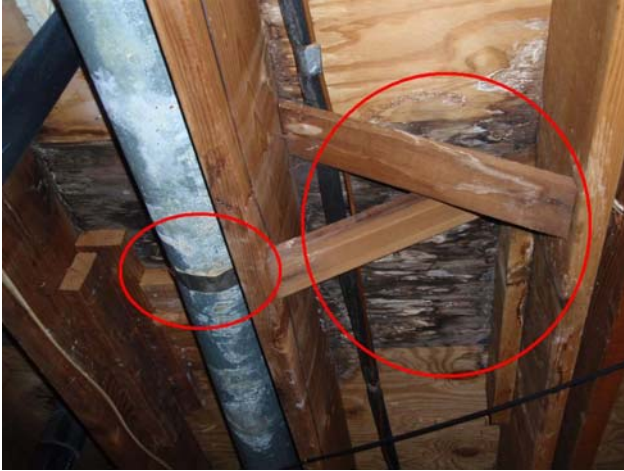
- **Monitor:** Water staining of the subflooring below the master bath was observed at the basement ceiling. Where only limited areas of damage exist this repair can be deferred until combined with other carpentry work at the property. Beware of damaged subfloor below carpet or vinyl flooring as it may be unsafe.

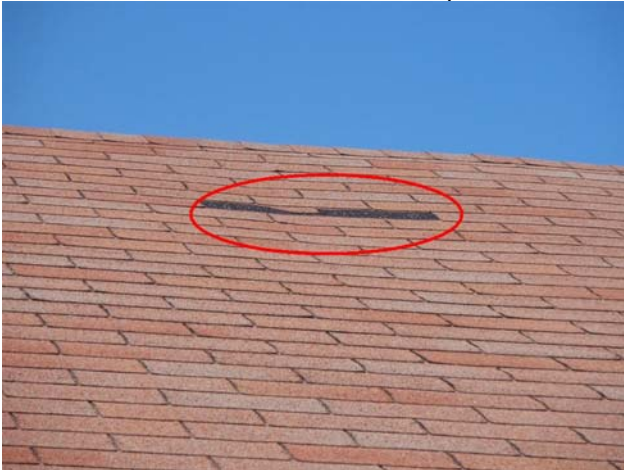
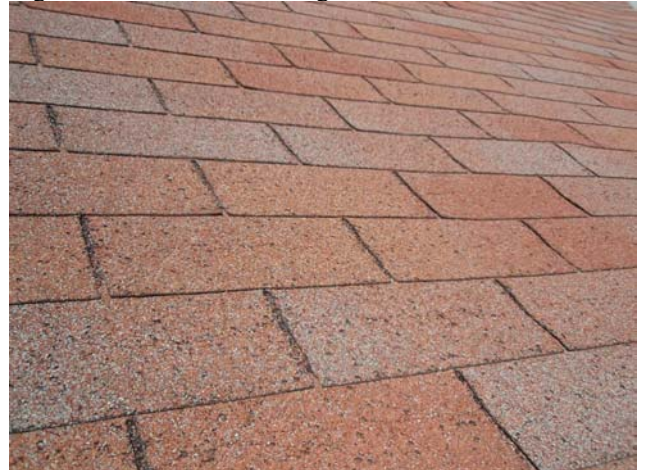
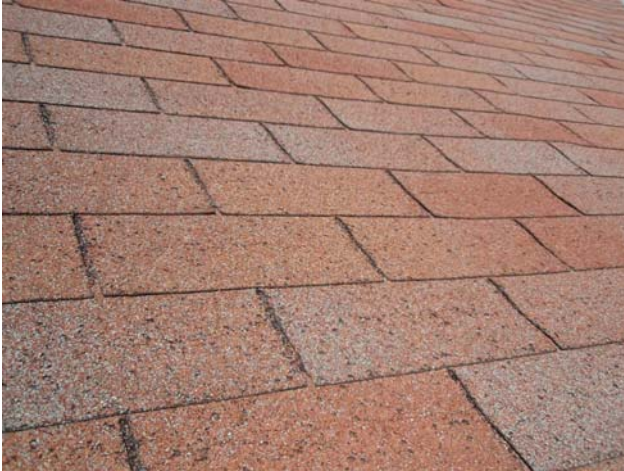
- **Major Concern, Repair:** Missing tabs were observed. Repairs are recommended. What appears to be hail damage was observed on the roof. Hail damage can shorten the life of a roof. This should be investigated further and may eligible for an insurance claim. The roofing is near the end of its life. Minor repairs might be possible to extend the roof life and to defer leaks. Damaged or missing roofing material should be repaired. All roof penetrations should be examined and sealed as necessary. Expect to replace the roof soon. Older roofs are, by their nature, a high maintenance roof. Annual inspection and repair should be anticipated. In addition, the older flashings should be monitored. In some cases, a deteriorated flashing can result in expensive repairs, because sections of the roofing have to be removed. As a rule of thumb, replacement of the entire roof covering may be logical if more than ten percent of the roof requires repair. It is recommended that the present layers of roofing materials be removed prior to re-roofing. This adds cost of demolition and debris removal to the re-roof cost. Replace the roof flashing materials when re-roofing to avoid leaks in these areas.

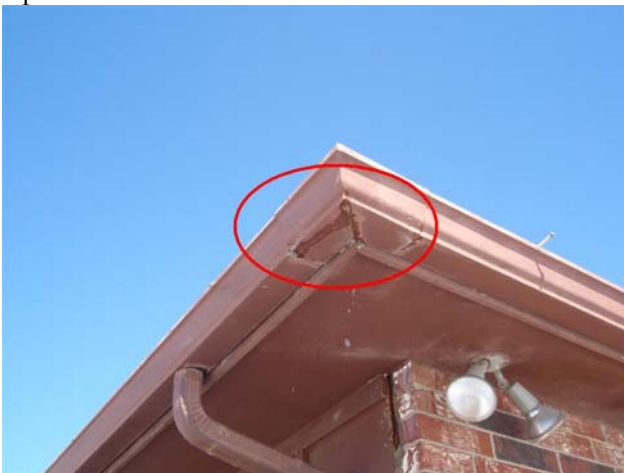
- **Repair:** Minor leaks in the gutters should be repaired. The old galvanized gutters and downspouts are rusting noticeably. Replacement should be anticipated over the next few years. In the interim, leaks that develop should be repaired.

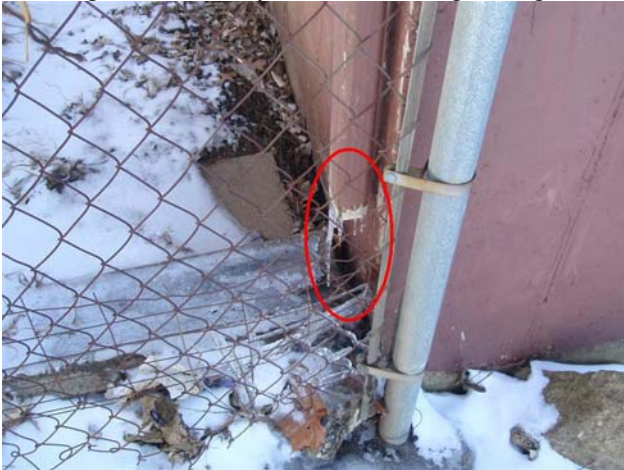
- **Repair:** The downspout(s) should discharge water at least five (5) feet from the house. Storm water should be encouraged to flow away from the building at the point of discharge.

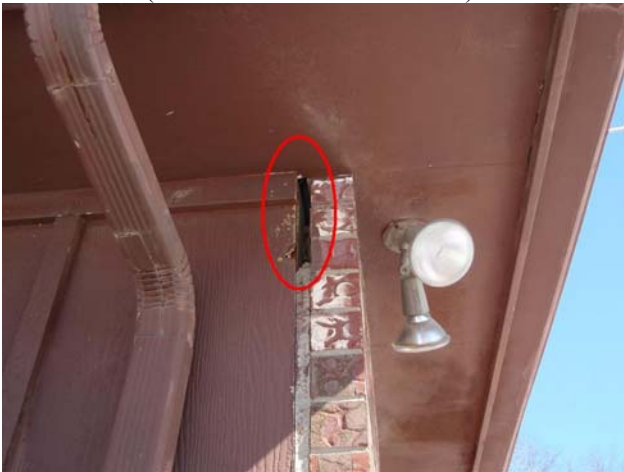
- **Repair:** Localized pointing of deteriorated mortar between the bricks of the exterior walls is advisable to prevent further deterioration (i.e. at front southwest corner.)

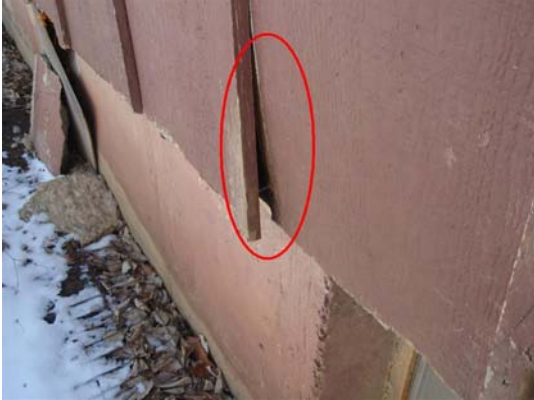
- **Repair:** Loose siding/siding trim should be secured and caulked.

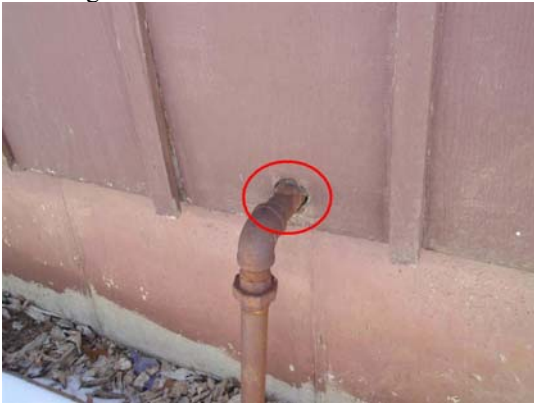
- **Repair:** Any openings in the exterior siding should be sealed. An example is where the gas line enter the house. Caulking is needed.

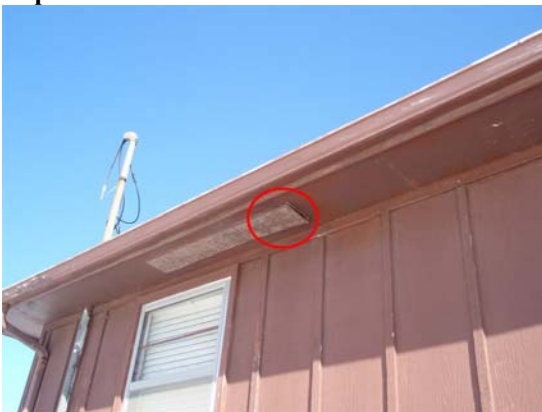
- **Repair:** Localized rot was observed in the fascia (the wooden board to which the gutter is typically fastened).
- **Improve:** The loose soffit vent at the west side of the home should be better secured.

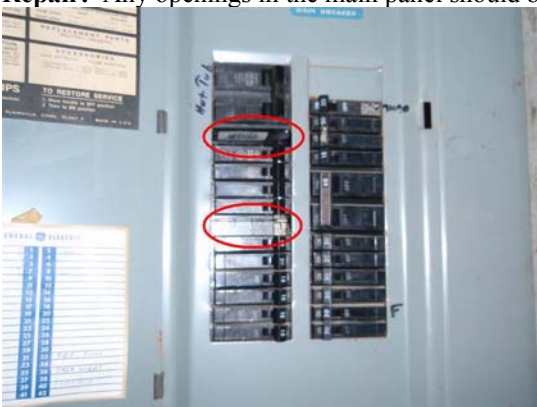
- **Repair:** Oversized breaker within the main distribution panel for the air condition should be replaced. The data plate on the unit specifies a maximum breaker size of 50 Amps and the one in the panel is 60 Amps.
- **Repair:** Any openings in the main panel should be covered.

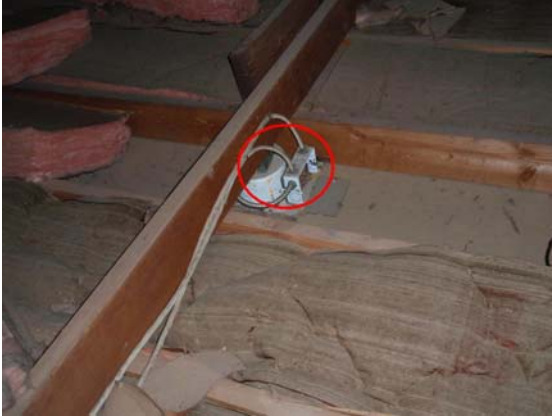
- **Repair:** Extension cords should not be used as permanent wiring. This wiring in the garage should be removed and replaced with permanent wiring and an outlet(s).
- **Repair:** All junction boxes should be fitted with cover plates, in order to protect the wire connections (i.e. attic.)

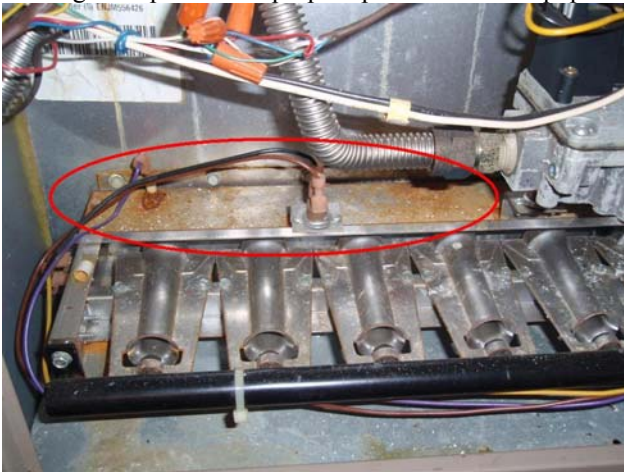
- **Improve:** The dirty air filter should be replaced.
- **Repair:** The condensate line leading from the furnace appears dirty or to have been dirty (minor surface rust observed in furnace housing.) Further investigation is needed when air conditioner is in use, if needed this should be cleaned to avoid blockage and possible improper operation of the equipment.

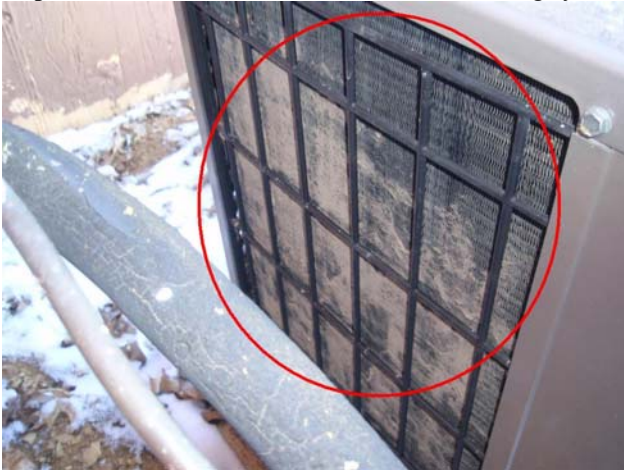
- **Repair:** The outdoor unit of the air conditioning system is out of level. This should be improved.
- **Improve:** The outdoor unit of the air conditioning system requires cleaning.

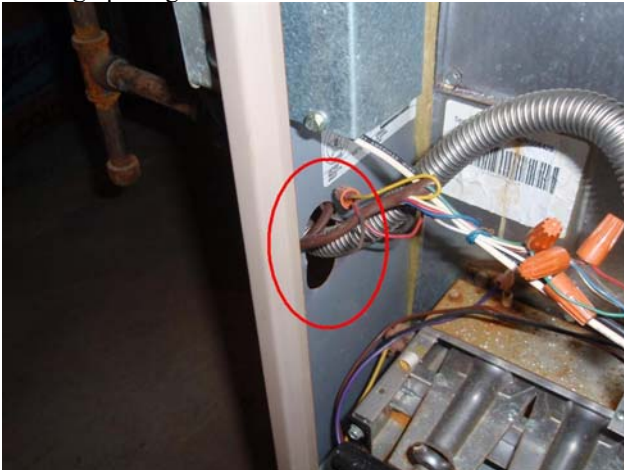
- **Repair:** Flexible gas appliance connections should not pass through walls, floors or the appliance housing as is the case of the furnace. This connector should be replaced with one of suitable solid gas piping or a rubber grommet installed at housing opening.
