# Star Home Inspection Services

## *Home Inspection Report*

**22 Wycklow St, Overland Park, KS 66207**

**Report Number: 03062008-2A**

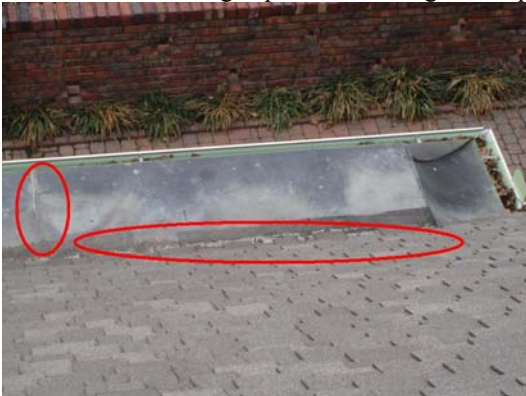
- **Note:** Rolled roofing is prone to leaking and requires close monitoring and higher than normal maintenance.

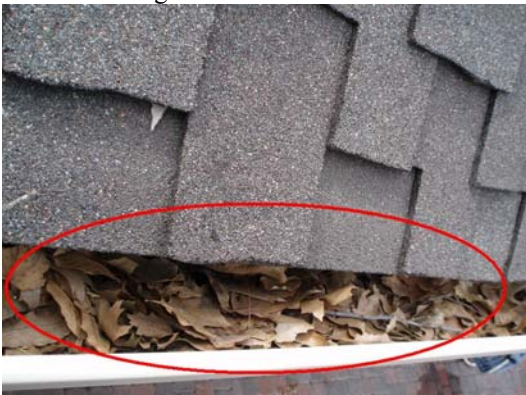
- **Repair:** The gutters require cleaning to avoid spilling roof runoff around the building – a potential source of water entry or water damage.

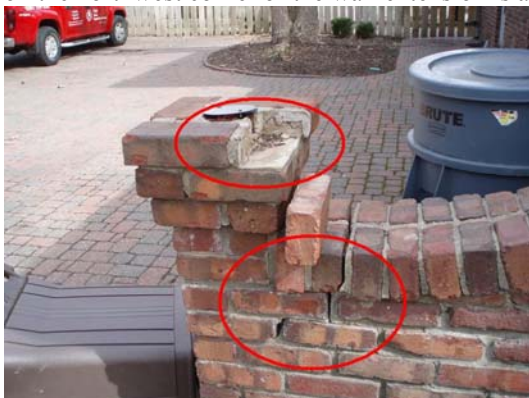
- **Repair:** Localized pointing of deteriorated mortar between the bricks of the front exterior wall extension and loose brick on the northwest corner of the wall extension is advisable to prevent further deterioration.

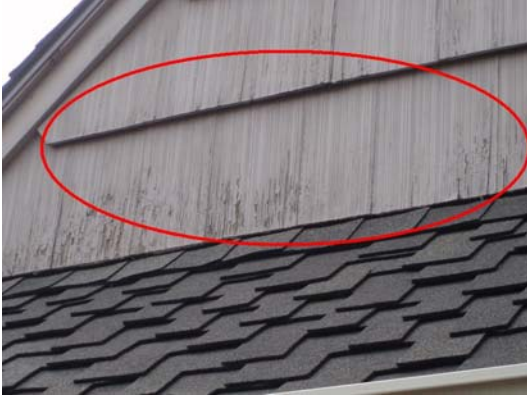
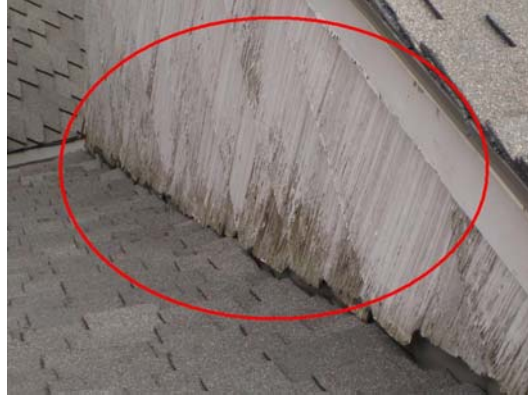
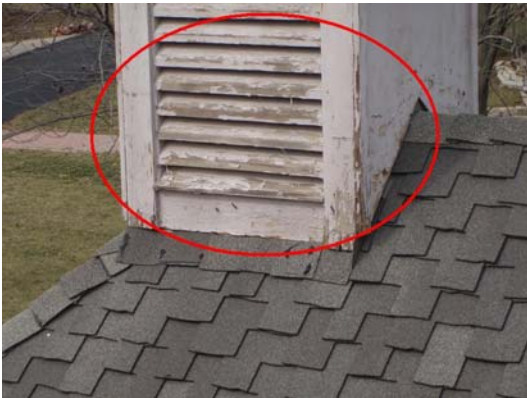
- **Repair:** The exterior of the house needs to be painted.

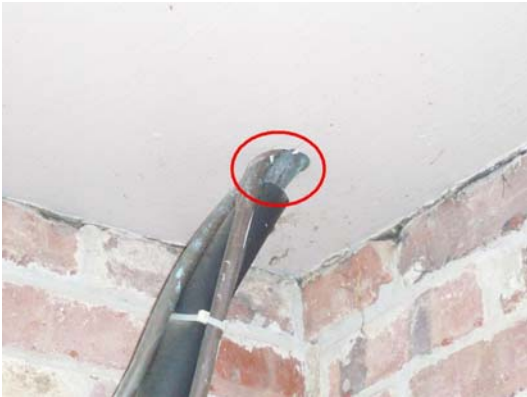
- **Repair:** The paint on the back iron railing is peeling and rusting in some areas. These areas should be painted to prevent water damage and rust.
- **Improve:** The hole in front soffit for air conditioner refrigerant lines should be caulked around opening to prevent insect infestation.

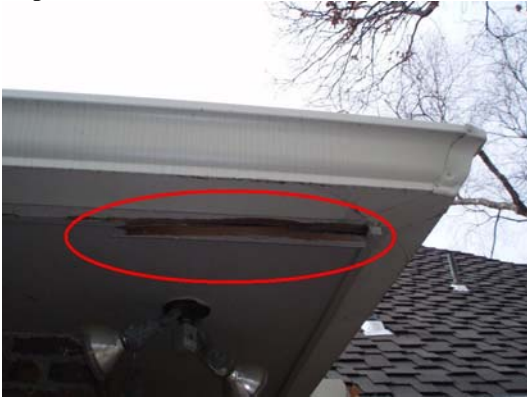
- **Repair:** The broken fascia board on the back northeast corner should be repaired.

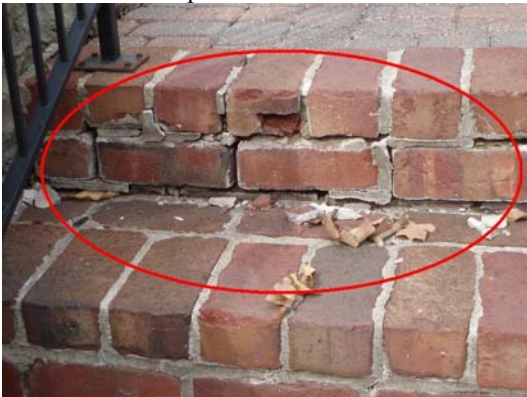
- **Repair, Safety Issue:** The back brick steps have deteriorated noticeably in localized area near the top step. Repairs are recommended to prevent further deterioration.

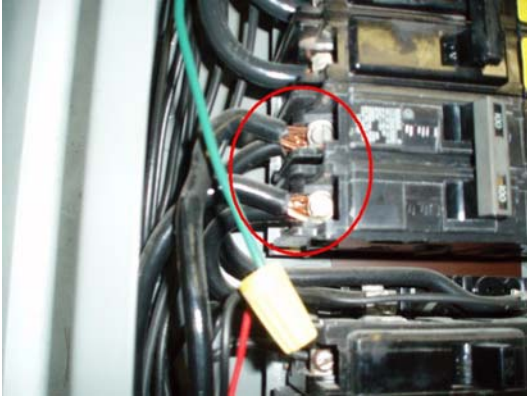
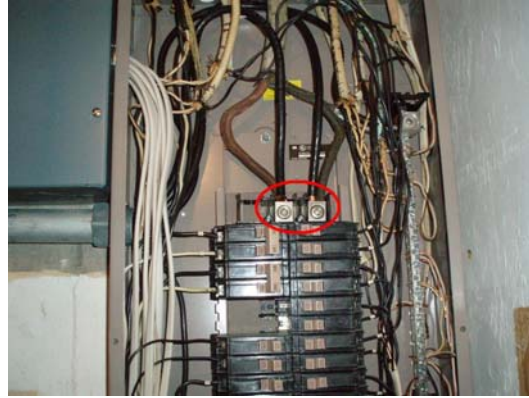
- **Repair:** Circuits within the main distribution panels (main panel and southwest basement panel) that are doubled up (referred to as “double taps”) should be separated. Each circuit should be served by a separate fuse or breaker.

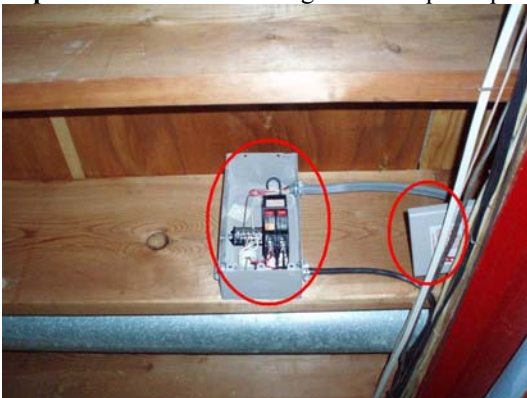
- **Repair:** The cover servicing the 40 amp sub panel in the north basement ceiling is missing and should be on panel.

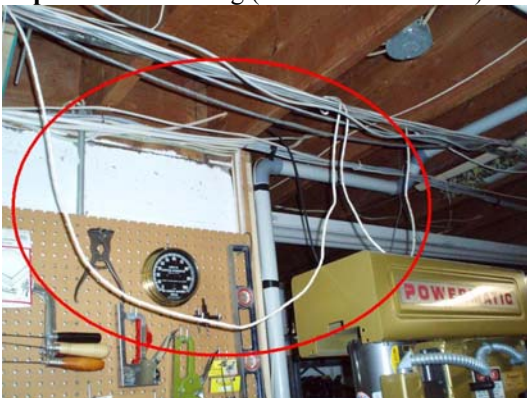
- **Repair:** Loose wiring (north basement area) should be secured.

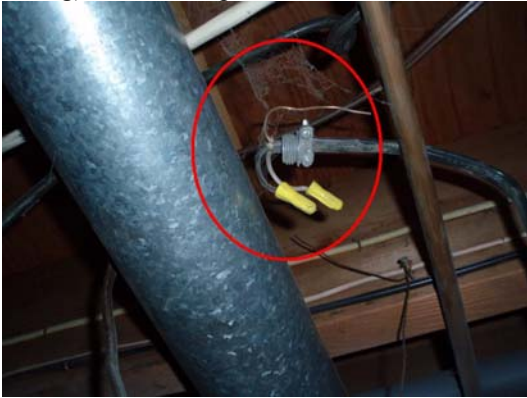
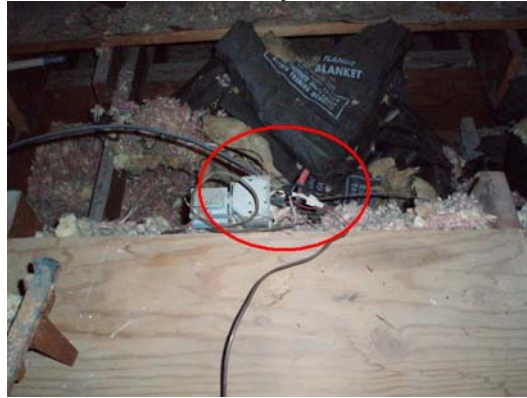
- **Repair:** Improper electrical connections (examples in basement, attic, southeast bedroom bathroom, living room west ceiling) should be repaired. All electrical connections should be made inside junction boxes fitted with cover plates.

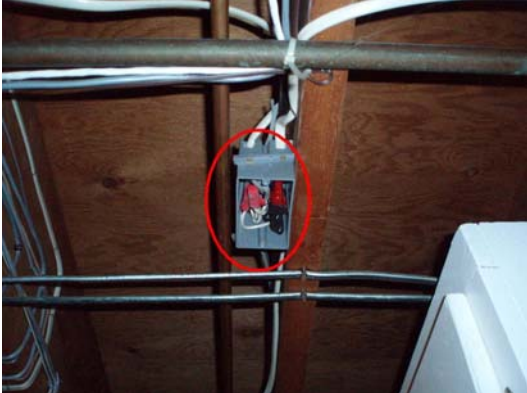
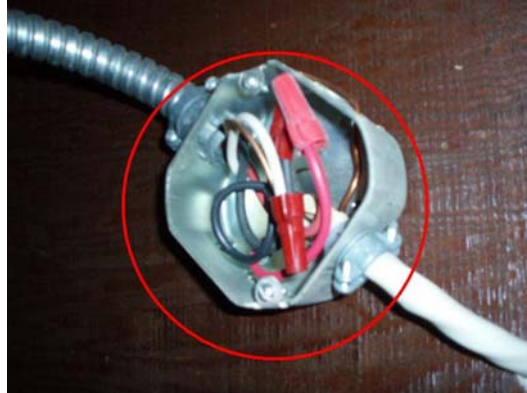
- **Repair:** All junction boxes should be fitted with cover plates, in order to protect the wire connections.

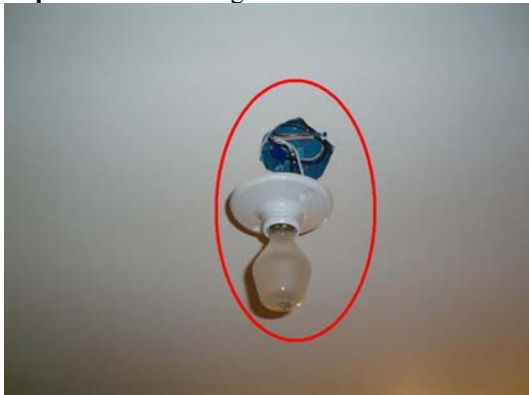
- **Repair:** The loose light fixture in the southeast bedroom closet should be repaired or replaced.

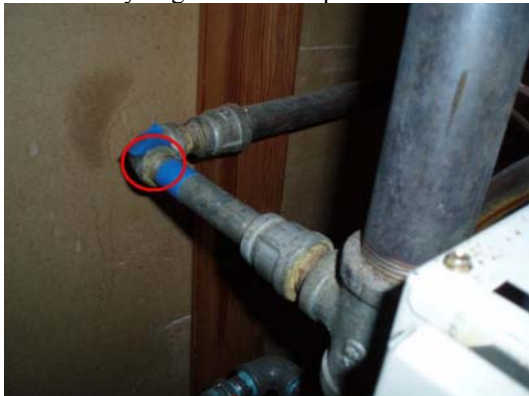
- **Repair, Safety Issue:** The gas piping servicing the south basement furnace was tested for gas leaks with a TIFF 8800 and positive readings were observed for gas (marked with blue tape at corner elbow where leak was detected and confirmed with soapy water. *This condition is a safety risk.* Since home inspectors are not considered to be experts in these matters it is recommended that a qualified service technician or utility company representative should be engaged immediately to get a second opinion on the condition of the furnace and to make any repairs necessary.

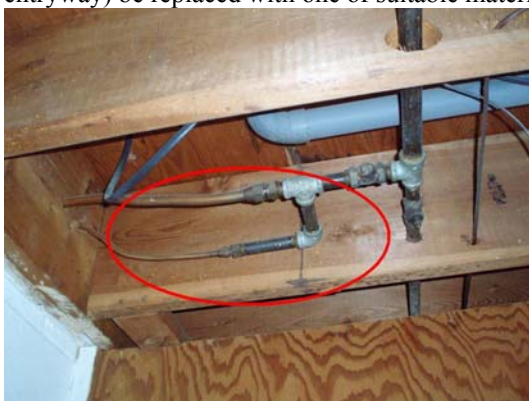
- **Repair:** The gas pipe should be capped (north laundry room) when not in use.
- **Repair:** Copper tubing is no longer suitable for gas piping. It's recommended this pipe (basement ceiling in north shop entryway) be replaced with one of suitable material.

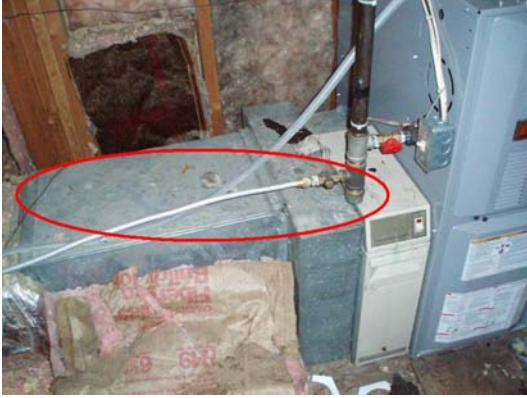
- **Repair:** Aluminum tubing is not suitable for gas piping. It's recommended this pipe (at attic furnace servicing garage heater) be replaced with one of suitable material.

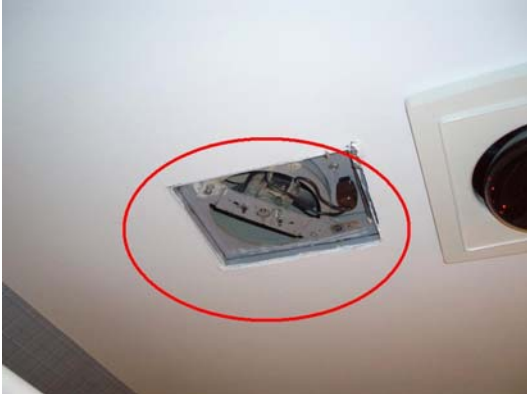
- **Repair:** The faucet in the basement kitchen has a hole in it and is leaking.
- **Monitor, Repair:** The toilet in the main floor north bathroom was observed to flush slowly at the time of the inspection.
- **Improve:** Cracked, deteriorated and/or missing bathtub enclosure grout and caulk should be replaced (upstairs south bathroom and main floor southeast bedroom bathroom tile).
- **Improve:** Missing and/or damaged tile was noted in the southwest and southeast bedroom bathrooms.
- **Repair:** An exhaust fan in the upstairs north bathroom is missing its cover.
