Star Home Inspection Services

Home Inspection Report

22003 W 56th Terr Shawnee, KS 66226

Inspection Date: 03/24/2010

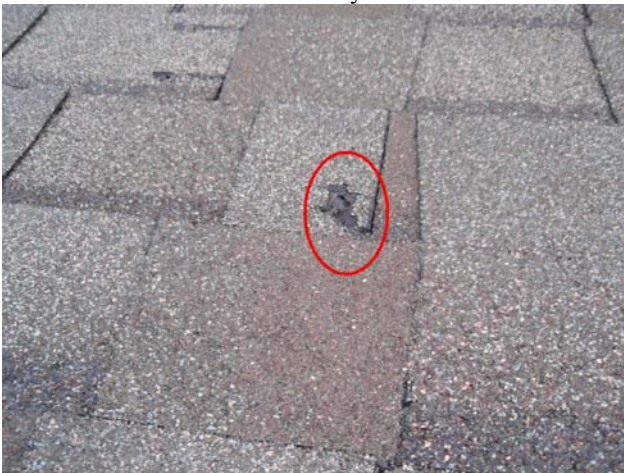
- **Repair:** Minor repair to the roofing are needed. Damaged or missing roofing material should be repaired (i.e. damage to roofing shingle at east side of home visible from master bedroom east window.) All roof penetrations should be examined and sealed as necessary. **REPAIRED**

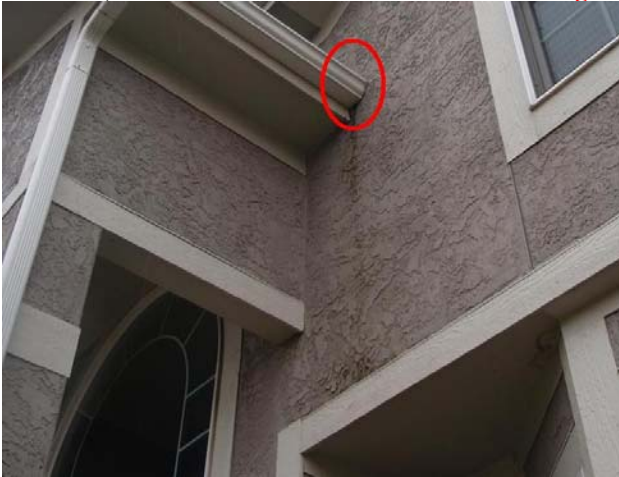
- **Repair:** The installation of the flashing is incomplete and should be repaired (i.e. diverter flashing is needed at the corner of the gutter at the front of the house where the gutter meets the stucco, staining at the wall behind the gutter was observed.) **REPAIRED – Installed diverter flashing**

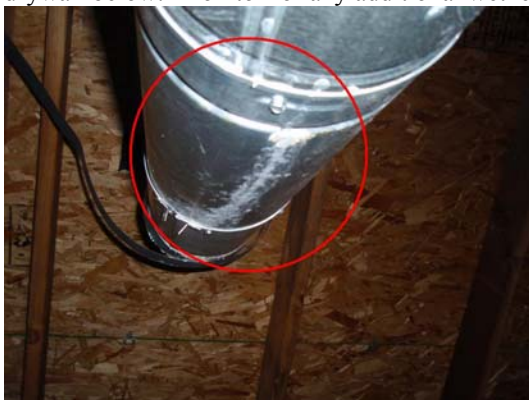
- **Monitor:** While in the attic water stains were observed on the lower sections of the furnace flue. The insulation below the elbow also showed signs of past moisture. It appears that rain blew in under the rain cap and came down the interior of the flue until it got to the first joint where it then transferred to the outside surface and dripped off the elbow. This is a common condition in 80% of homes but very seldom is enough to penetrate completely through the insulation to the drywall below. Monitor for any additional wetness after rains.

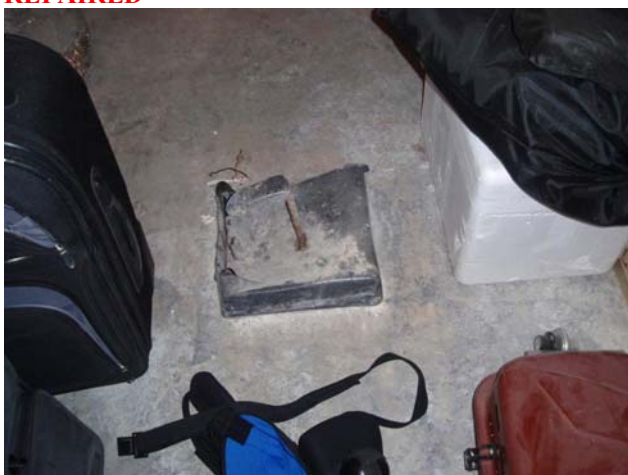
- **Monitor:** The carpet shows typical wear and/or soiled spots and stains. **Steam Cleaned all carpeted areas to remove soiled spots and/or stains**
- **Monitor:** Some surface wear, scuffing of the hardwood floor was observed.
- **Monitor, Repair, Safety Issue:** The stub in for the basement bath represents a safety issue at protruding rebar. **REPAIRED**
