Home Inspection Report

2204 NE 110th St Kansas City, MO 64155

Inspection Date: 10/23/2010

Report Number: 10232010-1J

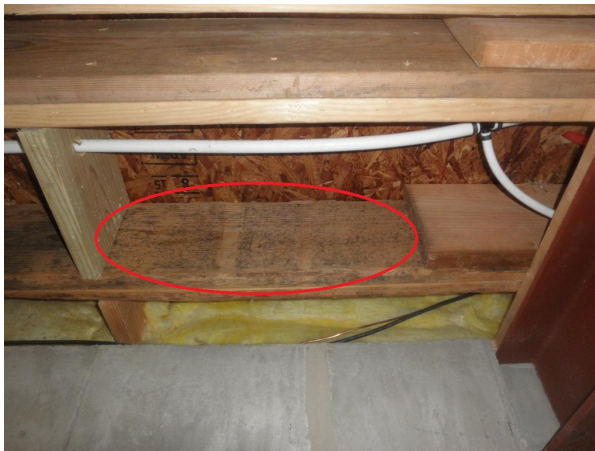
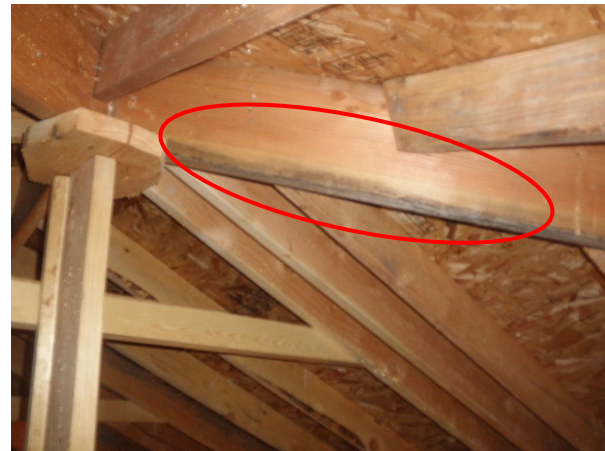
- **Monitor:** Construction mold was visible on some floor joists and roof rafters. This is mold that grows on the lumber while lying in the weather during construction. Most homes have some level of this mold and it goes dormant once removed from the elements and normally does not present any problems.

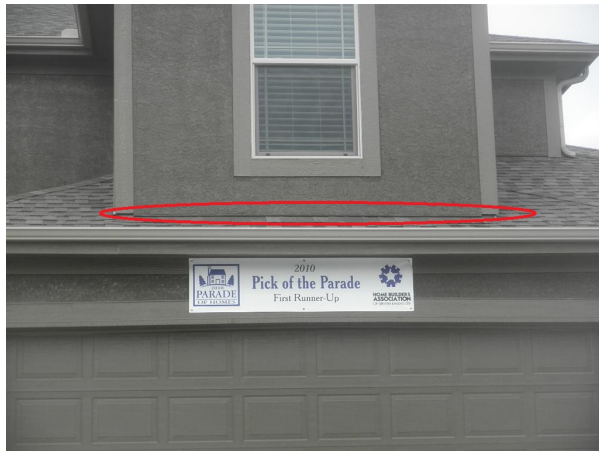
- **Monitor:** The flashing along wall underneath the window of the master bedroom closet is vulnerable and should be carefully monitored for leaks.

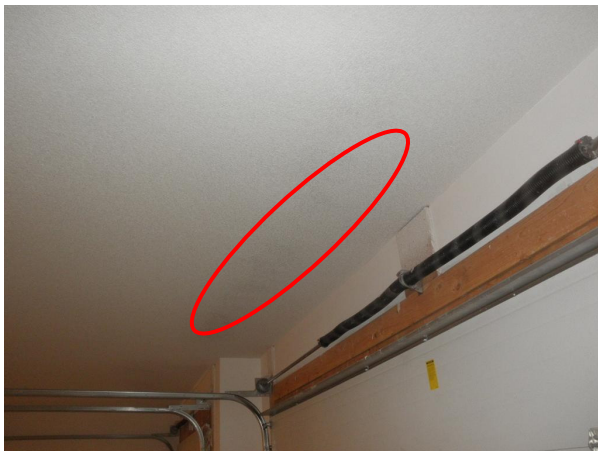
- **Monitor:** Water staining was noted on the ceiling in the garage. Please see notes under “Flashings” in the Roofing section.

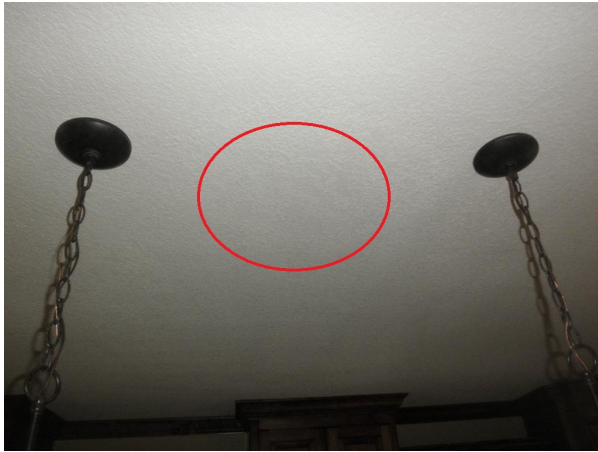
- **Monitor:** Repaired ceiling was noted between the two lights above the kitchen island.
