**Star
Home
Inspection Services**

Home Inspection Report

223 E Colleen Dr, Gardner, KS 66030

Inspection Date: 3/18/2009

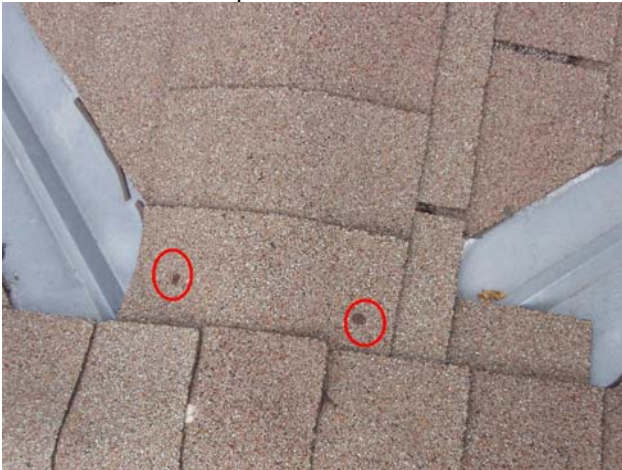
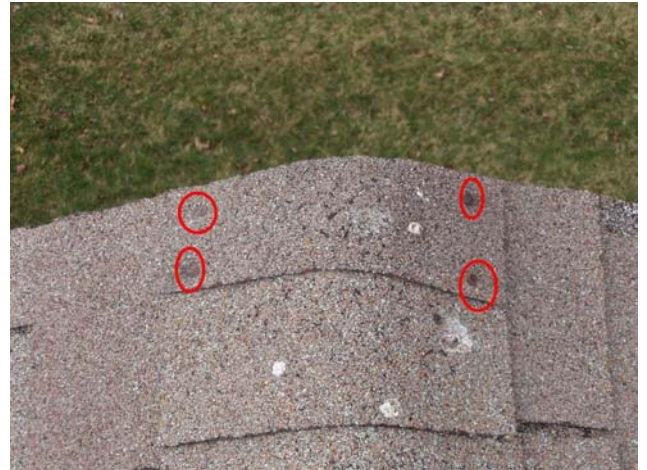
- **Repair:** Exposed nail heads were observed in the roofing shingles and/or ridge caps. All exposed nail heads should be caulked to reduce the potential of leaks.

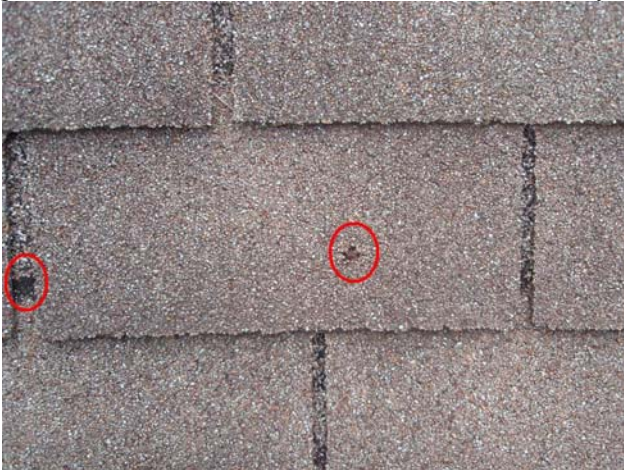
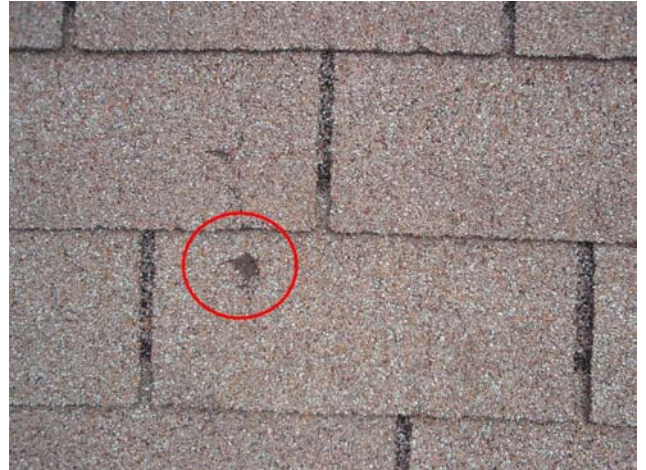
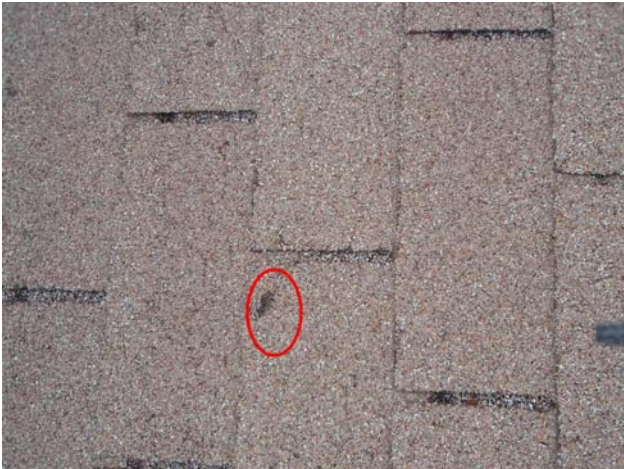
- **Repair:** Minor repairs to the roofing are needed. Damaged or missing roofing material should be repaired. All roof penetrations should be examined and sealed as necessary.

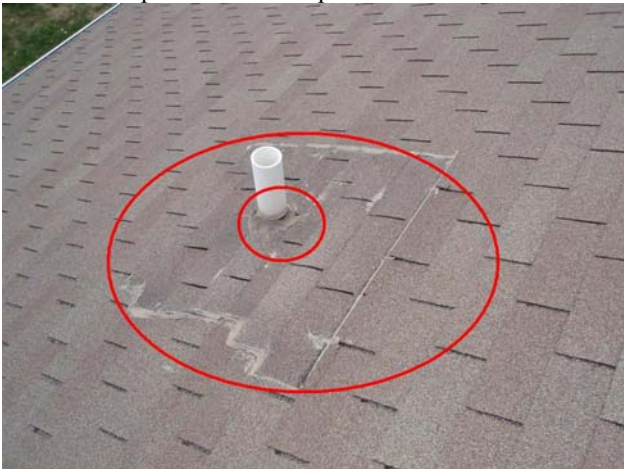
- **Monitor:** Prior repairs to the roofing and plumbing vent boot flashing are evident. This would suggest that problems have been experienced in the past. This area should be monitored.

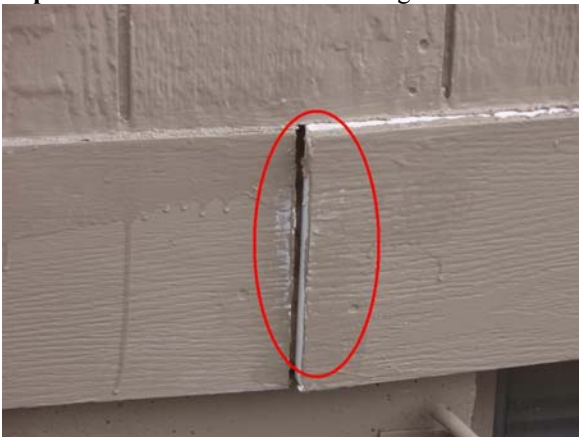
- **Monitor:** Siding of this type requires monitoring and maintenance. It has a tendency to pop out past nail heads creating a space where two panels join together. Re-securing and caulking these areas is standard maintenance for this type of siding.
- **Repair:** Localized rot was observed in the siding. Following repair of the damaged areas (which should be combined with exterior painting/maintenance) proper maintenance of the siding and control of water from roof or surface runoff can avoid further damage.
- **Repair:** The lower edge of the bottom of the siding is not painted. These areas should be painted to prevent water damage and rot.
- **Repair:** Loose trim around the siding was observed on the west side of the home.

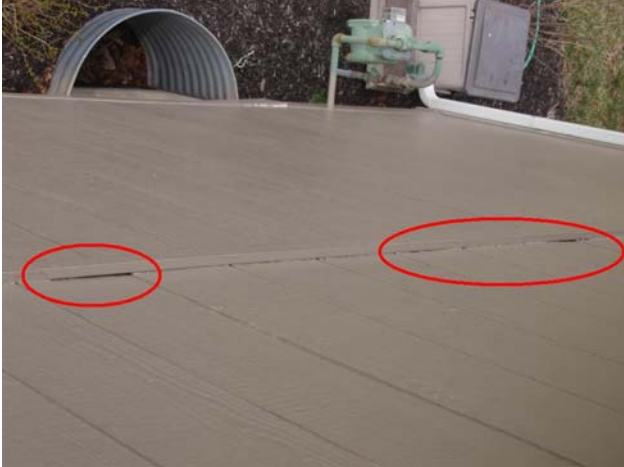
- **Repair:** The top edge of the top horizontal siding trim should be caulked.

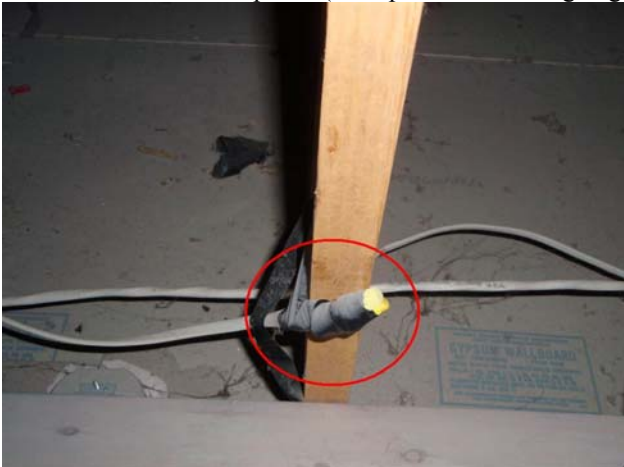
- **Repair:** Improper electrical connections should be repaired. All electrical connections should be made inside junction boxes fitted with cover plates (example in attic over garage).

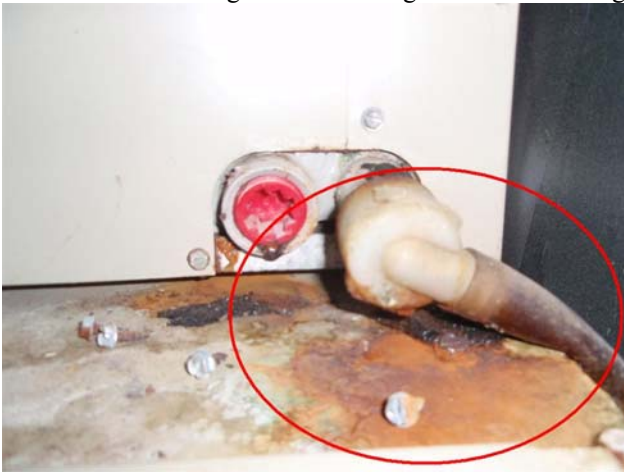
- **Monitor:** The condensate line leading from the furnace shows evidence of previous leakage. This area should be monitored when using air conditioning and cleaned if clogged and still leaking.

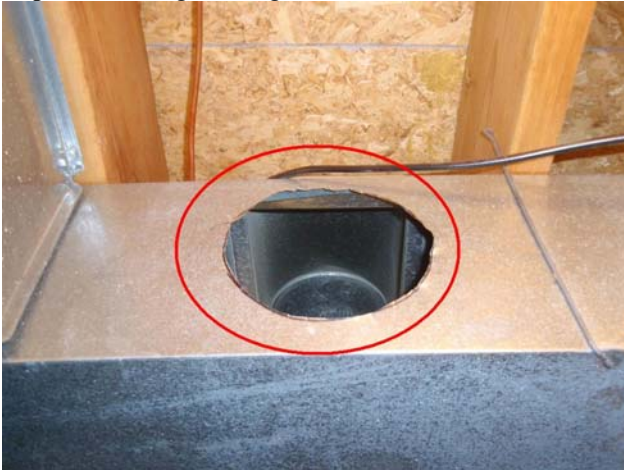
- **Repair:** Missing vent register cover in the furnace room should be covered /repaired.
