# Star Home Inspection Services

## *Home Inspection Report*

**2402 W 69th Terr, Mission Hills, KS 66208**

**Report Number: 01212009-1A**

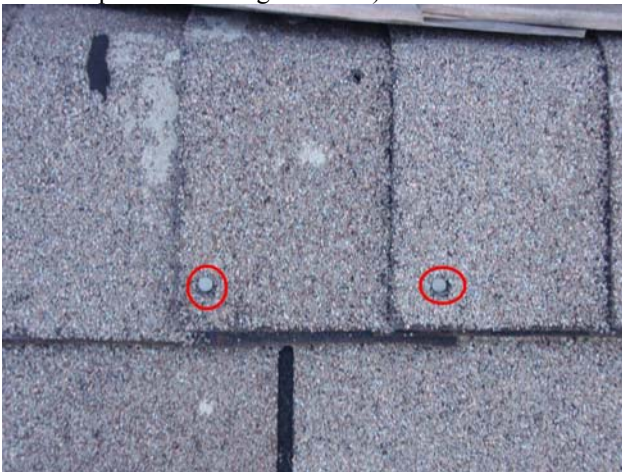
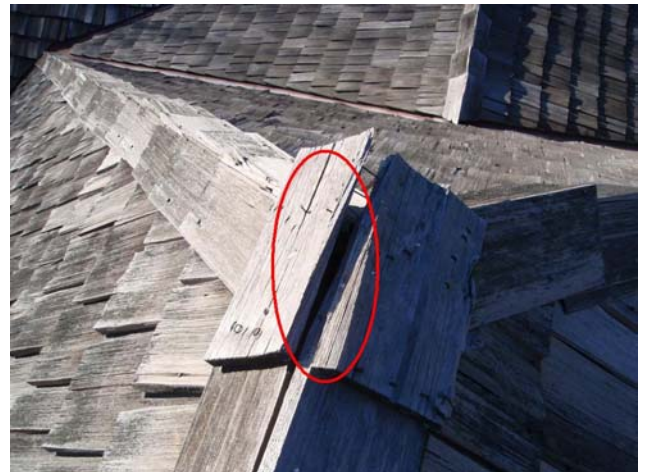
- **Repair:** Exposed nail heads were observed in the roofing shingles and/or ridge caps. All exposed nail heads should be caulked to reduce the potential of leaks.
- **Monitor:** The life expectancy of wood roofs is generally 15to 20 years. This will depend on several factors such as the quality of shingle or shake, the slope of the roof (steeper is better), the amount of exposed shingle, and the amount of sun or shade. As with all roofs, annual maintenance is needed. Cracked, curled, or displaced shingles or shakes should be repaired. As a rule of thumb, replacement of the entire roof covering may be logical if more than ten percent of the wood roof requires repair.
- **Repair:** Split, loose or damaged ridge caps of the roofing require repair (example at west end ridge cap of main room where exposed sheathing is visible).

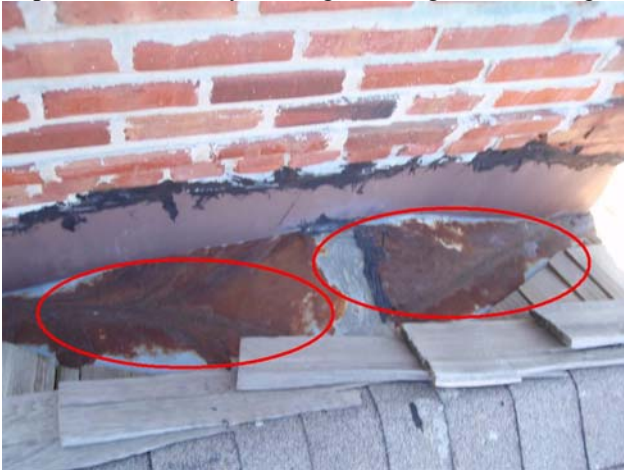
**Flashings**

- **Repair:** The chimney flashing is rusting. It should be painted to extend its life.

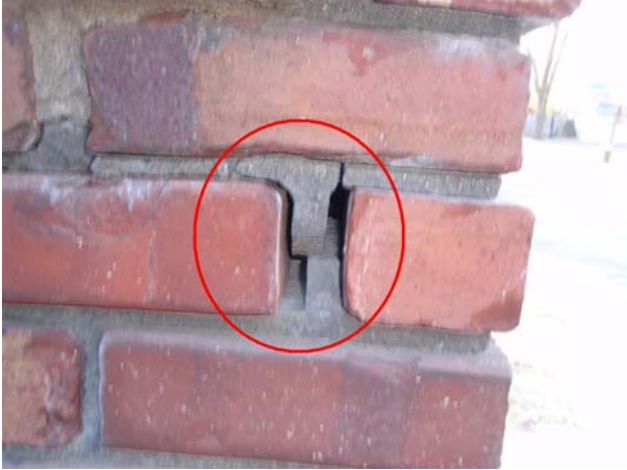
**Brick Wall Extension (West side)**

- **Monitor, Improve:** Minor pointing needed at west brick wall extension near driveway.

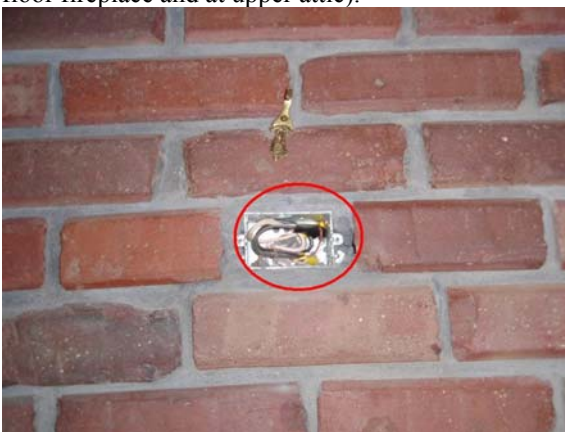
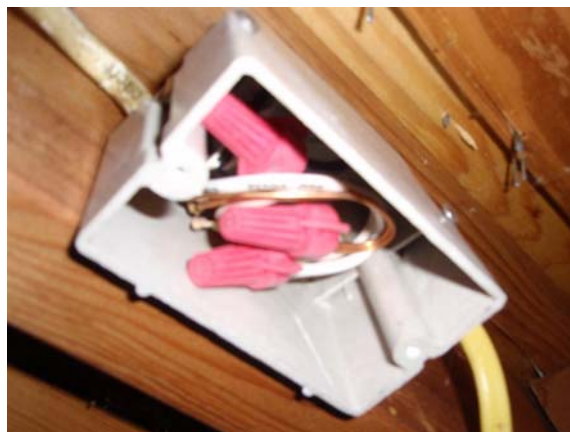
- **Repair:** All junction boxes should be fitted with cover plates, in order to protect the wire connections (examples at main floor fireplace and at upper attic).

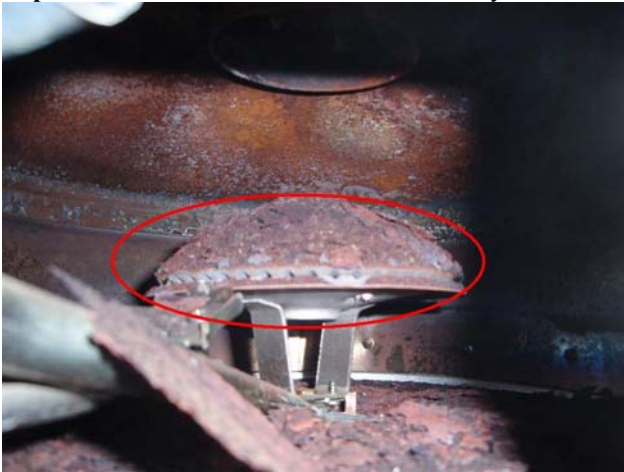
#### Water Heater

- **Repair:** The south water heater burner is dirty. It should be cleaned and adjusted.

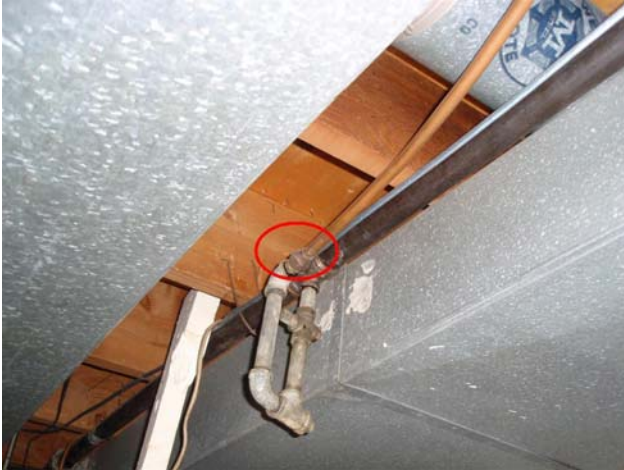
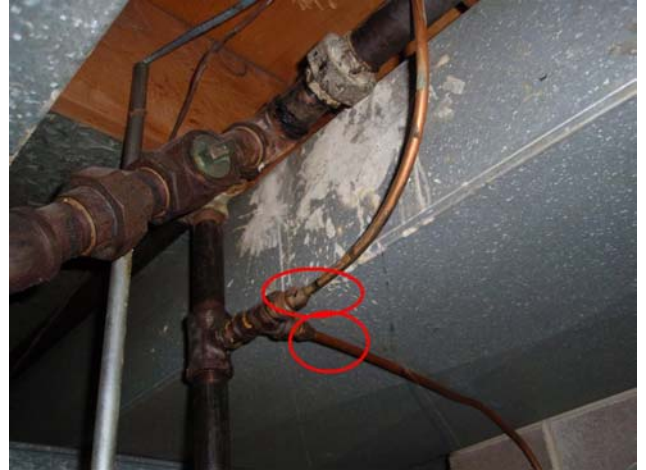
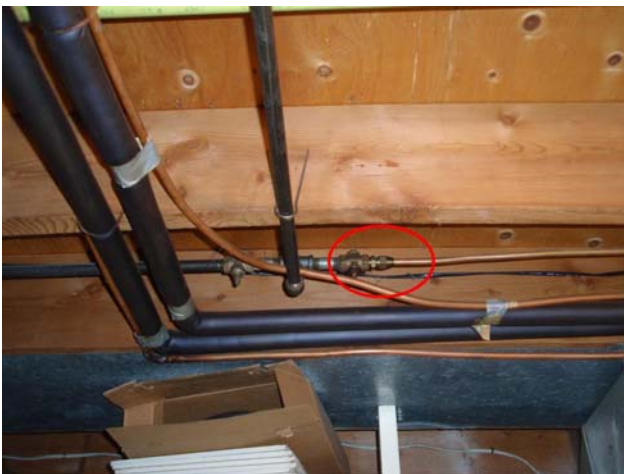
### Gas Piping

- **Repair:** Copper tubing is no longer suitable for gas piping. It's recommended these pipes be replaced with ones of suitable material.
