**Star  
Home  
Inspection Services**

*Home Inspection Report*

**2408 W 47th Terr, Westwood, KS 66205**

**Inspection Date: 08/14/2009**

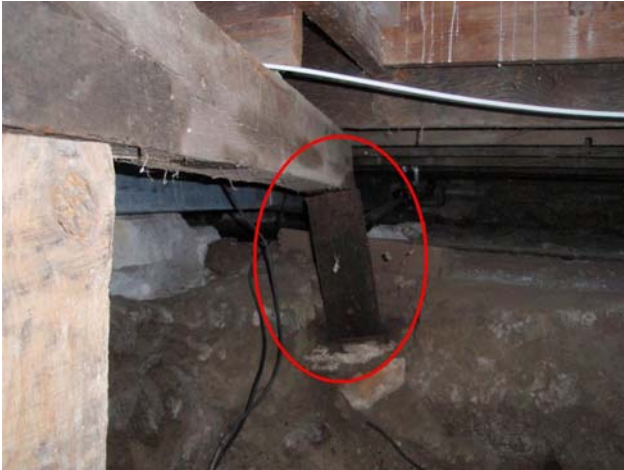
- **Monitor:** Minor unevenness was observed in the floor structure. This condition is common. It may be the result of the materials, framing design, installation methods and aging of the building. There was not evidence of need for immediate, costly repair.
- **Monitor:** Some movement of the support post in the crawl space was observed. It is impossible to determine the rate of movement during a one time inspection. This area should be monitored, if additional movement is observed repairs may be needed.

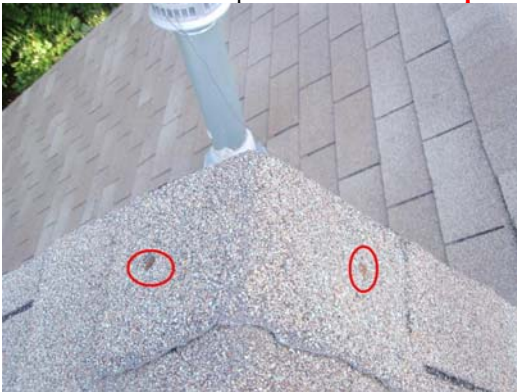
- **Repair:** Exposed nail heads were observed in the roofing shingles and/or ridge caps. All exposed nail heads should be caulked to reduce the potential of leaks. **Repaired by Dave Pollak, Pyramid Roofing Company, Inc. (816) 966-1101**

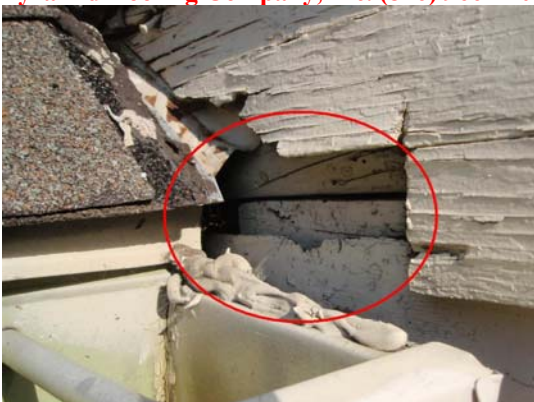
- **Repair:** Diverter flashing and caulking is needed at the siding corner near the roof step up at front and back of house at ends of gutter. A siding and flashing technician should be engaged to make necessary repairs. **Repaired by Dave Pollak, Pyramid Roofing Company, Inc. (816) 966-1101**

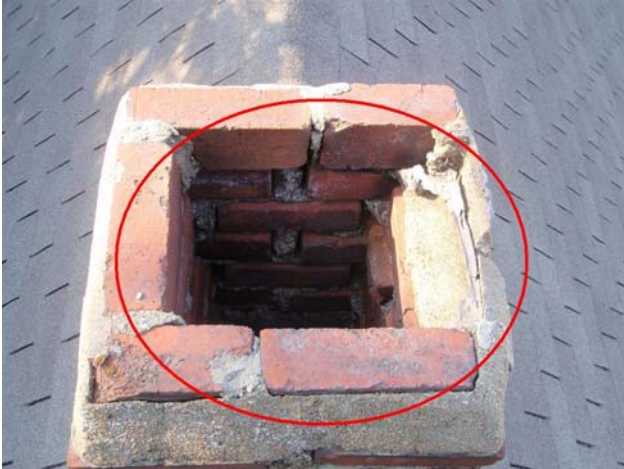
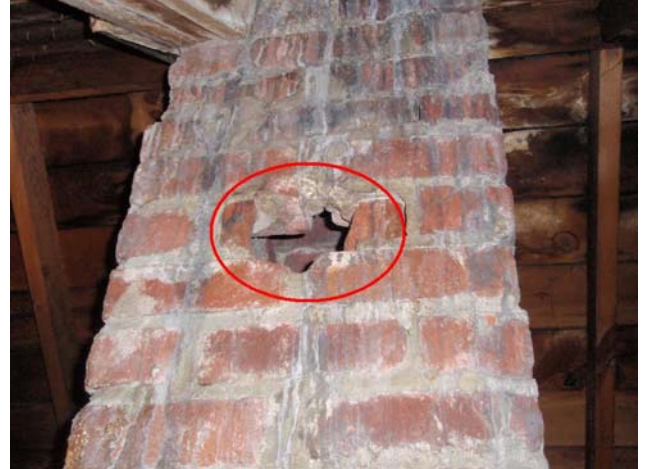
- **Monitor, Repair:** The masonry chimney shows evidence of minor deterioration at the chimney cap. Rebuilding is needed. The chimney is no longer in use. Repairs are discretionary.
- **Repair:** A rain cap and vermin screen should be installed on the masonry chimney and the chimney flue should be checked for damage. Chimney is no longer in use. **Repaired by Chimney Tech (816) 221-9981**

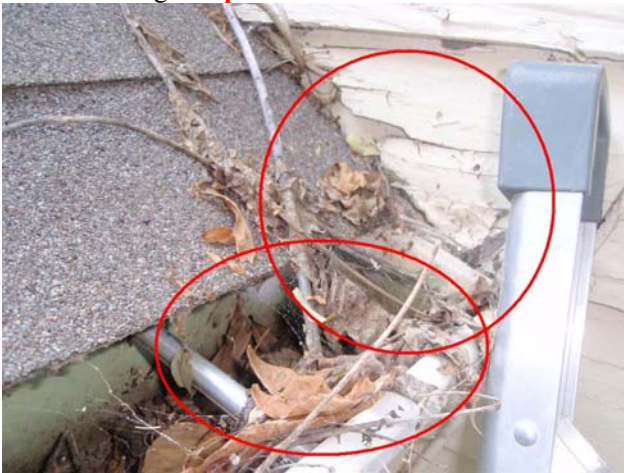
- **Repair:** The gutters require cleaning to avoid spilling roof runoff around the building – a potential source of water entry or water damage. **Repaired**

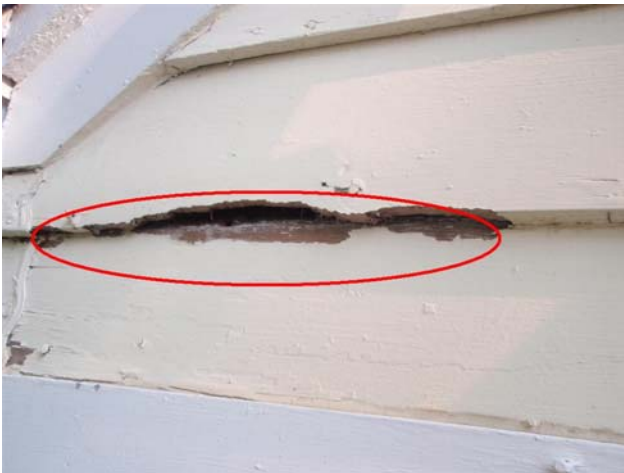
- **Repair:** The exterior siding paint is peeling and/or worn thin in localized areas. These areas should be painted to prevent water damage or rot in the future.
- **Repair:** The loose siding should be re-secured to avoid water and/or wind damage (i.e. back siding where roof steps up).
- **Repair:** Any openings in the exterior siding should be sealed. An example is at the front siding over the porch. Caulking is needed.
- **Repair:** Localized rot/damage was observed in the siding (i.e. at back corner over air conditioner). Following repair of the damaged areas (which should be combined with exterior painting/maintenance) proper maintenance of the siding and control of water from roof or surface runoff can avoid further damage.

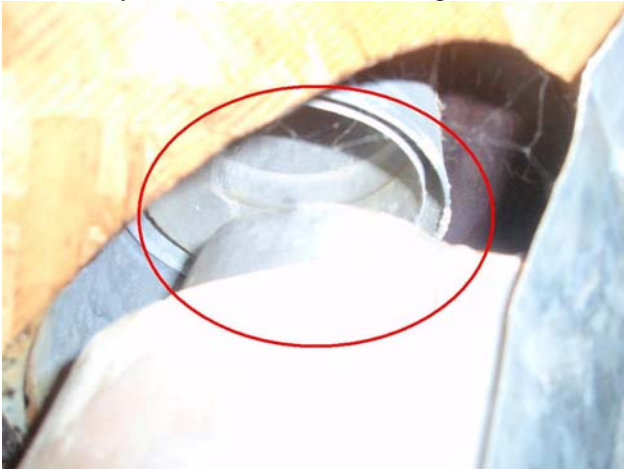
- **Repair, Safety Issue:** *Poor exhaust flue connection at the water heater flue in the attic should be improved immediately.* Poor connections risk flue gas and carbon monoxide leakage or other unsafe conditions.

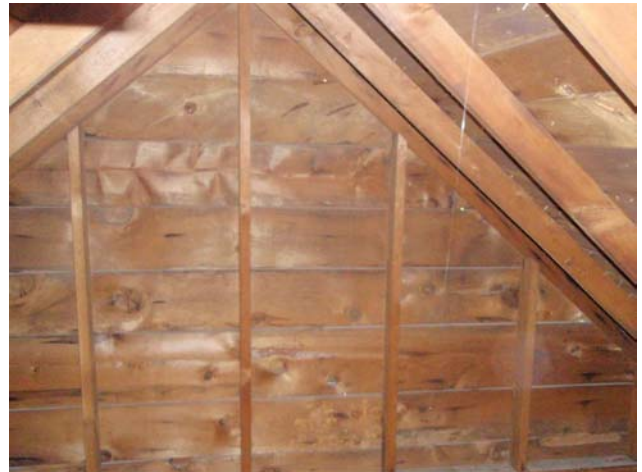
- **Repair:** Light was visible in attic at front porch siding. These should be sealed to prevent insect entry and water damage.

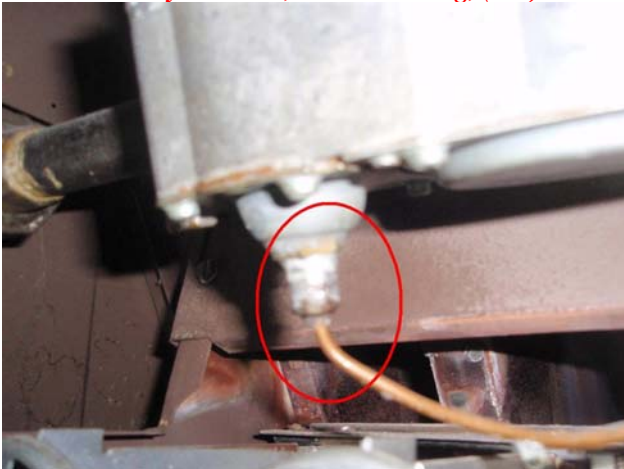
- **Repair, Safety Issue:** *A gas leak was detected (at the furnace controls inside the housing) with a TIF 8800 gas/carbon monoxide detector and confirmed with soapy water. This is a serious safety concern. It is recommended that the gas utility, HVAC company or plumber be engaged as soon as possible to make the necessary repairs. The current occupants of the home should also be notified. A plumber came and checked with soapy water, no gas leak was noted. Tony Gallardo, C&A Plumbing, (913) 660-3173*
