**Star
Home
Inspection Services**

Home Inspection Report

2544 SE Kimbrough Cr, Lees Summit, MO 64063

Inspection Date: 08/17/2009

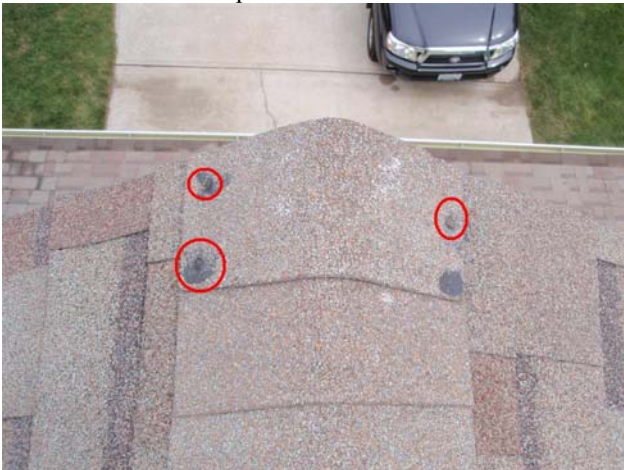
- **Repair:** Exposed nail heads were observed in the roofing shingles and/or ridge caps. All exposed nail heads should be caulked to reduce the potential of leaks.

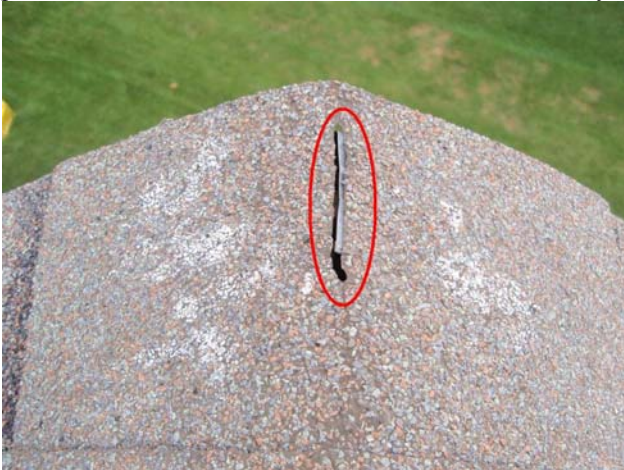
- **Repair:** Minor repairs to the roofing are needed at the north side at ridge cap where crack was observed. All roof penetrations should be examined and sealed as necessary.

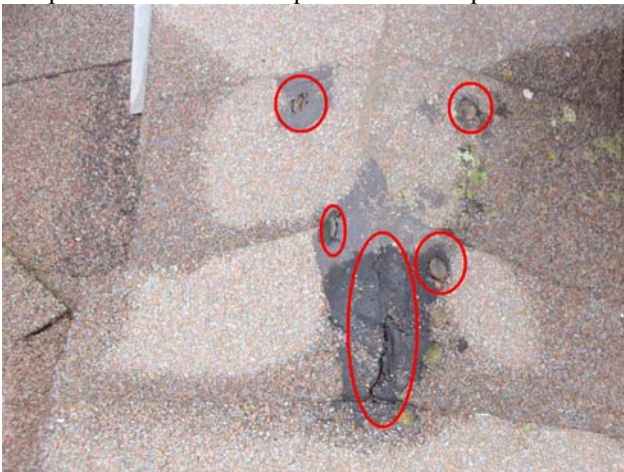
- **Monitor, Repair:** Prior repairs to the roofing are evident at small area at roofing behind chimney. This would suggest that problems have been experienced in the past. The roofing tar at this location is cracking and should be repaired.

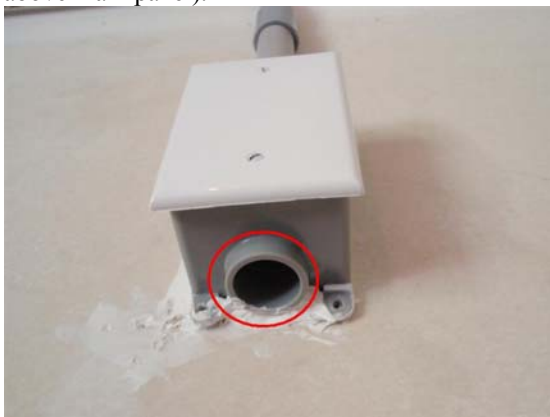
- **Repair:** All junction box openings should be sealed, in order to protect the wire connections (i.e. at garage junction box above main panel).

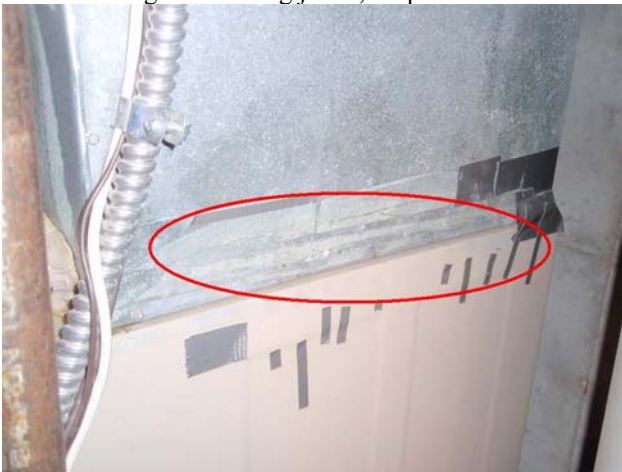
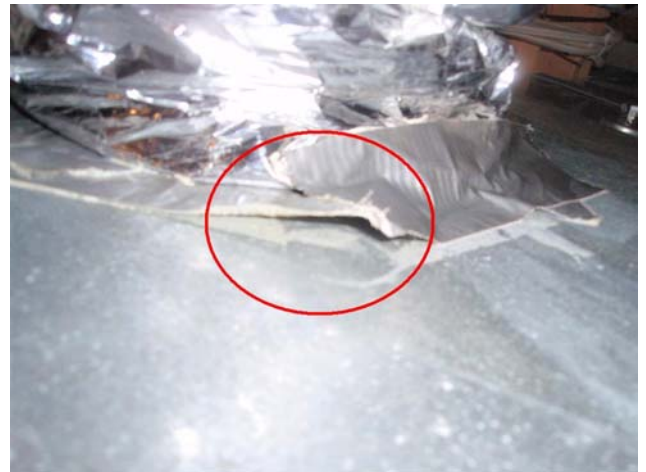
- **Repair:** Loose fitting joints and/or openings in the ductwork should be improved. Duct tape is not the proper material to use for sealing loose fitting joints, despite its name.

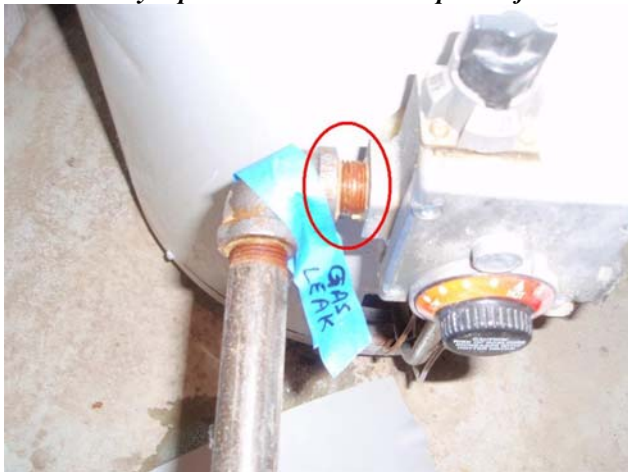
- **Repair, Safety Issue:** *A gas leak was detected with a TIF 8800 gas/carbon monoxide detector and confirmed with soapy water (at the gas piping to the water heater marked "GAS LEAK" with blue tape). This is a serious safety concern. It is recommended that the gas utility, HVAC company or plumber be engaged as soon as possible to make the necessary repairs. The current occupants of the home should also be notified.*
