Star Home Inspection Services

Home Inspection Report

2710 S 28th St, Kansas City, KS 66106

Inspection Date: 08/11/2009

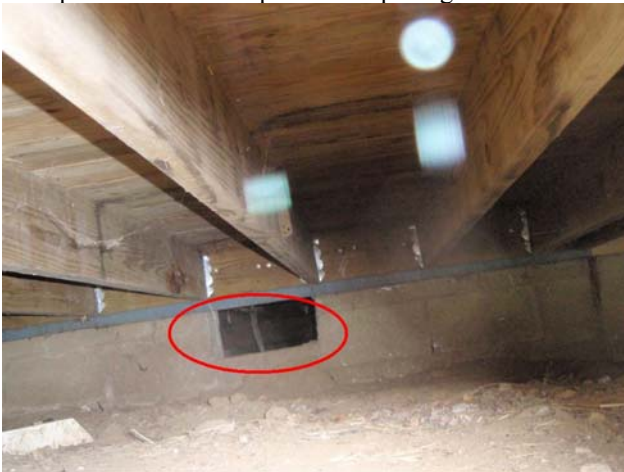
- **Improve:** All potential vermin entry points to the crawl space should be sealed to reduce risk of pest activity or damage example at front crawl space vent opening.

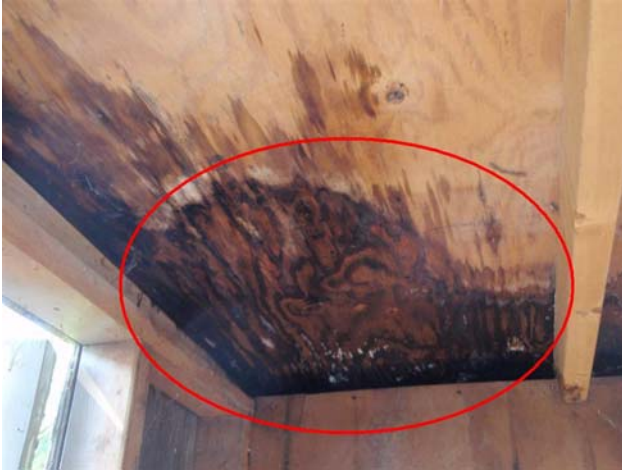
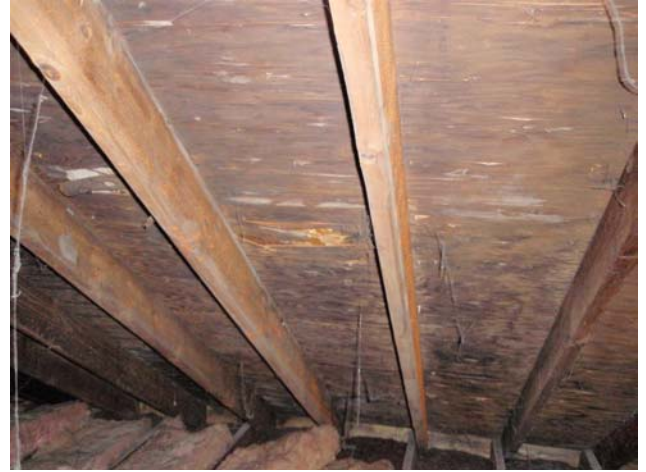
- **Repair:** The roof sheathing shows evidence of minor delaminating (deterioration caused by moisture) and possible mildew. In most cases, damaged roof sheathing must be replaced prior to re-roofing. Improved roof and attic ventilation can reduce moisture levels and cut future damage to the roof structure. Damaged sheathing should be replaced when re-roofing. The storage building sheathing shows evidence of moisture damage/mold at south storage building.

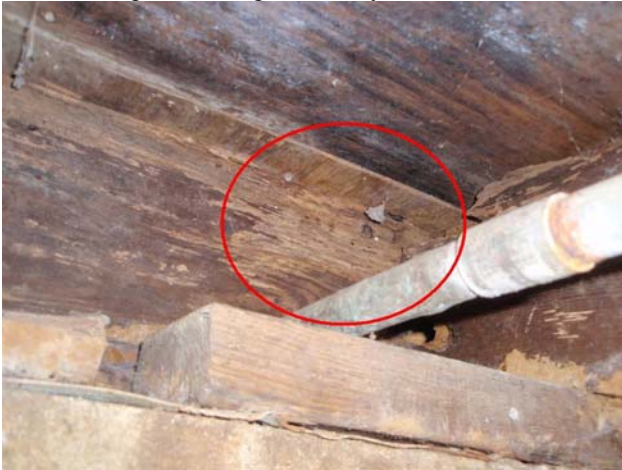
- **Repair:** Evidence of termite damage at the back crawl space rim joists was observed and there is risk of additional hidden damage since termites can do a substantial amount of damage. If the property has not already been treated, a licensed pest control specialist should be engaged to eliminate further termite activity within the home. Damaged wood should be repaired or replaced. Any wood soil contact should be eliminated.

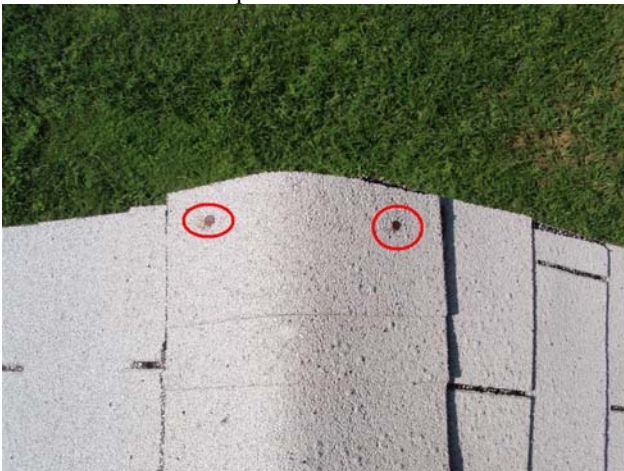
- **Repair:** Exposed nail heads were observed in the roofing shingles and/or ridge caps. All exposed nail heads should be caulked to reduce the potential of leaks.

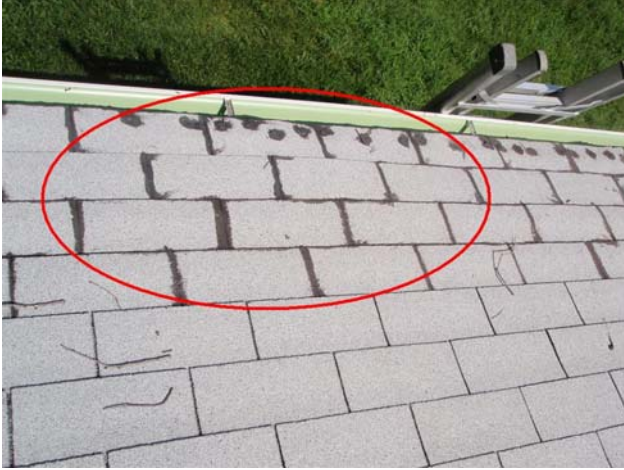
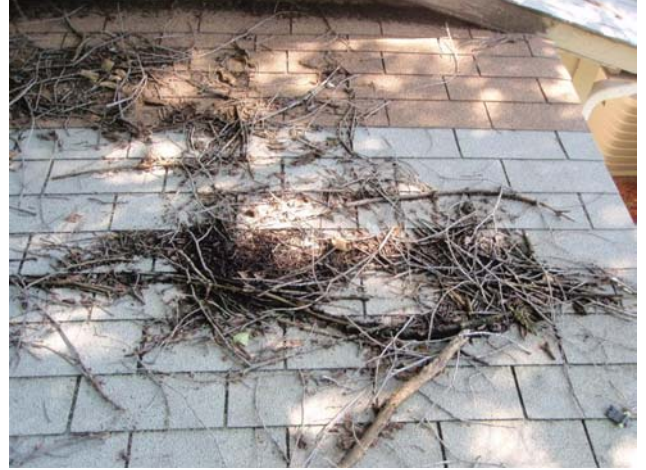
- **Monitor:** Prior repairs to the roofing are evident. This would suggest that problems have been experienced in the past. This area should be monitored.
- **Improve:** Debris should be removed from the roofing to reduce risk of leaks and early roof wear.

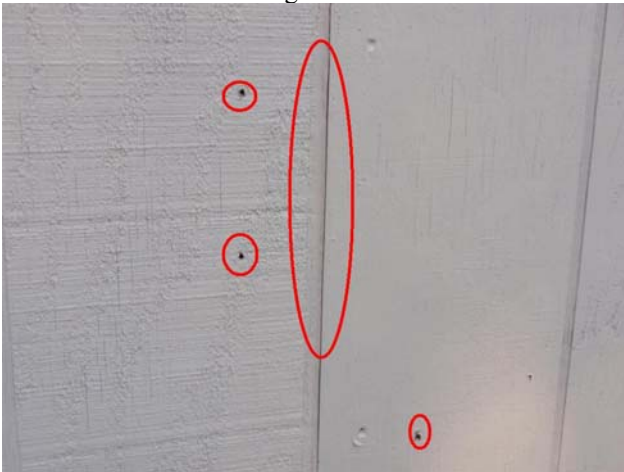
- **Monitor:** Siding of this type requires monitoring and maintenance. It has a tendency to pop out past nail heads creating a space where two panels join together. Re-securing and caulking the seams and nail holes is standard maintenance for this type of siding.
- **Repair:** Any openings in the exterior siding should be sealed. An example is at the front of the house near the house address numbers. Caulking is needed.

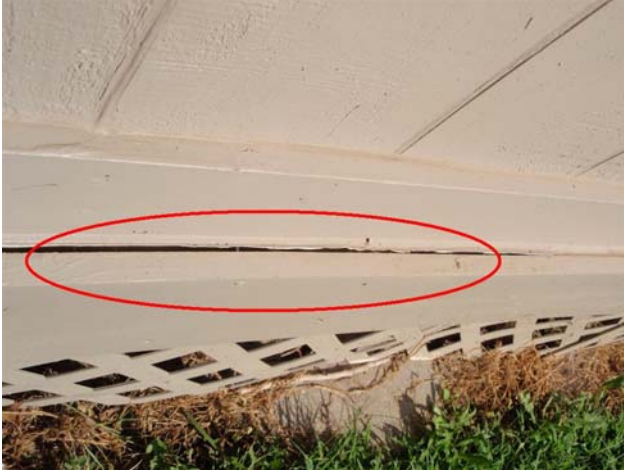
- **Repair:** Localized rot was observed in the siding at the back southeast corner and at outbuilding. Following repair of the damaged areas (which should be combined with exterior painting/maintenance) proper maintenance of the siding and control of water from roof or surface runoff can avoid further damage.
- **Repair:** The siding trim needs caulking improvements in localized areas to prevent water damage and rot.

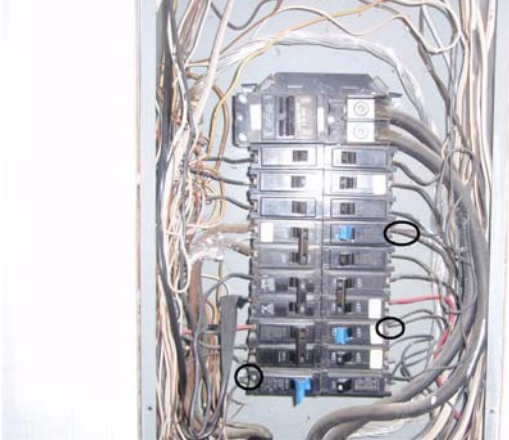
- **Repair:** Circuits within the main distribution panel that are doubled up (referred to as “double taps”) should be separated. Each circuit should be served by a separate fuse or breaker.

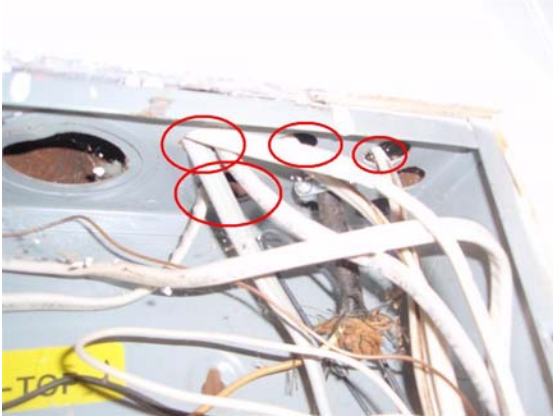
- **Repair:** Cable clamps (sometimes referred to as bushings or grommets) are required where wiring passes into the main distribution panel. Cable clamps serve to protect the wiring from the metal edges of the panel openings.

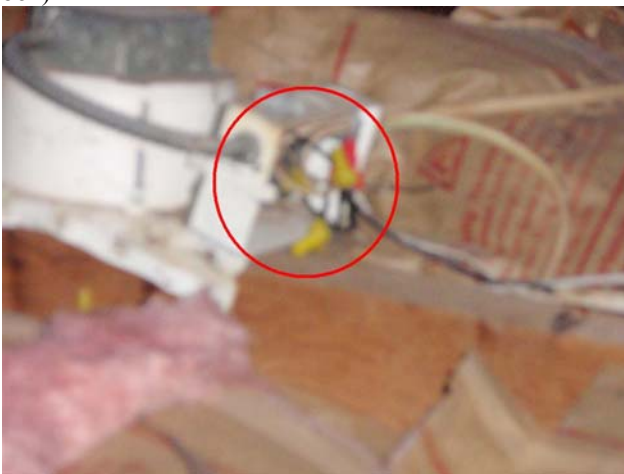
- **Repair:** All junction boxes should be fitted with cover plates, in order to protect the wire connection (i.e. attic junction box)

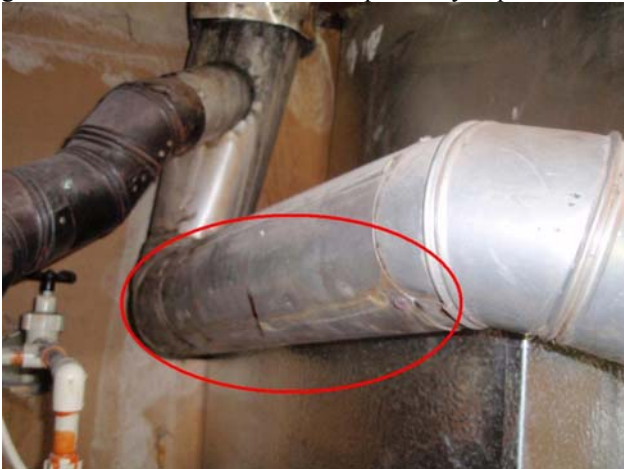
- **Repair, Safety Issue:** The slope of the exhaust flue does not appear to be sufficient to allow the safe flow of exhaust gases. This condition should be repaired by a qualified heating technician.

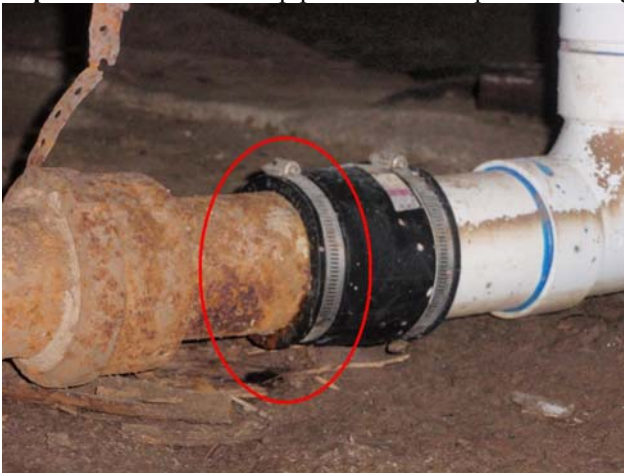
- **Repair:** The waste drain pipe in the crawl space is leaking.

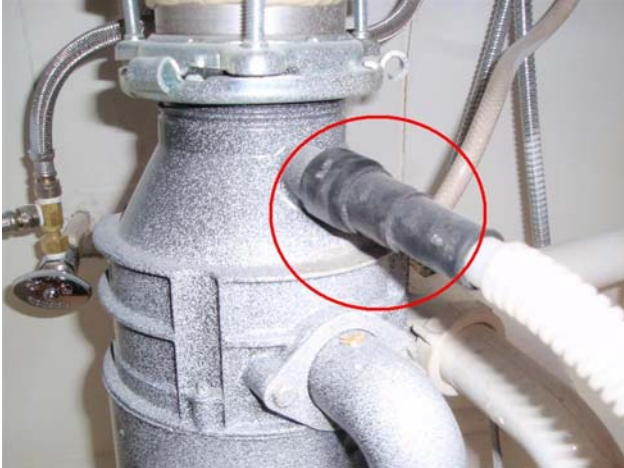
- **Monitor, Improve:** The hall bath tub faucet is slightly loose.
- **Repair:** The master bath shower head is leaky.
- **Monitor:** Minor surface damage to the hall bath bathtub was noted.
- **Repair:** The hall bath bathtub drain plug is inoperative or missing and needs repair.
- **Repair:** The hose bib is leaky.
- **Repair:** The master bath shower liner should be caulked at seam.
- **Monitor, Repair:** The master bath shower liner is loose.
- **Improve:** A clamp is needed at the dishwasher drain line connection.
