Star Home Inspection Services

Home Inspection Report

27845 W 89th St, Lenexa, KS 66227

Inspection Date: 12/4/2008

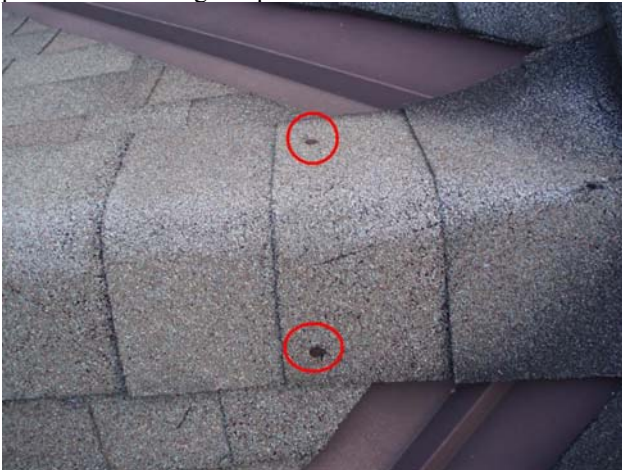
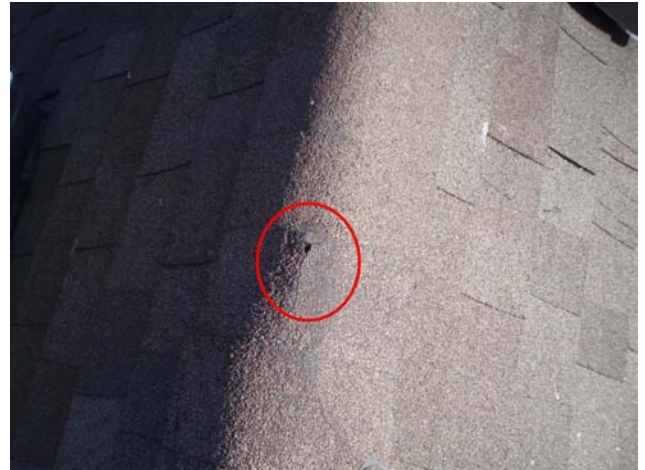
Sloped Roofing

- **Repair:** Exposed nail heads were observed in the roofing shingles and/or ridge caps. All exposed nail heads and any penetrations at ridge caps should be caulked to reduce the potential of leaks.

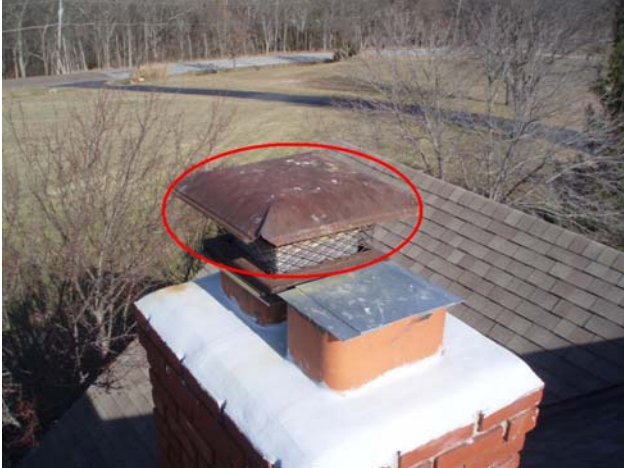
Chimneys

- **Repair:** The metal chimney cap is rusting. It should be painted with an appropriate paint to extend its life.

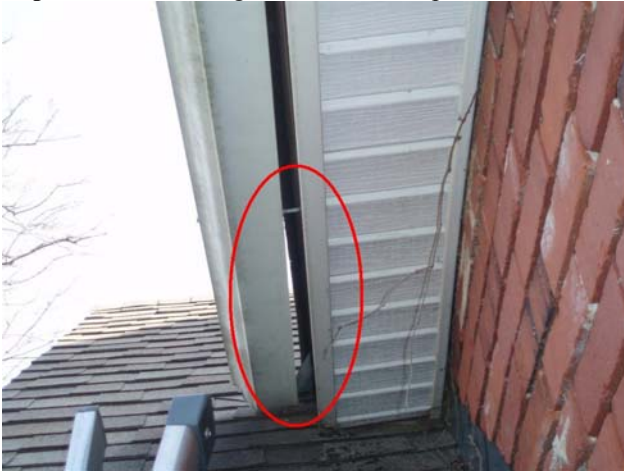
Gutters & Downspouts

- **Repair:** Loose front gutter should be repaired.

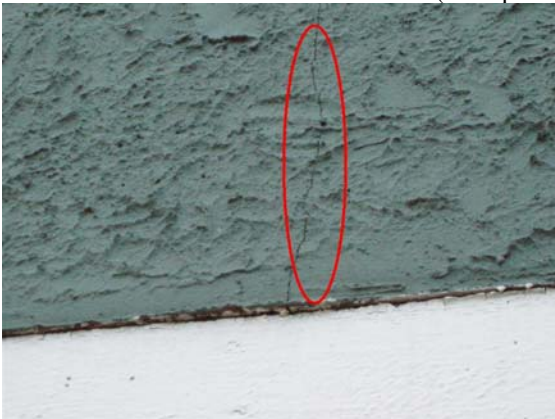
Exterior Walls

- **Monitor, Repair:** Localized pointing of deteriorated mortar between the bricks of the front decorative brick walls is advisable to prevent further deterioration.
- **Repair:** Back top open corners of siding trim should be sealed to prevent water damage. Hidden damage may be present where water entry is possible.
- **Repair:** The paint on the trim around the siding is peeling at north front side of garage. These areas should be painted to prevent water damage and rot.
- **Repair:** Localized rot was observed in the trim around siding at the base of front brick trim. Following repair of the damaged areas (which should be combined with exterior painting/maintenance) proper maintenance of the siding and control of water from roof or surface runoff can avoid further damage.
- **Monitor:** Minor cracks in stucco noted (example on north side garage area).

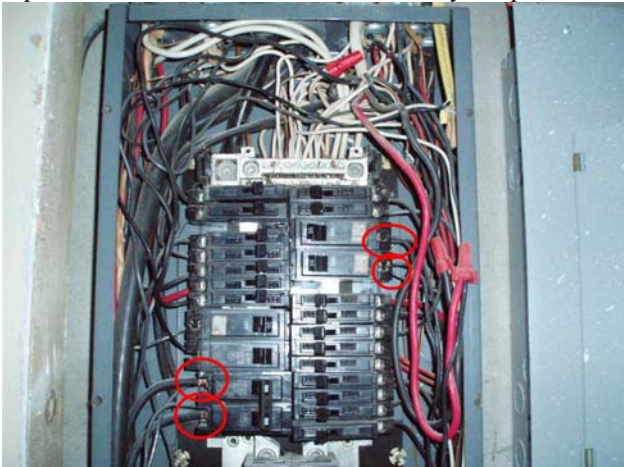
Main Panel

- **Repair:** Circuits within the main distribution panel that are doubled up (referred to as "double taps") should be separated. Each circuit should be served by a separate fuse or breaker.

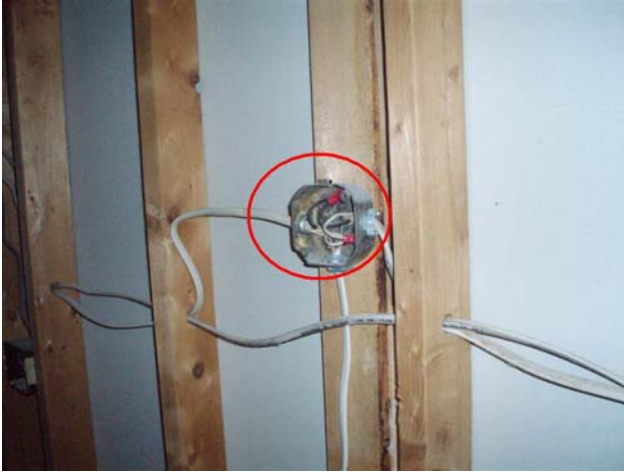
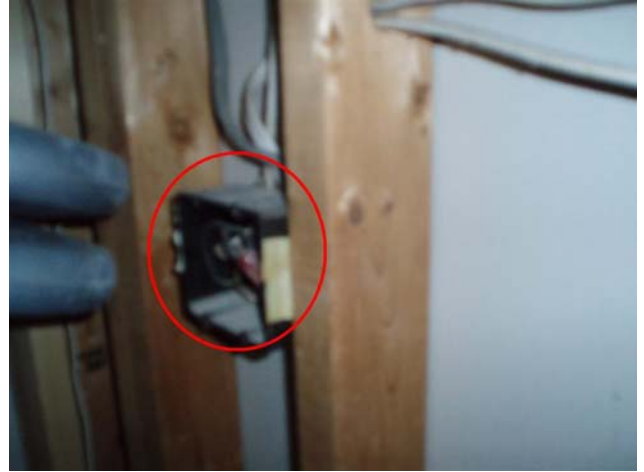
Distribution Wiring

- **Repair:** All junction boxes should be fitted with cover plates, in order to protect the wire connections (examples in furnace room).

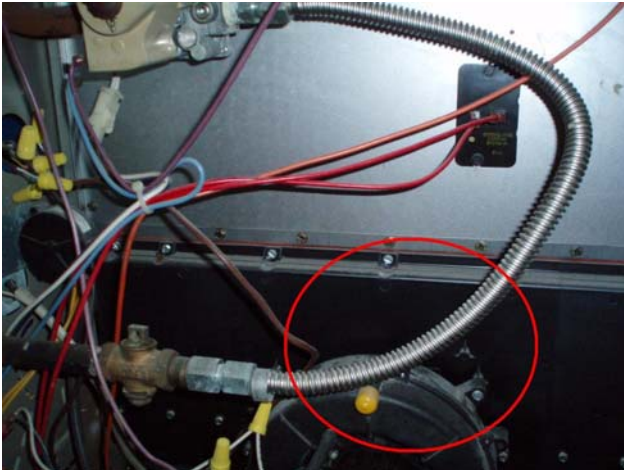
Furnace

- **Monitor:** The furnace has flexible gas piping inside the furnace housing. This configuration is not acceptable in some cities. Confirmation with local code administrator is recommended.

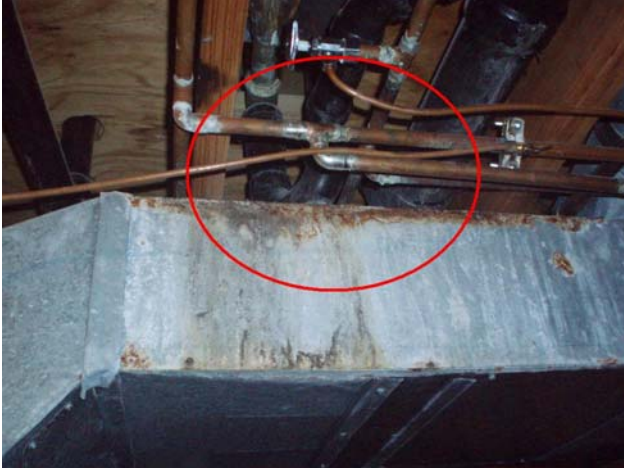
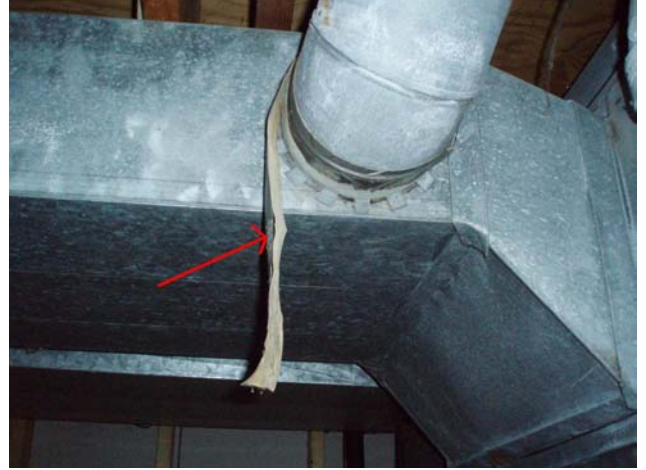
- **Monitor:** Rust was noted on ductwork in furnace room (suspect previous leak at waste drain above ductwork). This is a cosmetic condition.
- **Improve:** Loose tape on ductwork connections in furnace area should be improved.

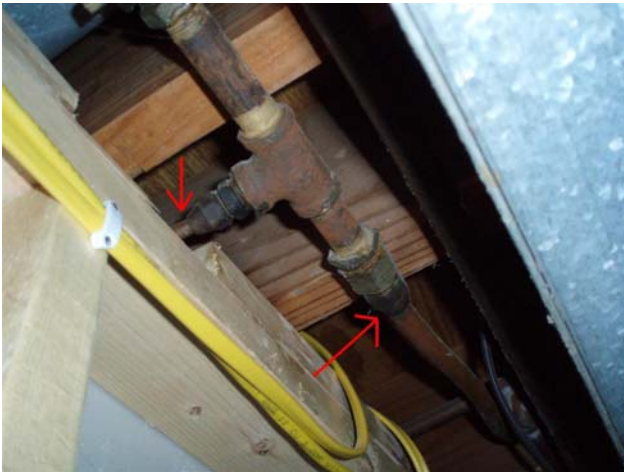
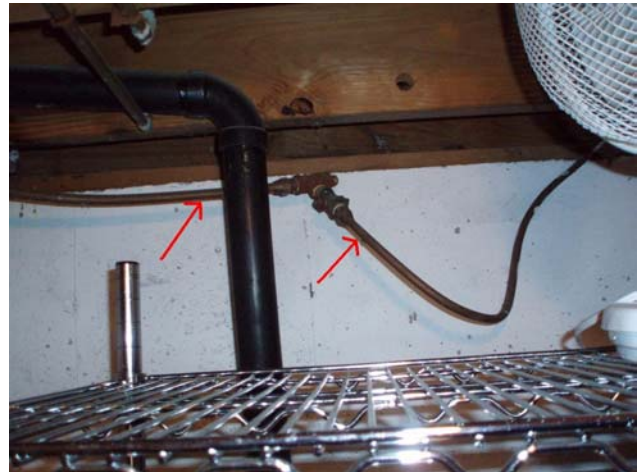
Gas Piping

- **Repair:** Copper tubing is no longer suitable for gas piping. It's recommended this pipe be replaced with one of suitable material.
