**Star  
Home  
Inspection Services**

*Home Inspection Report*

**2800 SW 12th St Lees Summit, MO 64081**

**Inspection Date: 10/28/2009**

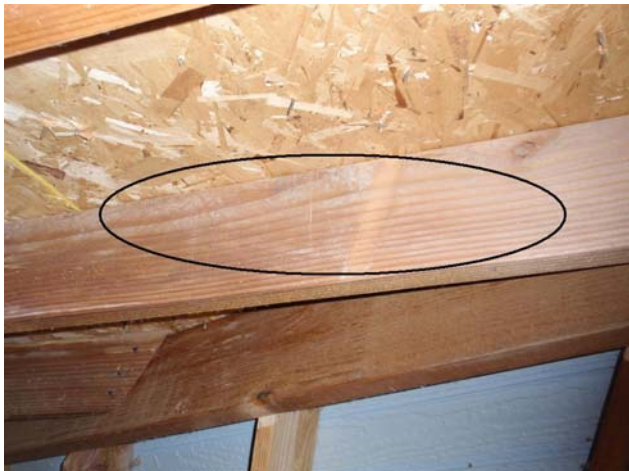
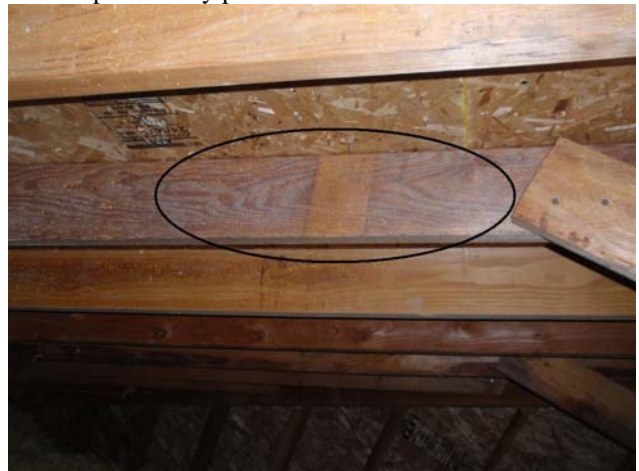
- **Monitor:** Construction mold was visible on some roof rafters. This is mold that grows on the lumber while lying in the weather during construction as evidenced by the strap marks. Most homes have some level of this mold and it goes dormant once removed from the elements and normally does not present any problems.

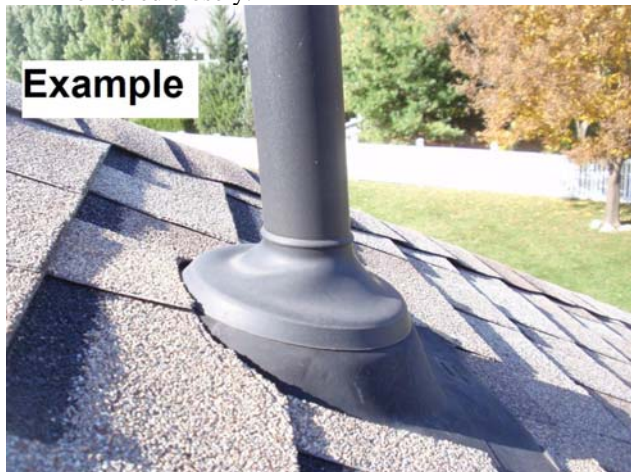
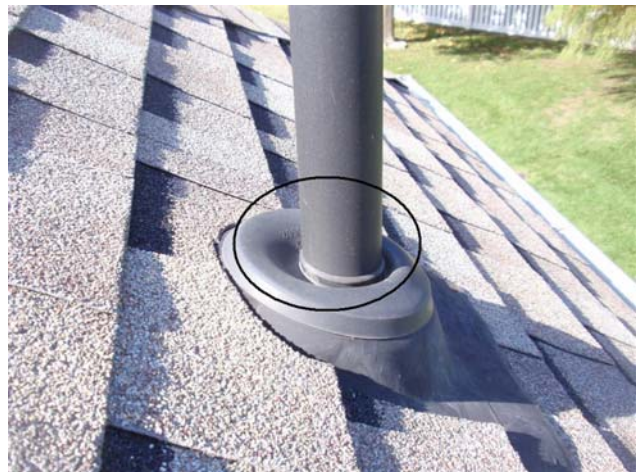
- **Monitor:** Some plumbing vent flashing boots are inverted which can reduce their life. These flashings should be monitored closely.

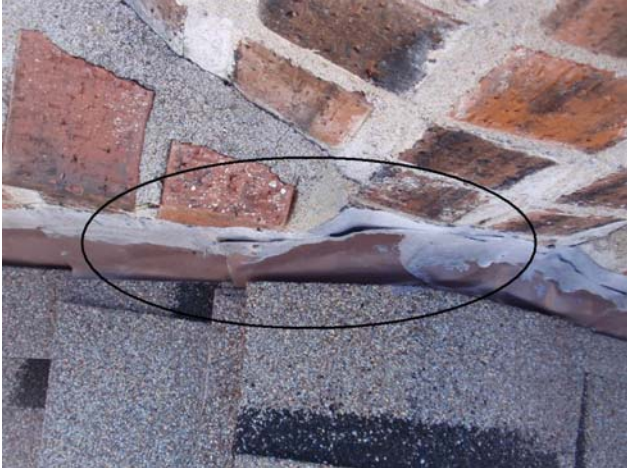
- **Repair:** The chimney flashing should be caulked on the east side to avoid leaks.

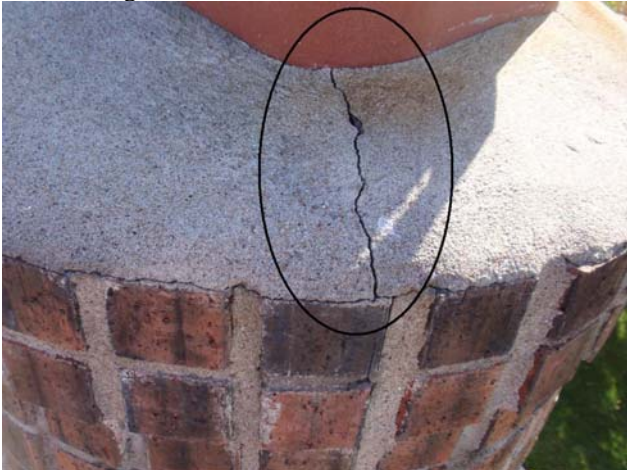
- **Repair:** The cap of the masonry chimney is cracked. These cracks should be sealed or caulked to prevent damage from freezing water.

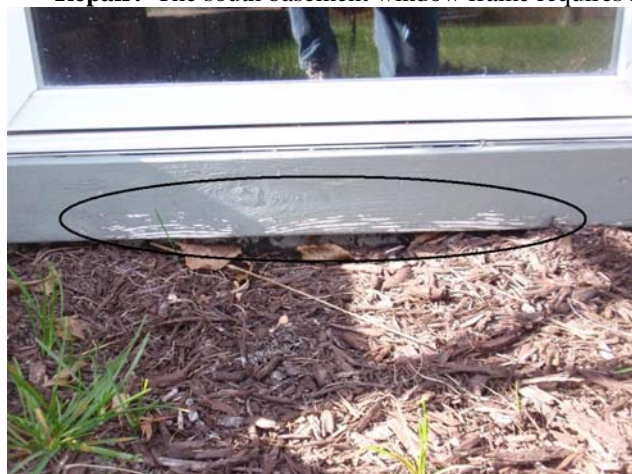
- **Repair:** The south basement window frame requires minor painting.

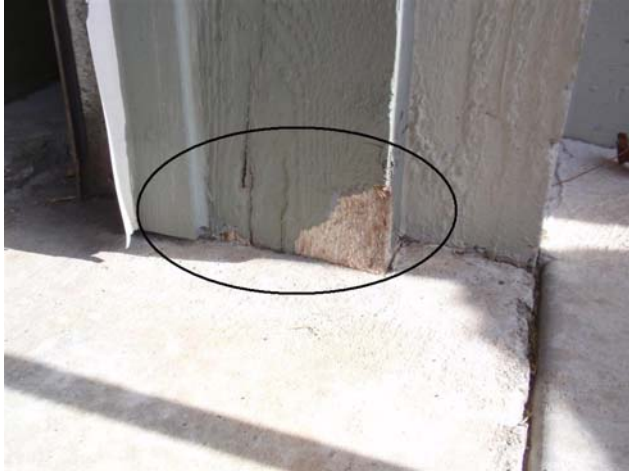
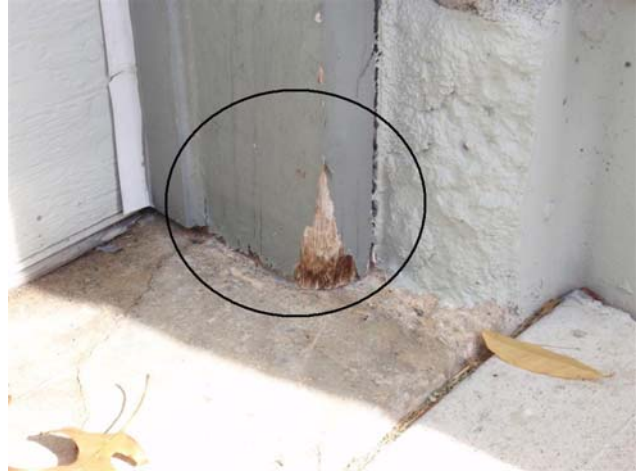
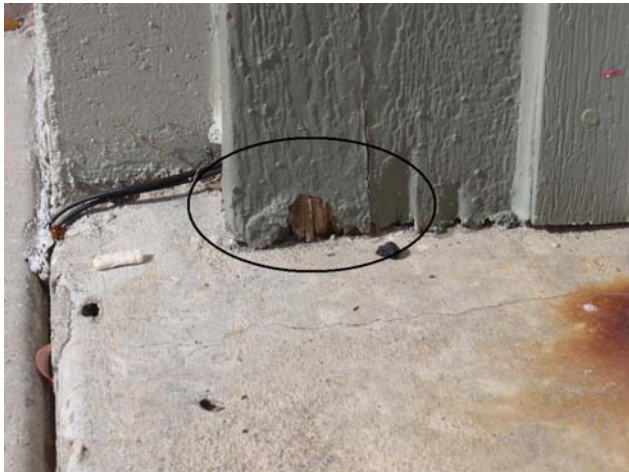
- **Repair:** The paint on the garage door frame/ trim is peeling and there is some vermin damage. These areas should be caulked and painted.

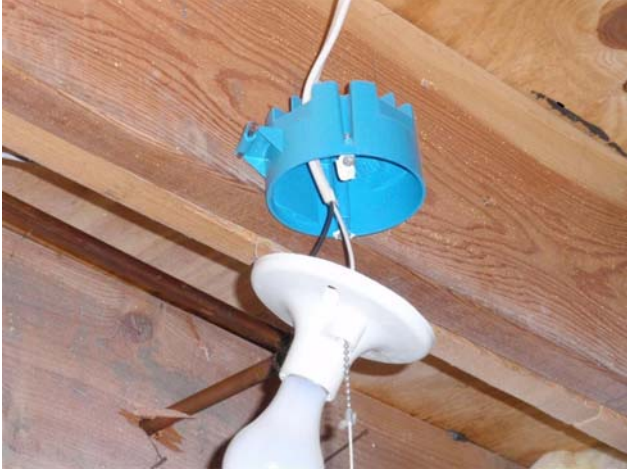
- **Repair:** Some basement lights are inoperative. If the bulbs are not blown, the circuit should be repaired.
- **Repair:** The loose light fixture in the unfinished basement should be repaired or replaced.

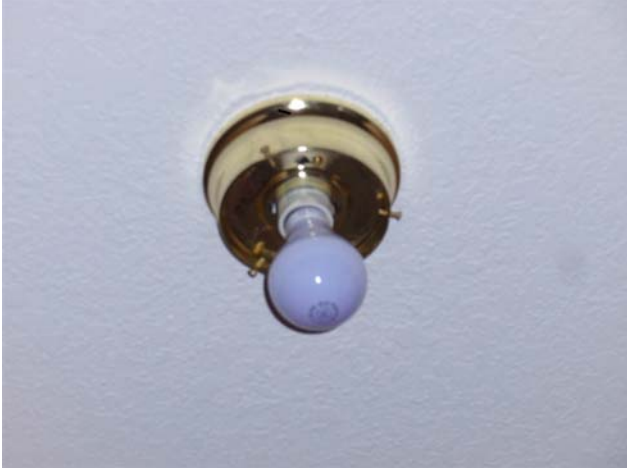
- **Monitor, Repair:** The food pantry light fixture is missing the glass cover. Repair is discretionary.

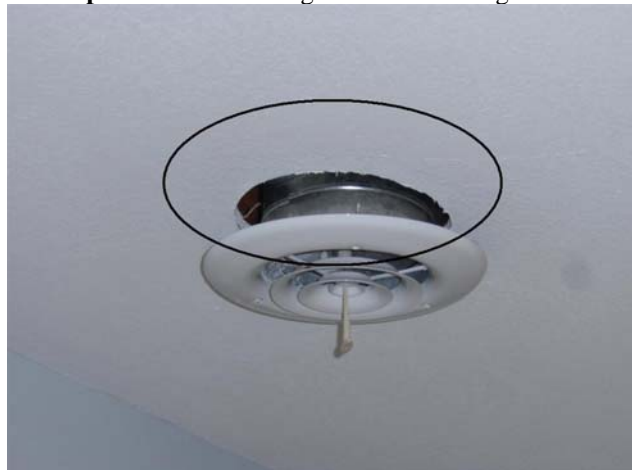
- **Repair:** Loose vent register in the sewing room should be replaced.

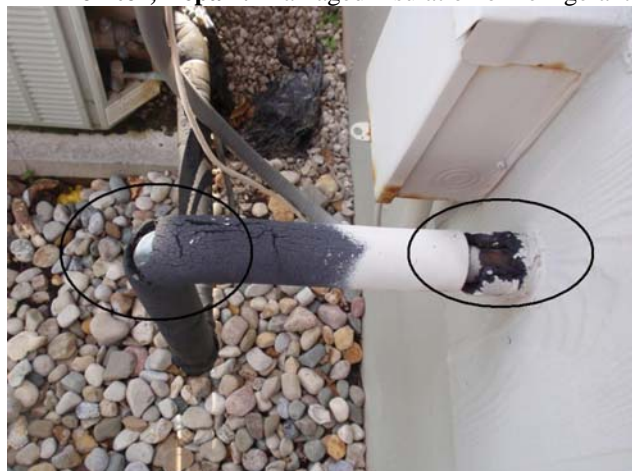
- **Monitor, Repair:** Damaged insulation on refrigerant lines could be improved.

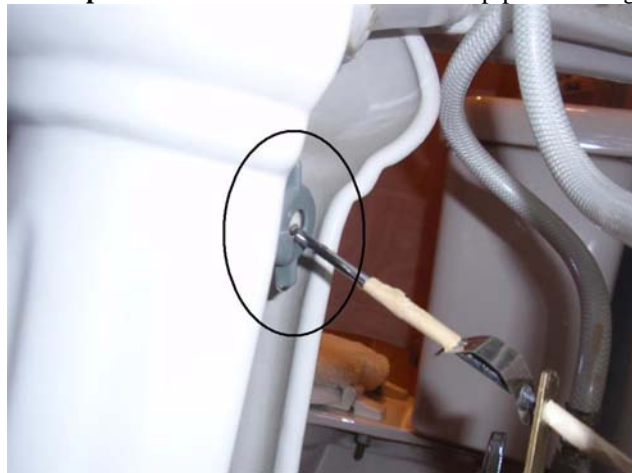
- **Repair:** The basement bathroom drain pipe is leaking.

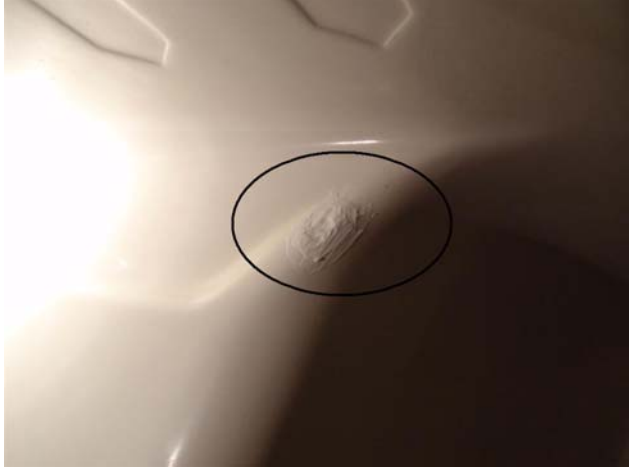
- **Repair:** The basement bathroom sink is slightly loose on the pedestal.
- **Repair:** The basement bathroom sink drain plug is inoperative and needs repair.
- **Repair:** The sink drain plugs are missing and needs repair in both south bathrooms.
- **Monitor:** The patio sink was observed to drain slowly, suggesting that an obstruction may exist.
- **Monitor, Repair:** The master bathroom shower seat has been patched. Repair is discretionary.

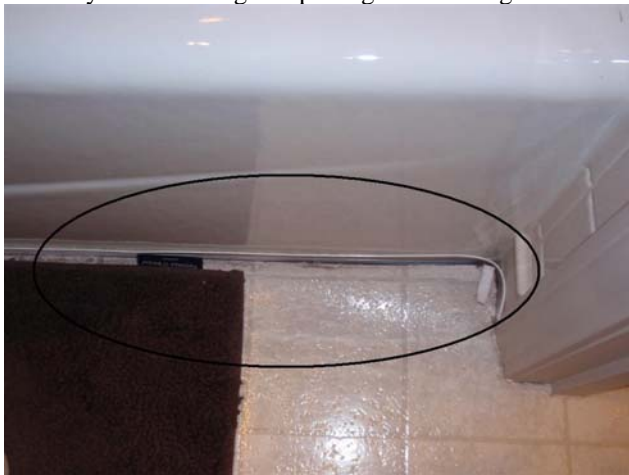
- **Improve:** Cracked, deteriorated and/or missing bathtub and shower enclosure caulk in the Jack & Jill bathroom could be improved along the floor. With vinyl flooring it's recommended a quarter round molding be installed to prevent the vinyl from curling and pulling the caulking loose.

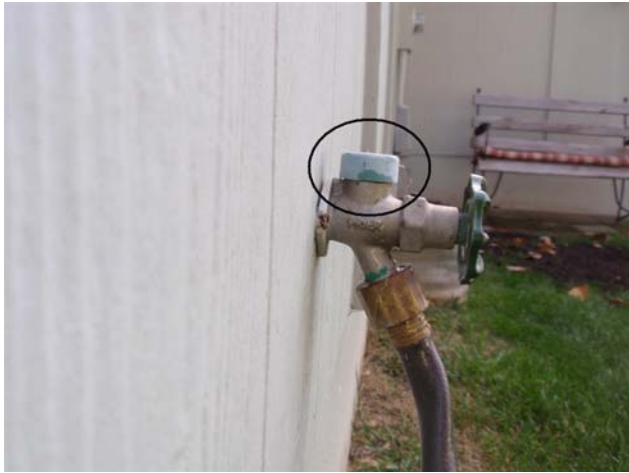
- **Repair:** The north hose bib leaks from the anti-siphon cap when the water is running. The anti-siphon valve needs to be replaced.

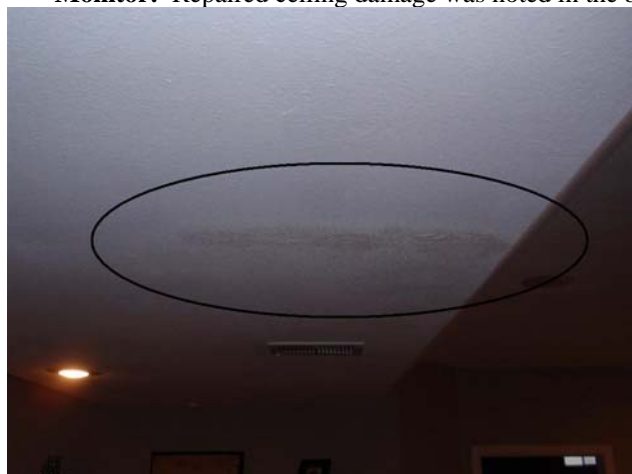
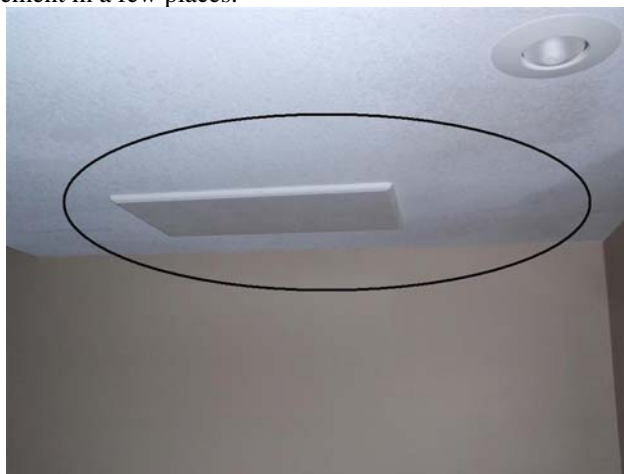
- **Monitor:** Repaired ceiling damage was noted in the basement in a few places.

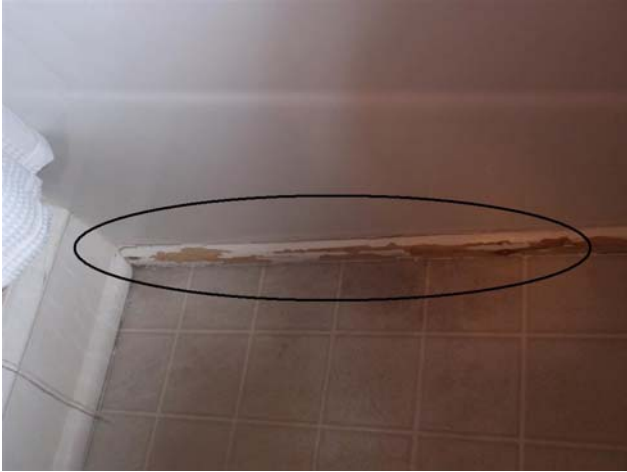
- **Monitor:** The carpet shows typical wear and/or soiled spots and stains.
- **Repair:** The quarter round trim by the bathtub in the southwest bedroom bath is peeling. Repair is discretionary.

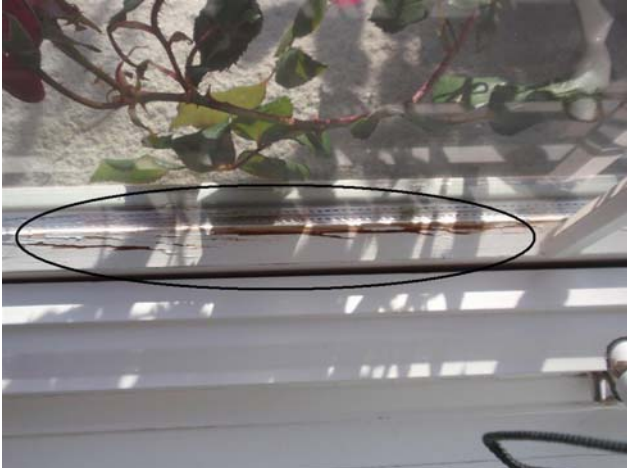
- **Monitor, Repair:** Some interior window trim is peeling. Repair is discretionary.

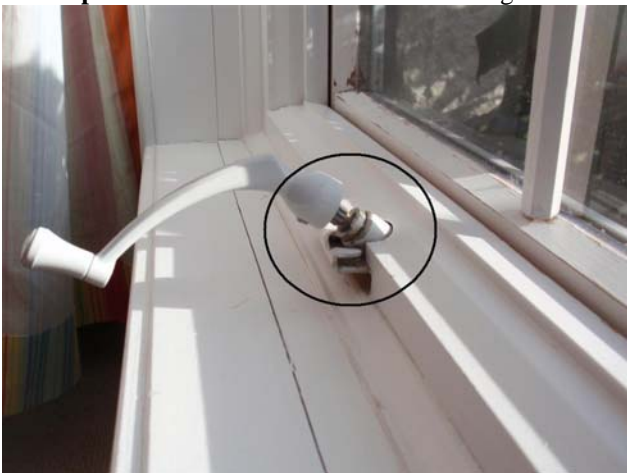
- **Repair:** The south window in the hearth room is inoperative. Repair is needed to the cranking hardware.
- **Repair:** The north window in the hearth room hangs up when closing. It had to be pushed from the outside to close.
- **Repair:** Window crank covers are missing in the southwest bedroom.

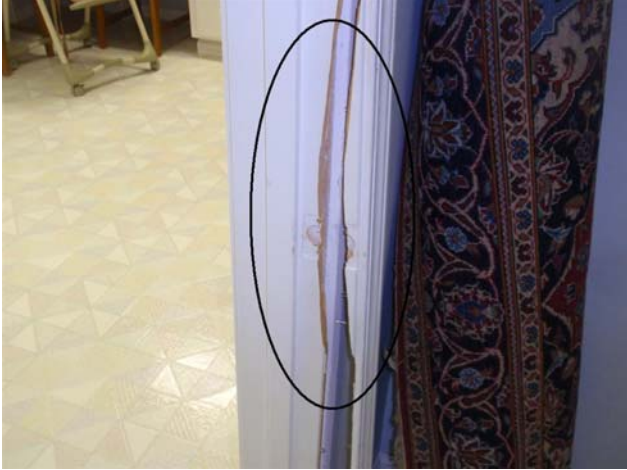
- **Monitor, Repair:** The door trim on the sewing room closet is damaged and needs repair

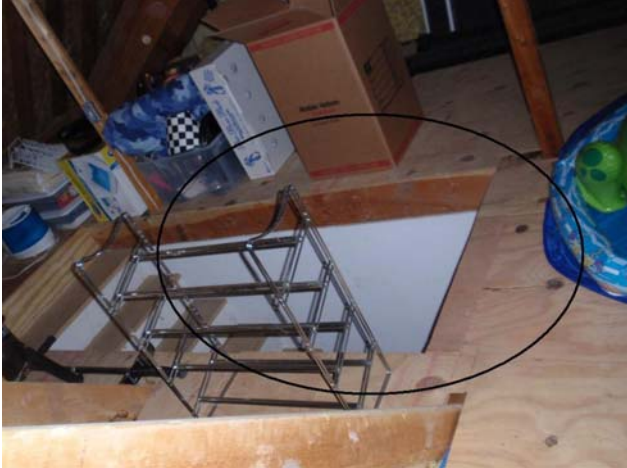
- **Repair, Safety Issue:** For improved safety, it is recommended that a railing be provided for the attic stairway.

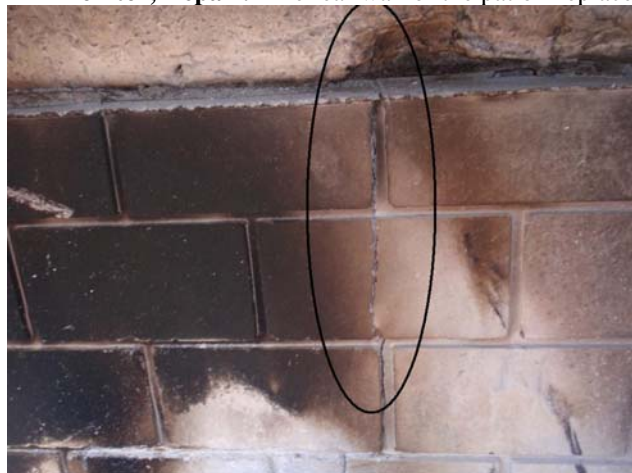
- **Monitor, Repair:** The rear wall of the patio fireplace is cracked. It should be monitored.

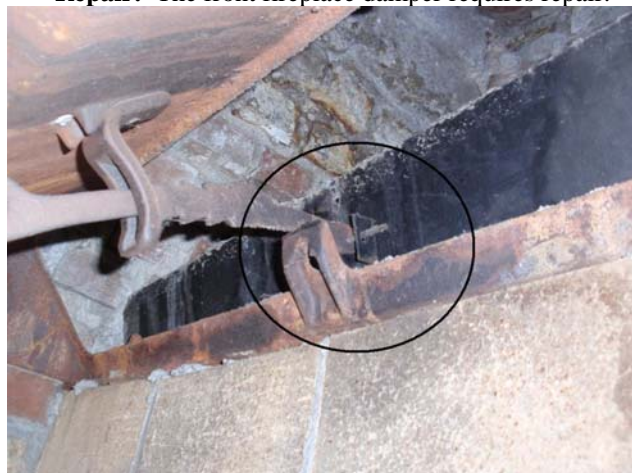
- **Repair:** The front fireplace damper requires repair.
