**Star  
Home  
Inspection Services**

*Home Inspection Report*

**2802 SW Corinth Dr Lees Summit, MO 64081**

**Inspection Date: 10/20/2010**

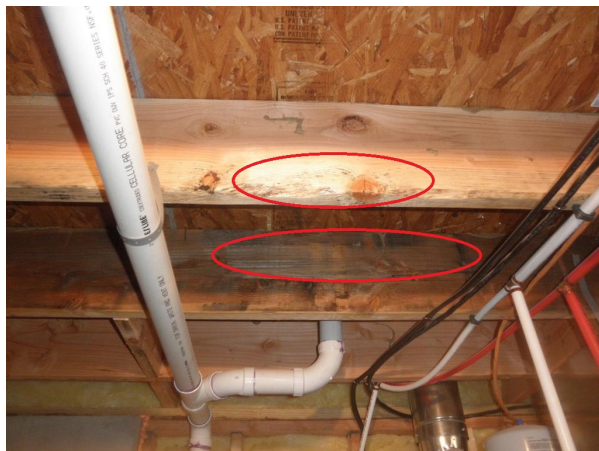
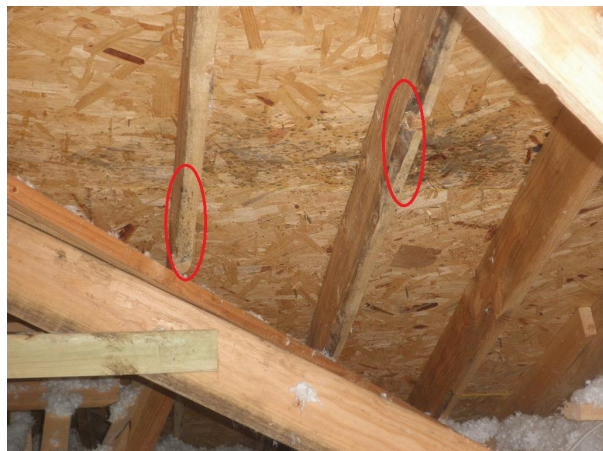
- **Monitor:** Construction mold was visible on some floor joists and some roof rafters. This is mold that grows on the lumber while lying in the weather during construction. Most homes have some level of this mold and it goes dormant once removed from the elements and normally does not present any problems.

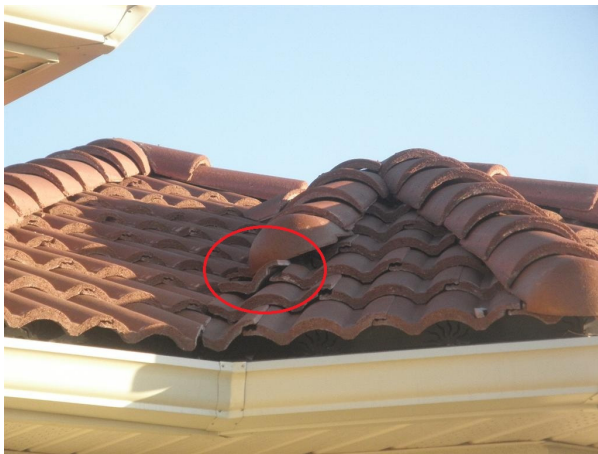
- **Monitor:** A raised tab was observed over the front bedroom. This area should be monitored closely.

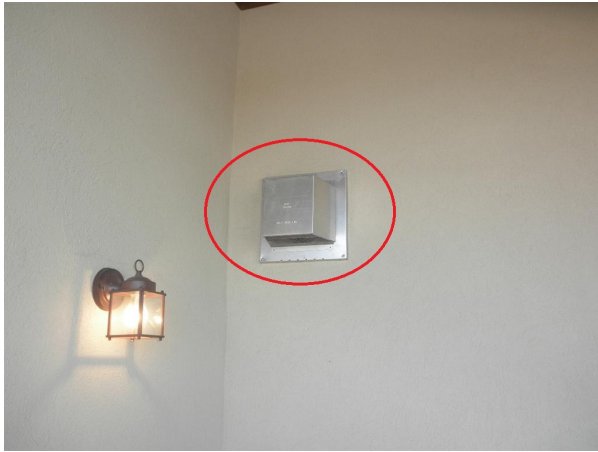
- **Note:** The fireplace vent is positioned where someone could touch the vent causing burns.
