**Star
Home
Inspection Services**

Home Inspection Report

2818 W 73rd Terr, Prairie Village, KS 66208

Inspection Date: 2/4/2009

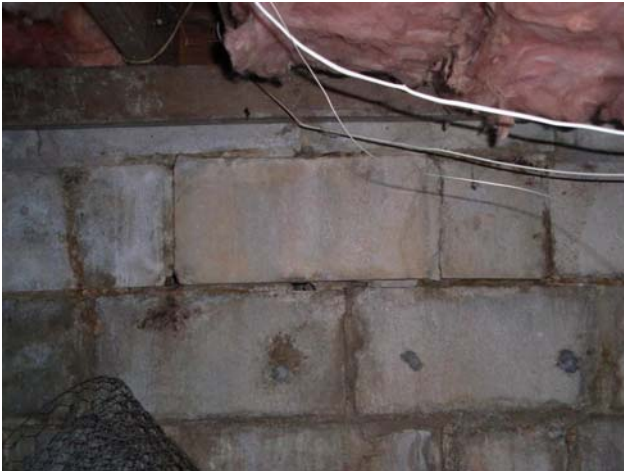
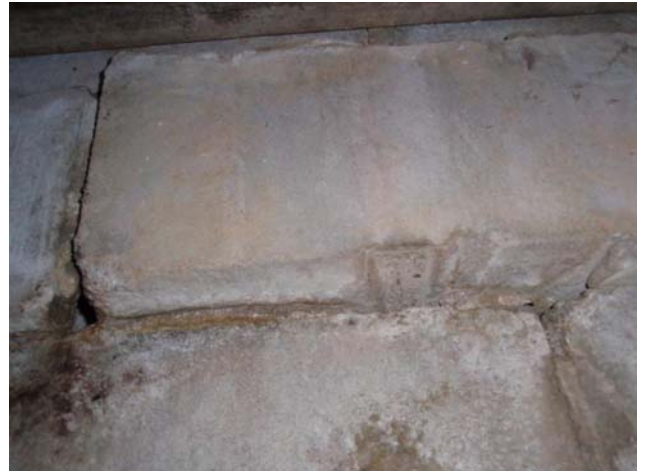
- **Monitor:** Common minor settlement cracks were observed in the foundation walls. This implies that some structural movement of the building has occurred. Cracks of this type should be watched for any sign of additional movement. In the absence of any sign of ongoing movement, repair should not be necessary. One concrete block below front porch area has moved in about two inches.

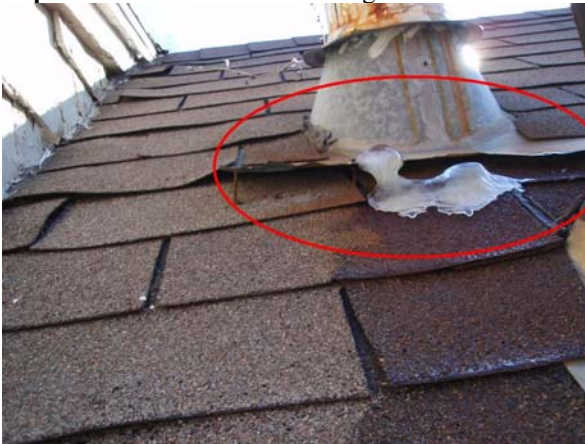
- **Repair:** The furnace vent flashing is loose and should be re-secured to avoid leaks. **Repaired**

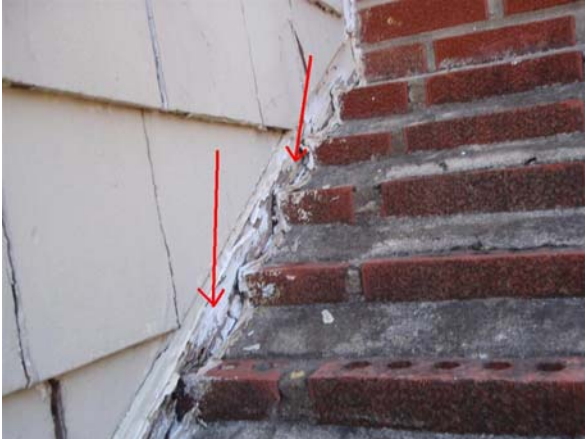
- **Repair:** The chimney flashing should be repaired/caulked to avoid leaks. **Repaired**

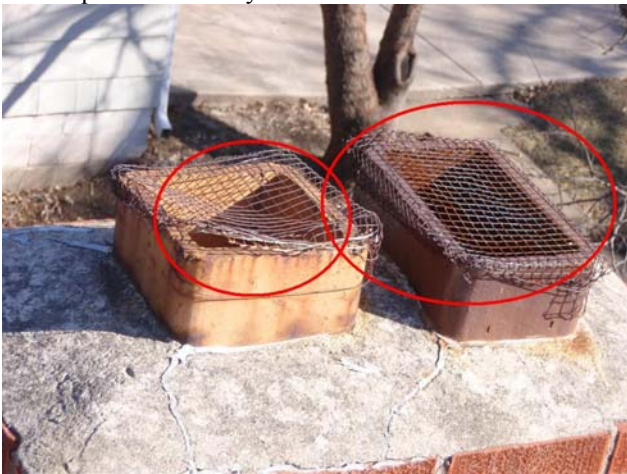
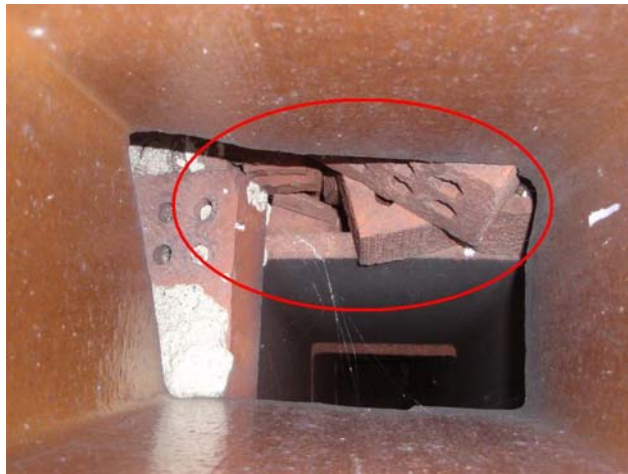
- **Repair:** A rain cap and vermin screen should be installed on the masonry chimney and the chimney flue should be checked for damage. Damaged flues can be unsafe. **Repaired (new rain cap and vermin screen installed)**
- **Repair, Safety Issue:** The flue liner of the masonry chimney is cracked. The flue needs to be repaired and the entire flue inspected for safety. **Excluded**

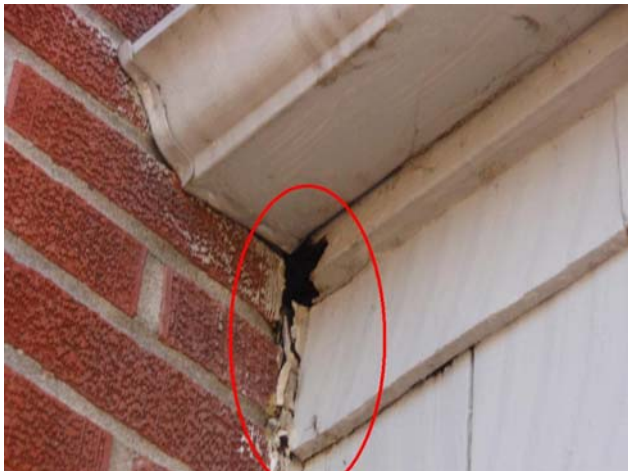
- **Repair:** Localized rot was observed in the eave near the chimney and at chimney south side chimney flashing. Following repair of the damaged areas (which should be combined with exterior painting/maintenance) proper maintenance and control of water from roof or surface runoff can avoid further damage. **Repaired**

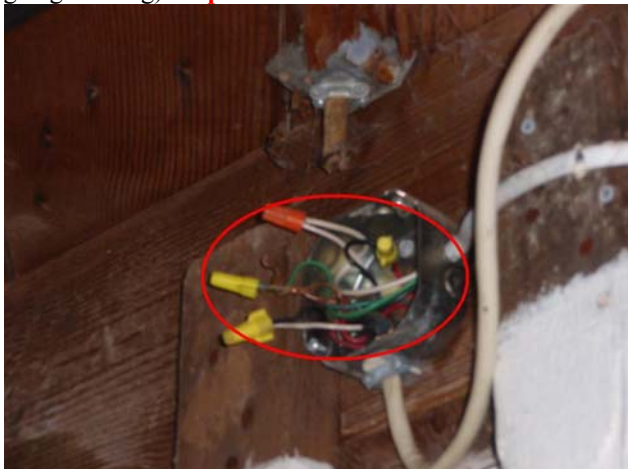
- **Repair:** All junction boxes should be fitted with cover plates, in order to protect the wire connections (example at garage ceiling). **Repaired**

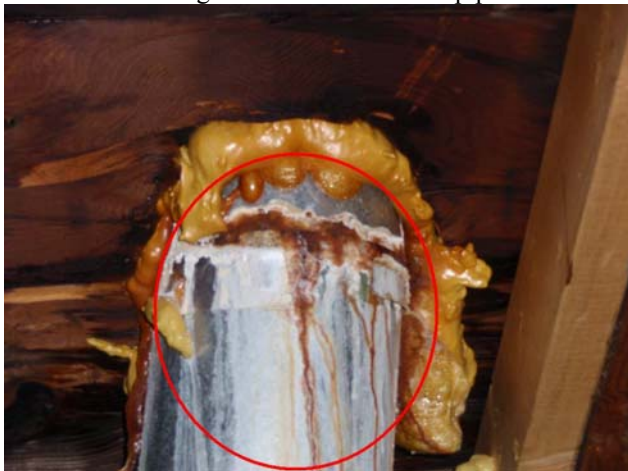
- **Monitor:** Staining noted on furnace vent pipe in attic.
