**Star
Home
Inspection Services**

Home Inspection Report

2926 W 50th Terr Westwood, KS 66205

Report Number: 10062009-2A

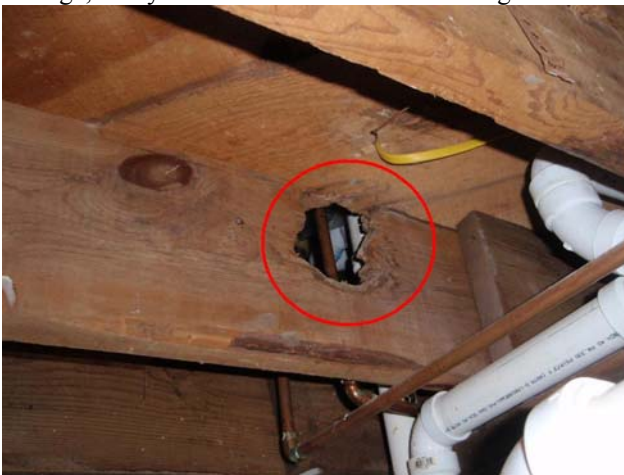
- **Monitor:** Floor joist at the west side of the basement is notched and or cut. This weakens the joist and risks structural damage; if any further movement is or cracking is observed repairs or additional support will be needed.

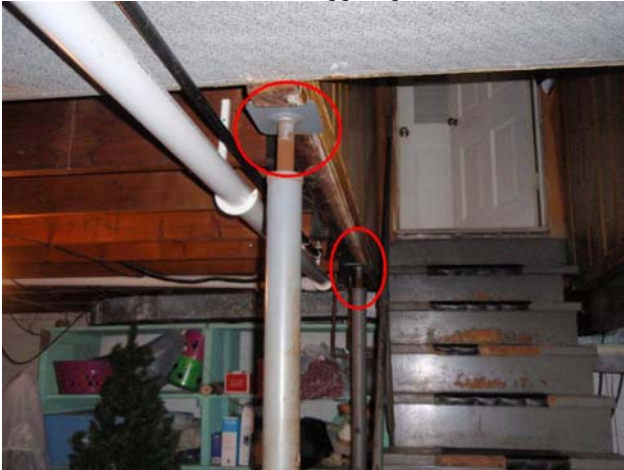
- **Monitor:** Additional metal support posts have been added in the basement near the stairs.

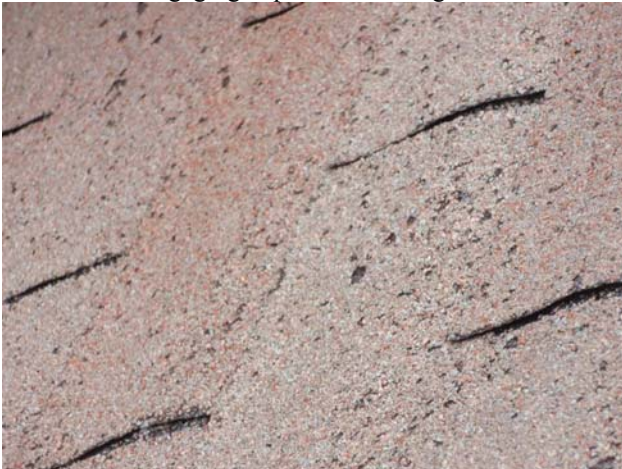
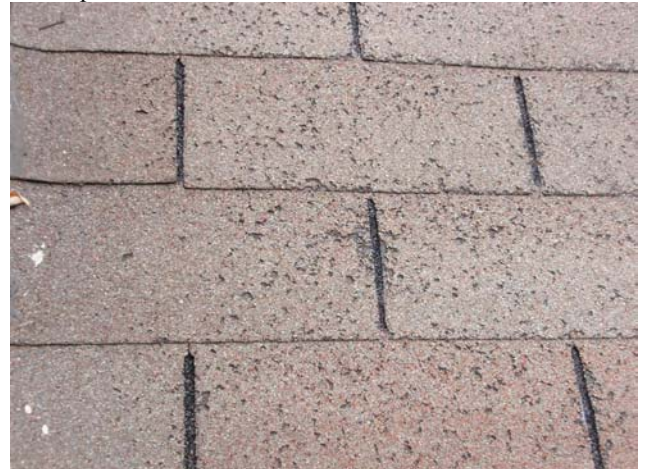
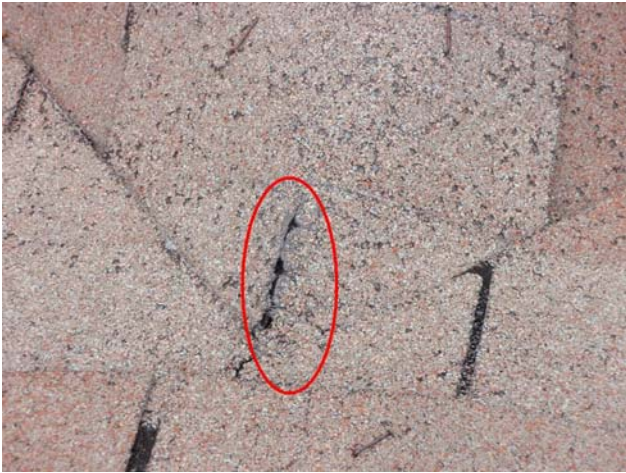
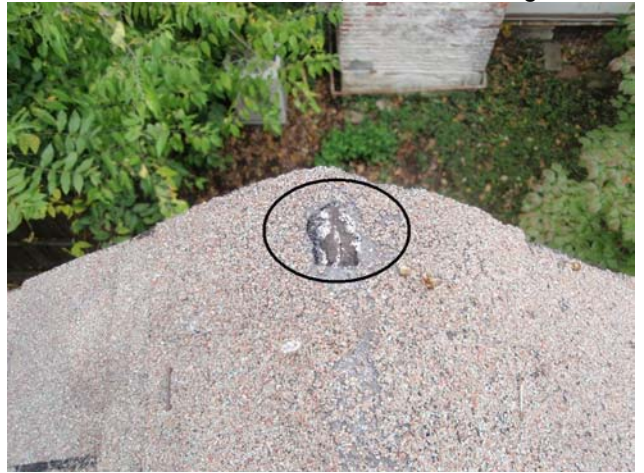
- **Repair:** Missing and/or damaged tabs was observed. Repairs are needed. Split, loose or damaged ridge caps of the roofing require repair.
- **Monitor, Repair:** What appears to be hail damage was observed on the south side of the roof. Hail damage can shorten the life of a roof. This should be investigated further and may eligible for an insurance claim. The roofing is near the end of its life. Watch for leaks and expect to replace the roof soon. Older roofs are, by their nature, a high maintenance roof. Annual inspection and repair should be anticipated. In addition, the older flashings should be monitored. In some cases, a deteriorated flashing can result in expensive repairs, because sections of the roofing have to be removed. As a rule of thumb, replacement of the entire roof covering may be logical if more than ten percent of the roof requires repair. Recommend engaging a qualified roofing contractor for a second opinion.

- It is recommended that the present layers of roofing materials be removed prior to re-roofing. This adds cost of demolition and debris removal to the re-roof cost.

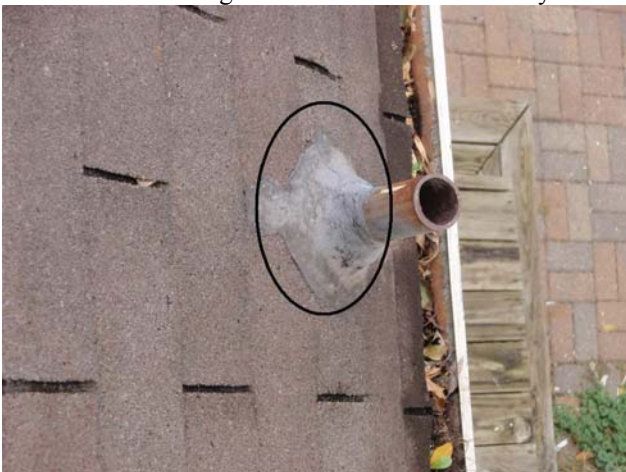
- **Monitor:** The plumbing vent flashing boot(s) have been heavily caulked, leaked in the past and may be vulnerable to leaks. These flashings should be monitored closely.

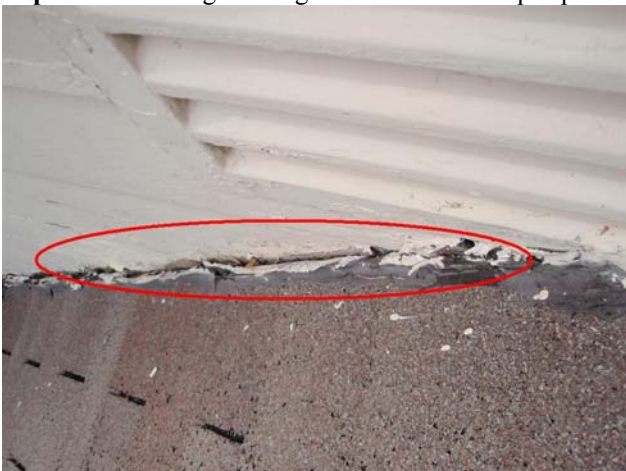
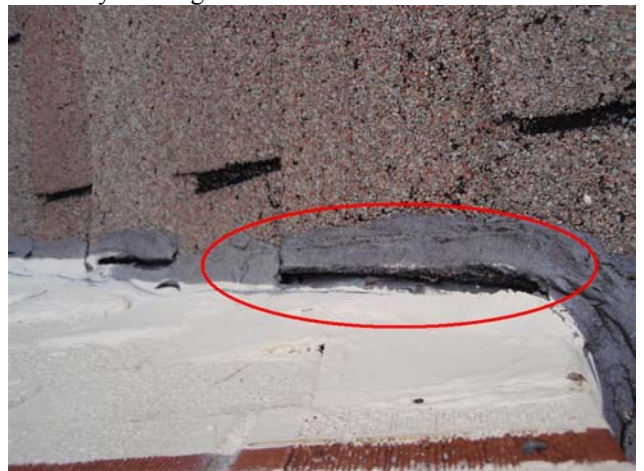
- **Repair:** The siding flashings where the roof steps up and the chimney flashing should be caulked to avoid leaks.

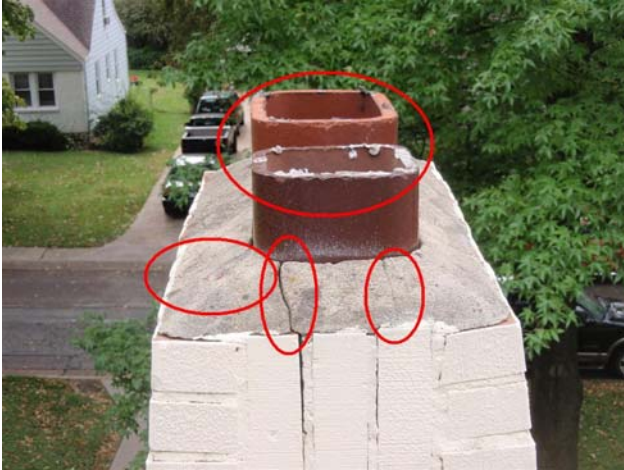
- **Repair:** The cap of the masonry chimney is cracked. These cracks should be sealed or caulked to prevent damage from freezing water.
- **Repair:** A rain cap and vermin screen should be installed on the masonry chimney and the chimney flue should be checked for damage. Damaged flues can be unsafe.

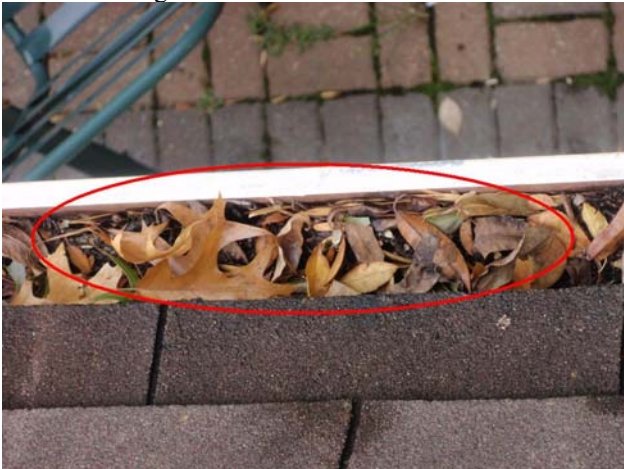
- **Repair:** The gutters require cleaning to avoid spilling roof runoff around the building – a potential source of water entry or water damage.

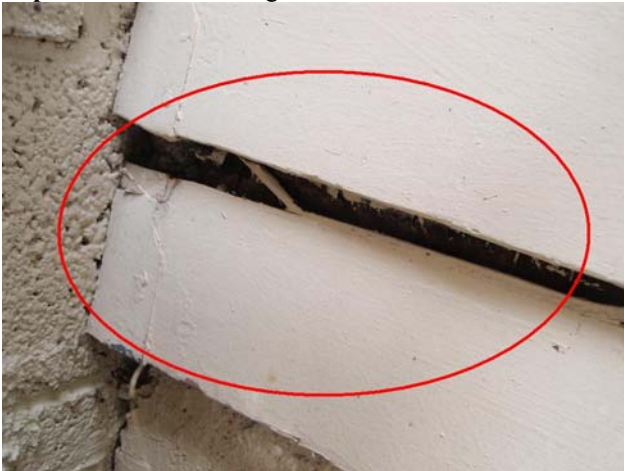
- **Repair:** The exterior siding paint is peeling and/or worn thin in localized areas including the bottom edge of the siding at some areas. These areas should be painted to prevent water damage or rot in the future.
- **Repair:** The loose siding to the left of the overhead door should be re-secured to avoid water and/or wind damage.

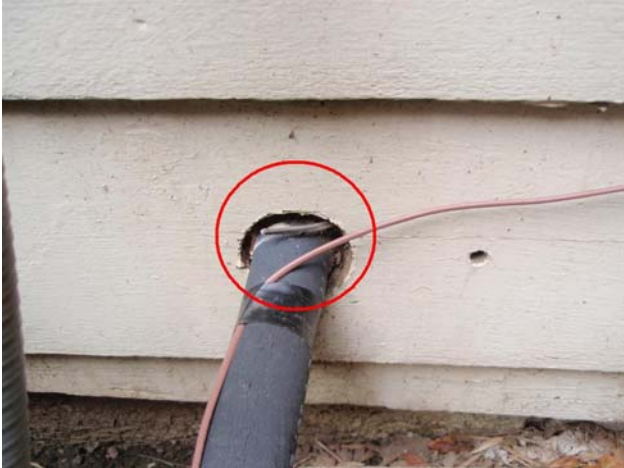
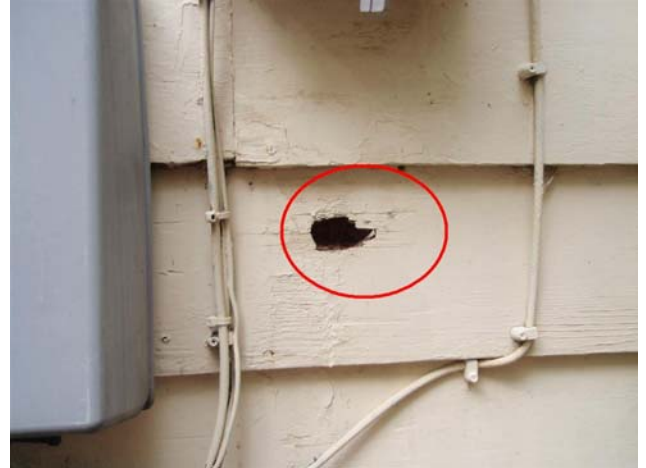
- **Repair:** Any openings in the exterior siding should be sealed. An example is where the air conditioner refrigerant lines enter the house and at east side of house. Caulking is needed.

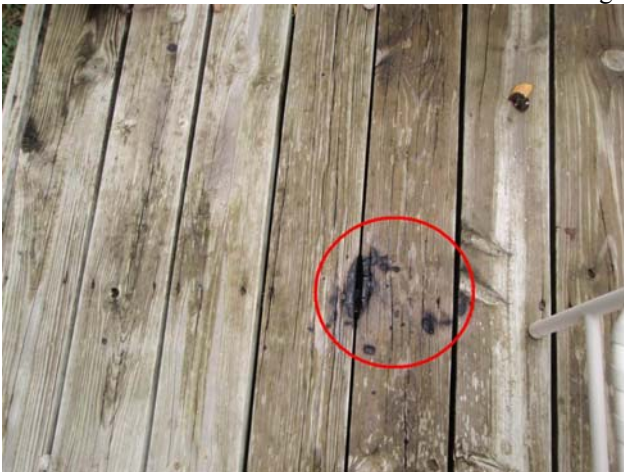
- **Recommend:** The deck should be painted or stained to improve durability.
- **Monitor:** The deck shows evidence of minor fire damage.

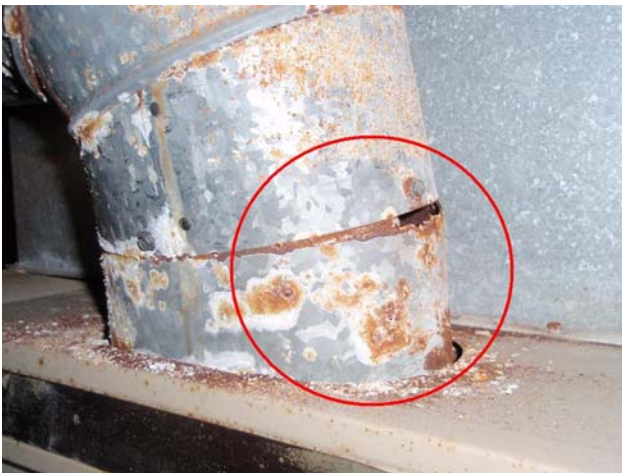
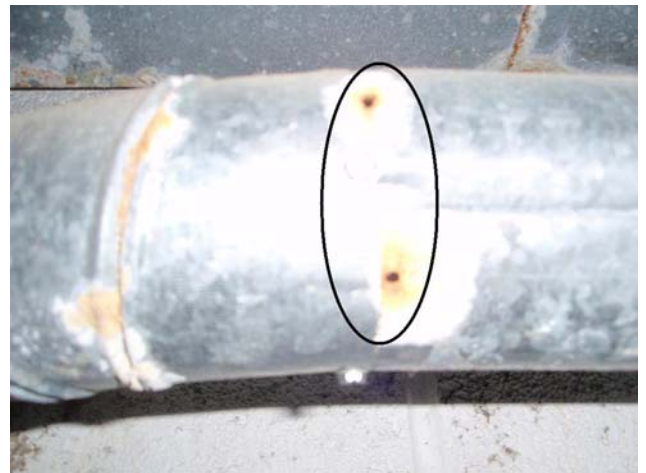
- **Repair, Safety Issue:** *Poor exhaust flue connections for the furnace and water heater should be improved immediately.* Rusted exhaust piping should be replaced. Poor connections risk flue gas and carbon monoxide leakage or other unsafe conditions.

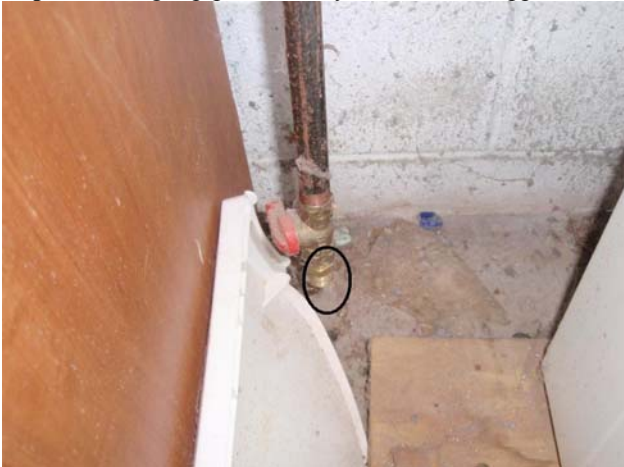
- **Repair:** The gas pipe to the dryer should be capped when not in use.

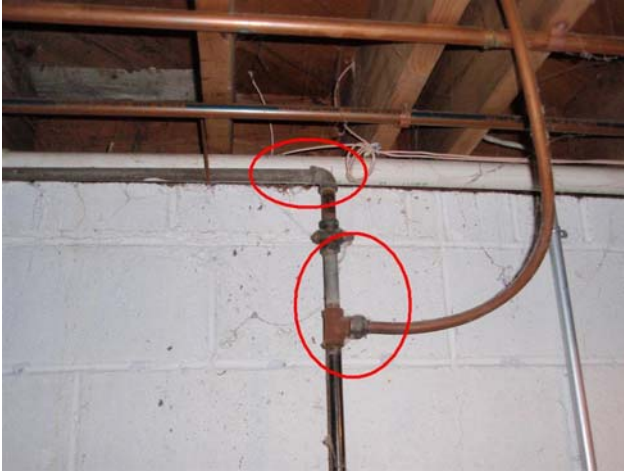
- **Monitor, Repair:** Copper tubing is no longer suitable for gas piping by most gas utility companies. This should be confirmed or verified with the local gas company and if confirmed it's recommended this pipe be replaced with one of suitable material.
- **Monitor, Repair:** Galvanized steel pipe is no longer suitable for gas piping by most gas utility companies. This should be confirmed or verified with the local gas company and if confirmed it's recommended this pipe be replaced with one of suitable material.
