**Star  
Home  
Inspection Services**

*Home Inspection Report*

**3101 NE 67th Terr, Gladstone, MO 64119**

**Inspection Date: 4/10/2009**

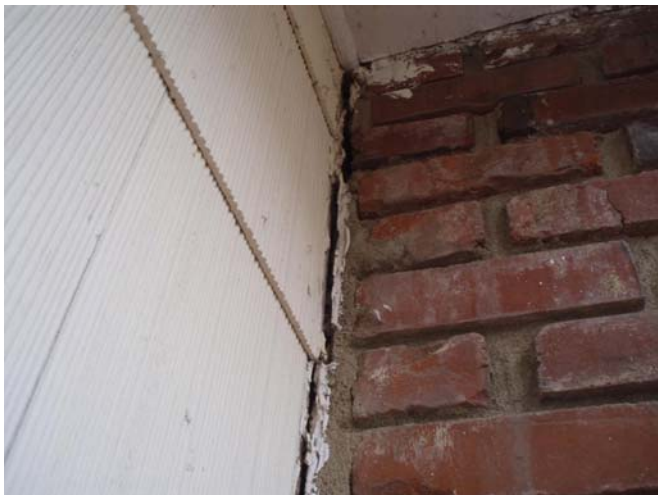
- **Repair/Monitor:** The chimney shows evidence of pulling away from the wall structure of the house proper. Since chimney movement can damage the chimney's interior flue (an unsafe condition) you should have the chimney inspected by a chimney sweep. If chimney relining or chimney foundation repair is needed significant cost could be involved. If the amount of movement is minor, old, not-ongoing, and if the flue is not damaged, only monitoring is required.

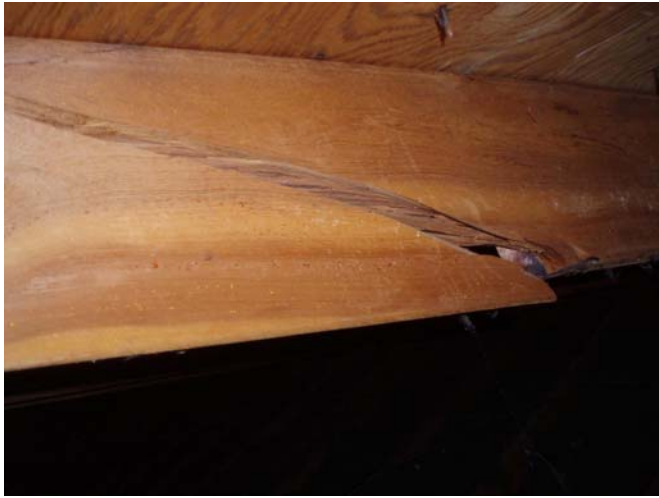
- **Monitor/Repair:** A rafter in the roof structure is cracked. Strengthening the roof structure would resist further movement. This improvement is not priority unless the roof is likely to be subjected to heavy loads such as from snow or additional layers of roofing material whose weight could cause further damage. Additional support can often be added easily.

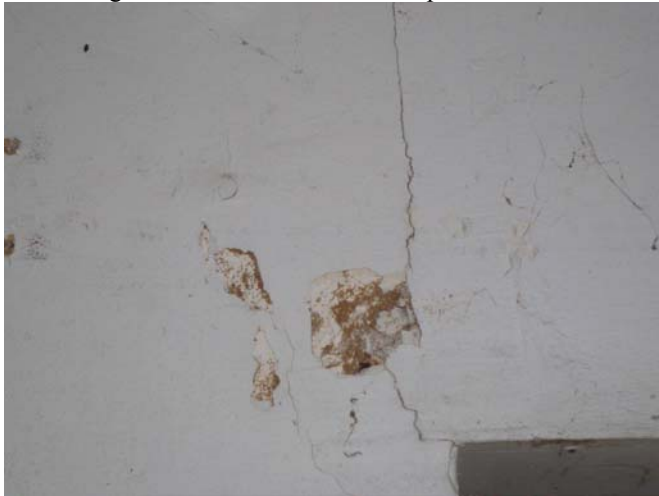
- **Improve:** Evidence of termite activity was observed and there is risk of additional hidden damage. If the property has not already been treated, a licensed pest control specialist should be engaged. Termites can do a substantial amount of damage to the wood structural components of a home. Termites can do a substantial amount of damage to a home.

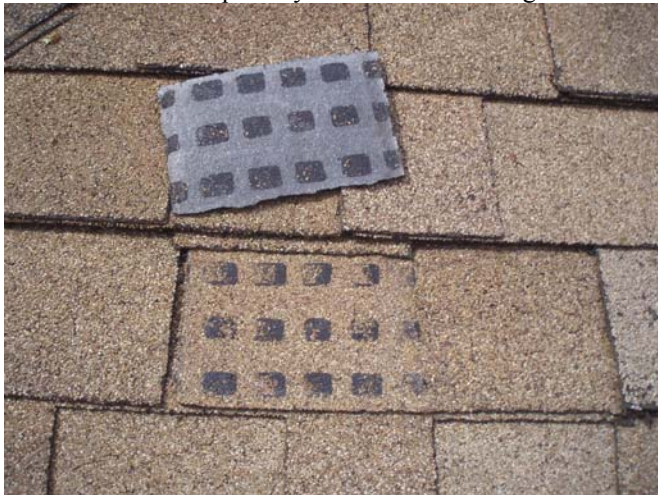
- **Monitor/Repair:** There are missing tabs on shingles. Although repairs are not necessary at this time these areas should be monitored especially after instances of high wind.

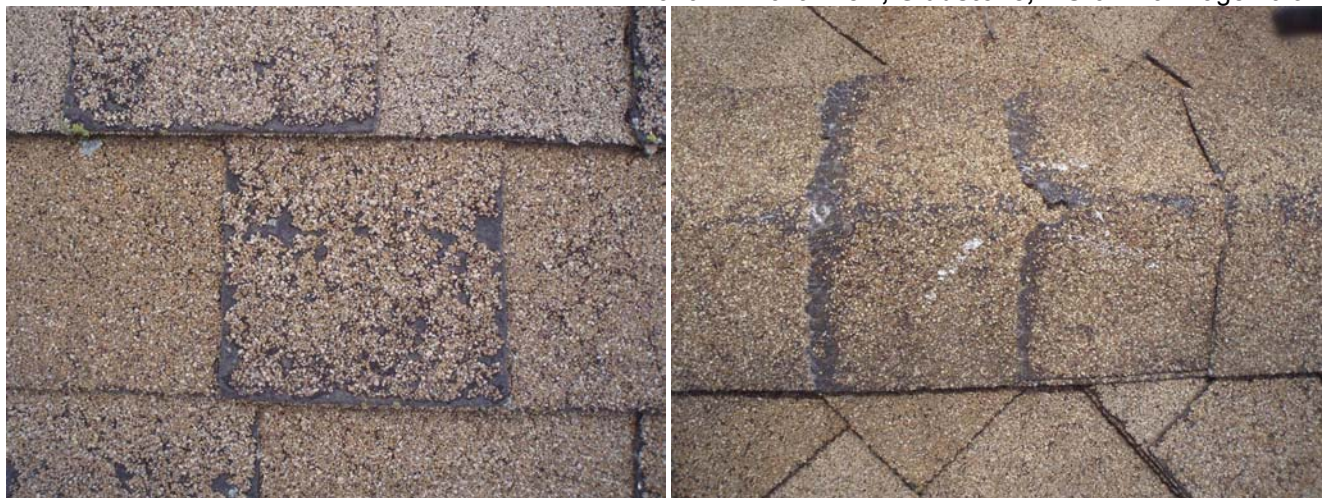
- **Monitor:** Older roofs are, by their nature, a high maintenance roof. Annual inspection and repair should be anticipated. In addition, the older flashings should be monitored. In some cases, a deteriorated flashing can result in expensive repairs, because sections of the roofing have to be removed. As a rule of thumb, replacement of the entire roof covering may be logical if more than ten percent of the roof requires repair.

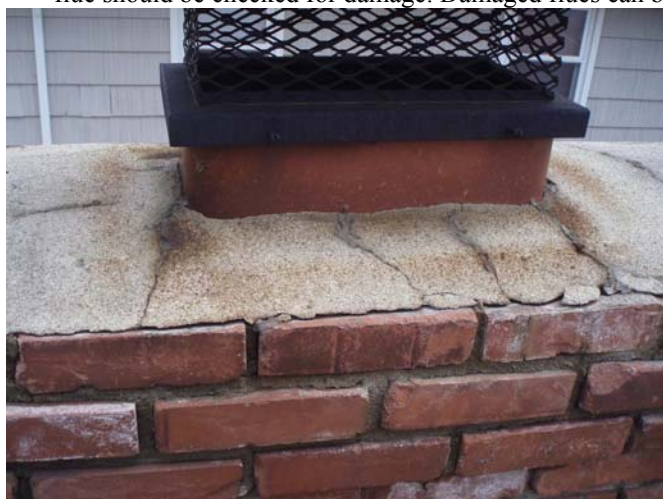
- **Repair:** The cap (crown) of the masonry chimney should be replaced as it is deteriorated and loose, and the chimney flue should be checked for damage. Damaged flues can be unsafe.

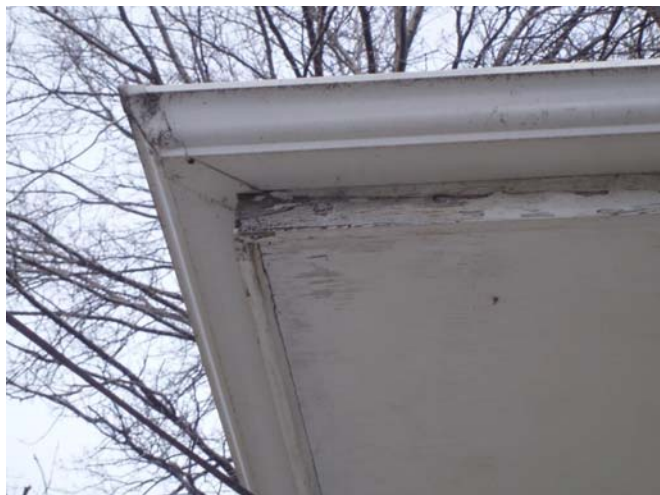
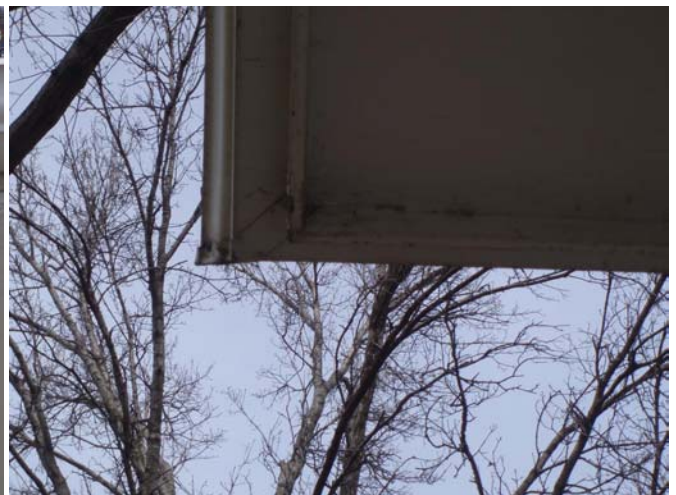
- **Monitor:** Localized rot was observed in the fascia (the wooden board to which the gutter is typically fastened). Improvement is not necessary at present, although this condition should be repaired when exterior painting or maintenance are planned.

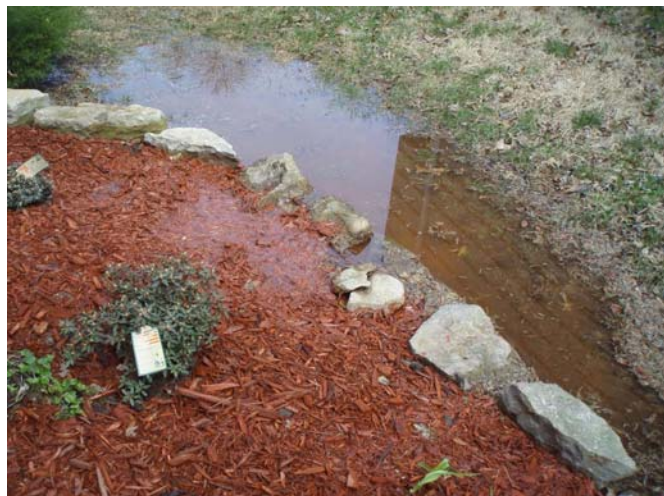
- **Recommend:** The grading should be improved to promote the flow of storm water away from the house. Additionally, modifications to the drainage between this house and the one up the hill to the east are recommended. This can often be accomplished by the addition of top soil. The ground should slope away from the house at a rate of one inch per foot for at least the first ten feet. At least eight (8) inches of clearance should be maintained between soil level and the bottom of exterior wall siding.

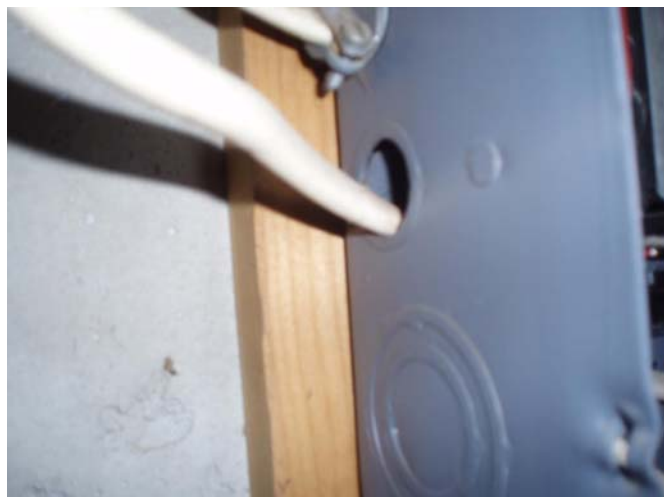
- **Repair:** Any openings in the main panel should be covered.
- **Repair:** Cable clamps (sometimes referred to as bushings or grommets) are required where wiring passes into the main distribution panel. Cable clamps serve to protect the wiring from the metal edges of the panel openings.

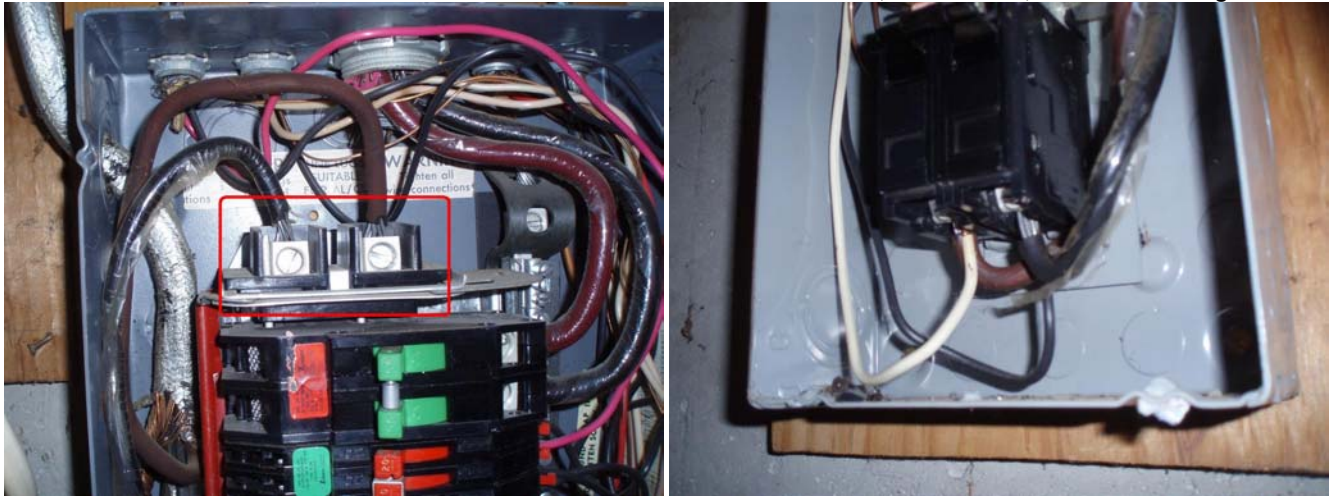
- **Repair:** The feed wire leading to the auxiliary panel should be protected by fuses or breakers in the main panel.
- **Repair:** Circuits within the auxiliary panel that are doubled up (referred to as "double taps") should be separated. Each circuit should be served by a separate fuse or breaker.

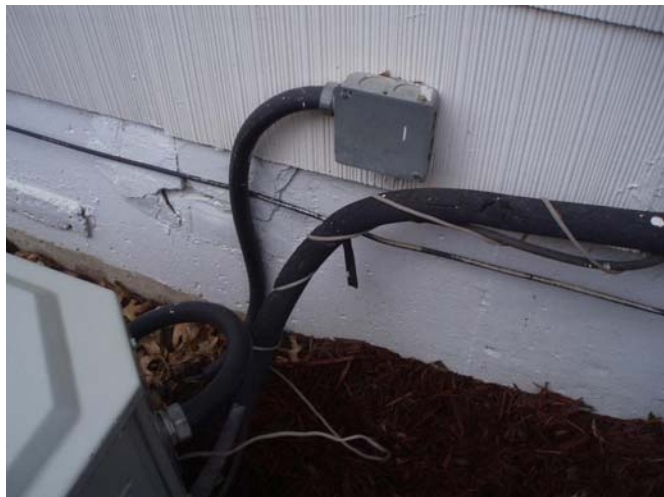
- **Repair:** The air conditioning system needs an external power cut-off switch.
- **Improve:** The outdoor unit of the air conditioning system requires cleaning.

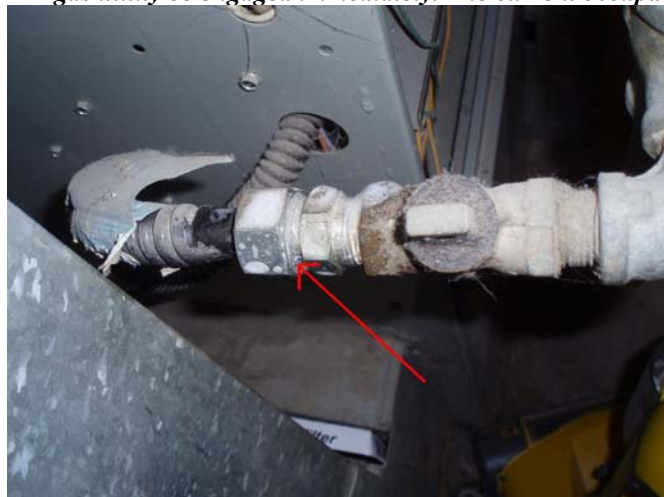
- **Repair, Safety Issue:** *A gas leak was detected in the supply to the furnace using a TIFF 8800 multi gas detector and soapy water (see photo). This is a serious safety concern. It is recommended that a plumber, HVAC Technician, or the gas utility be engaged immediately. The current occupants of the home should be notified.*

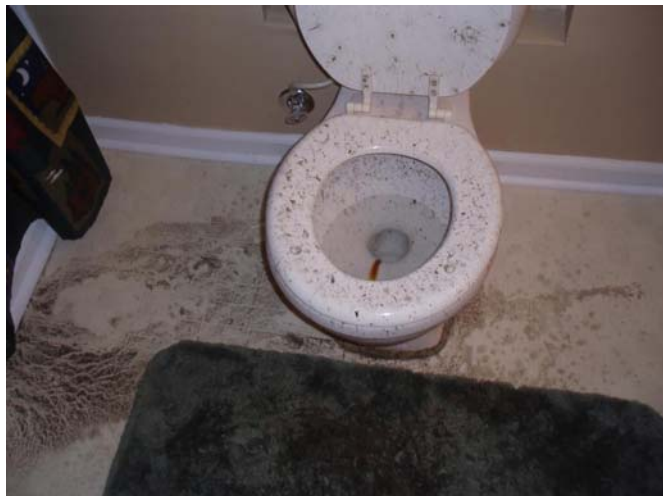
- **Repair:** The trap is leaking under the basement bathroom sink.
- **Monitor:** For the most part, the waste piping is older. It may be prone to unexpected problems. Improvement is recommended on an as needed basis.
- **Monitor:** Signs were evident that the basement toilet backed up from storm water. This area should be monitored. If odor persists, a plumber should be engaged.
