# Star Home Inspection Services

## *Home Inspection Report*

**3104 Creekwood Dr, Lawrence, KS 66049**

**Inspection Date: 3/16/2009**

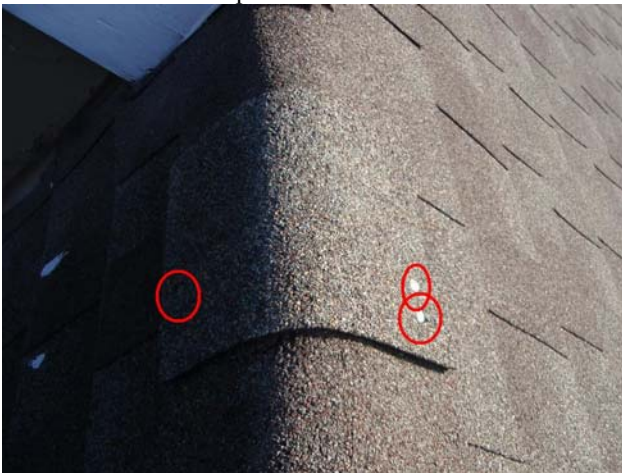
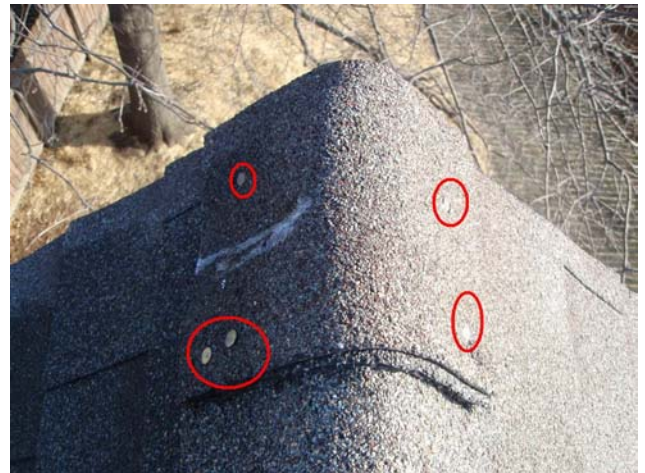
- **Repair:** Exposed nail heads were observed in the roofing shingles and/or ridge caps. All exposed nail heads should be caulked to reduce the potential of leaks.

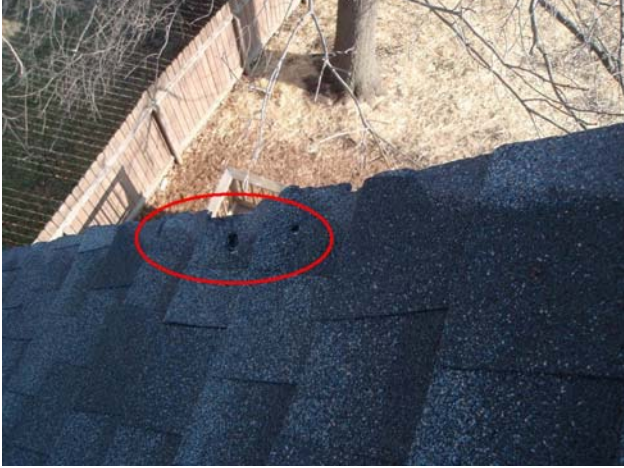
- **Repair:** Minor repairs to the roofing are needed. Damaged or missing roofing material should be repaired (example at small area of two shingles just below northwest ridge cap). All roof penetrations should be examined and sealed as necessary.

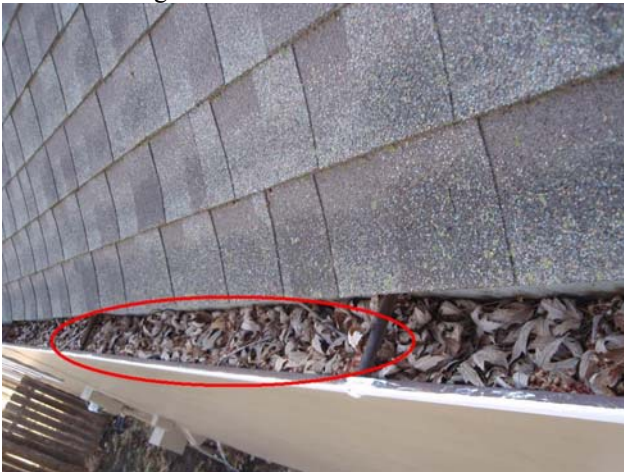
- **Repair:** The gutters require cleaning to avoid spilling roof runoff around the building – a potential source of water entry or water damage.

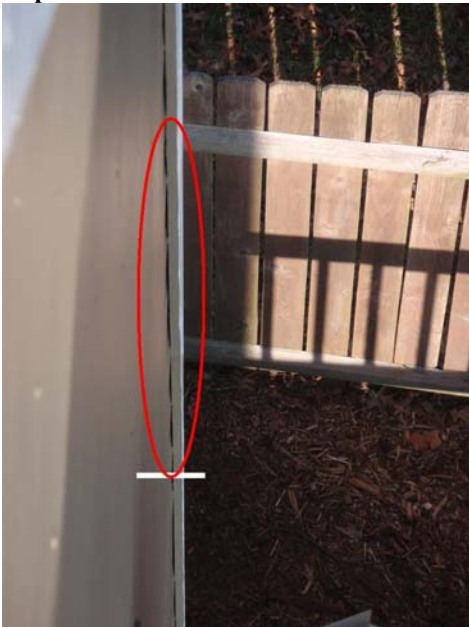
- **Improve:** The northwest corner trim should be caulked to prevent water entry.

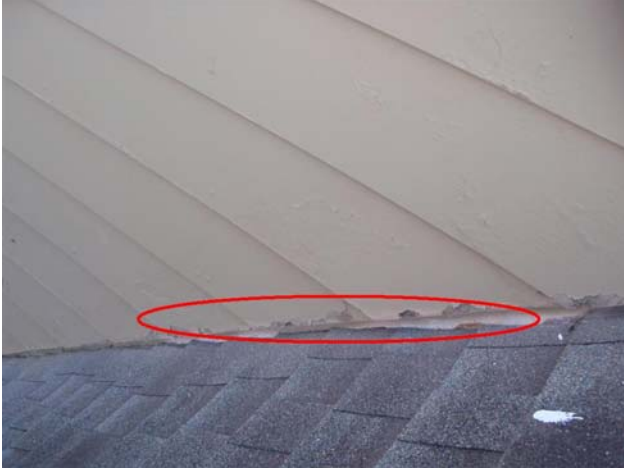
- **Monitor, Repair:** Localized rot was observed in the soffit (example below the back upstairs north windows). Improvement is not necessary at present, although this condition should be repaired when exterior painting or maintenance are planned.
- **Monitor, Repair:** Localized paint peeling at siding at roof step up near southwest end of house.

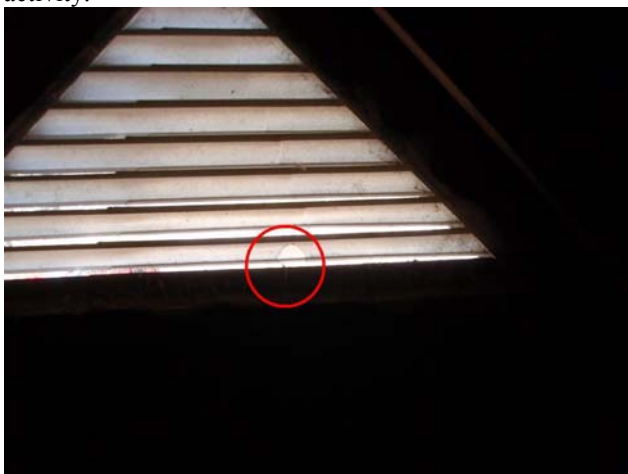
- **Repair:** The south gable vent screen appears to be damaged. It should be repaired or replaced to prevent vermin activity.
