# Star Home Inspection Services

## *Home Inspection Report*

**3417 Baltimore Ave, Kansas City, MO 64111**

**Inspection Date: 1/2/2009**

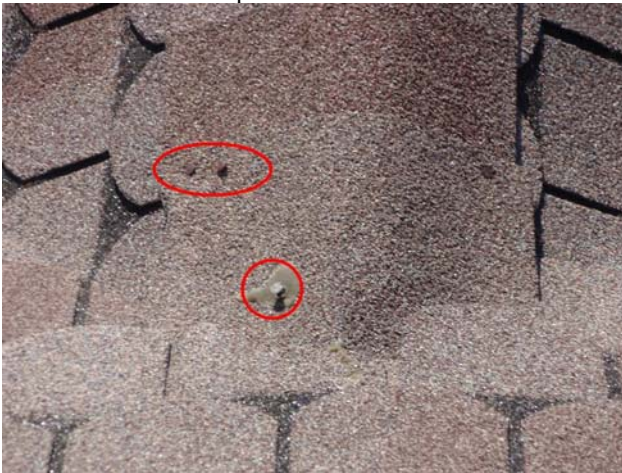
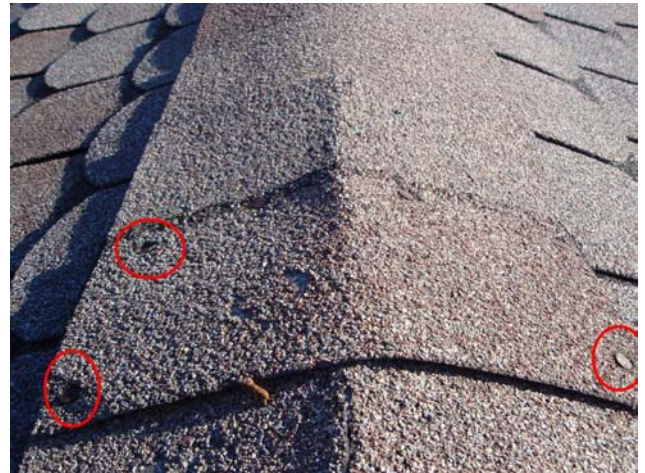
#### Sloped Roofing

- **Repair:** Exposed nail heads were observed in the roofing shingles and/or ridge caps. All exposed nail heads should be caulked to reduce the potential of leaks.

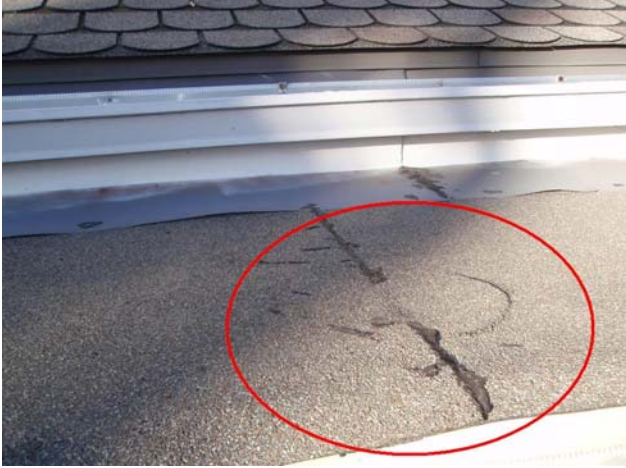
### Flat Roofing

- **Note:** Rolled roofing (over laundry room) is prone to leaking and requires close monitoring and higher than normal maintenance.

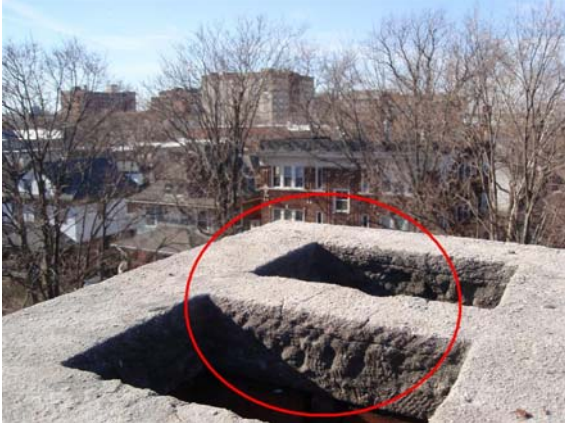
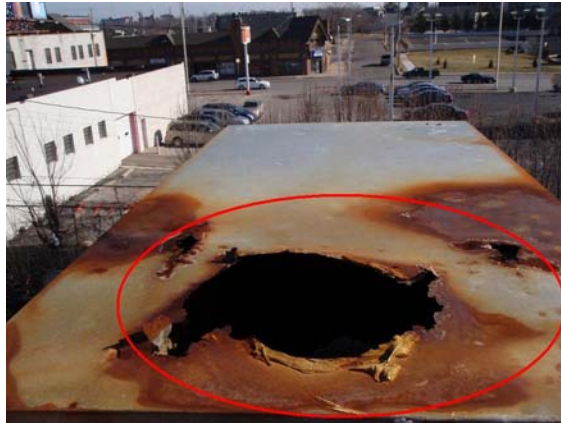
### Chimneys

- **Repair:** A rain cap and vermin screen should be installed on the masonry chimney and the chimney flue should be checked for damage. Damaged flues can be unsafe.
- **Repair:** The metal chimney cap is rusting. It should be painted with an appropriate paint, and covered with a chimney rain cap. Repairs to the rusted areas should be made or the metal cap replaced. **Repaired/Replaced**

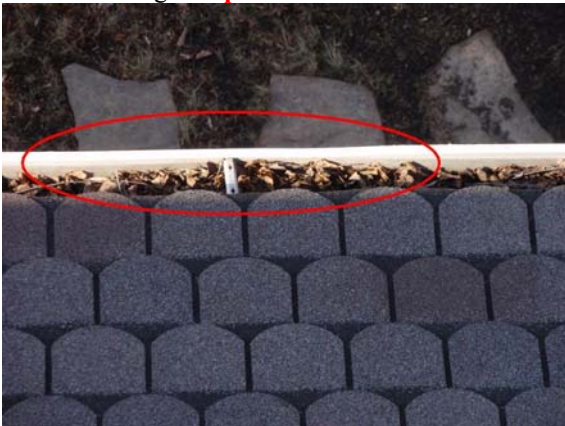
### Gutters & Downspouts

- **Repair:** The gutters require cleaning to avoid spilling roof runoff around the building – a potential source of water entry or water damage. **Repaired**

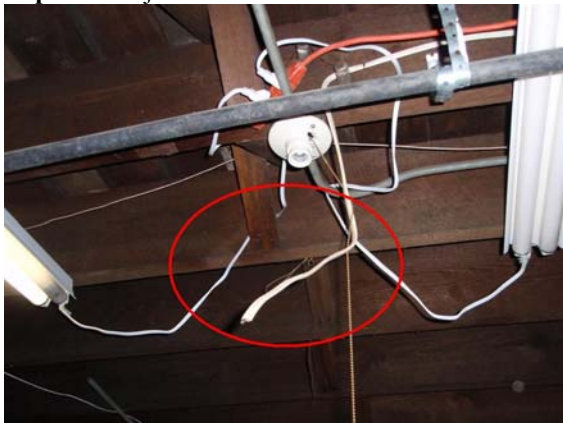
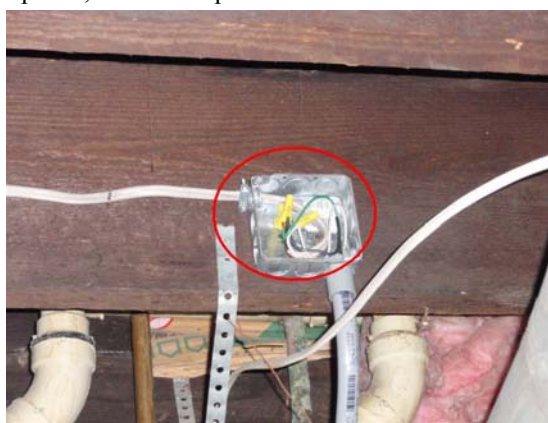
#### Distribution Wiring

- **Repair:** Loose wiring should be secured (example at basement ceiling northwest corner). **Repaired**
- **Repair:** All junction boxes should be fitted with cover plates, in order to protect the wire connections. **Repaired**
