**Star
Home
Inspection Services**

Home Inspection Report

3601 Matney Ave, Kansas City, KS 66106

Inspection Date: 3/24/2009

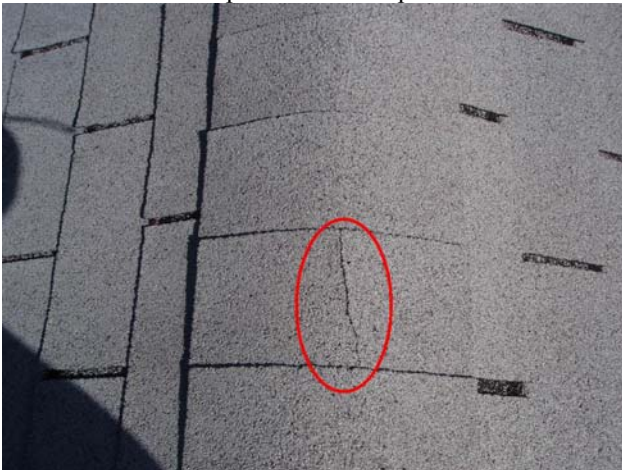
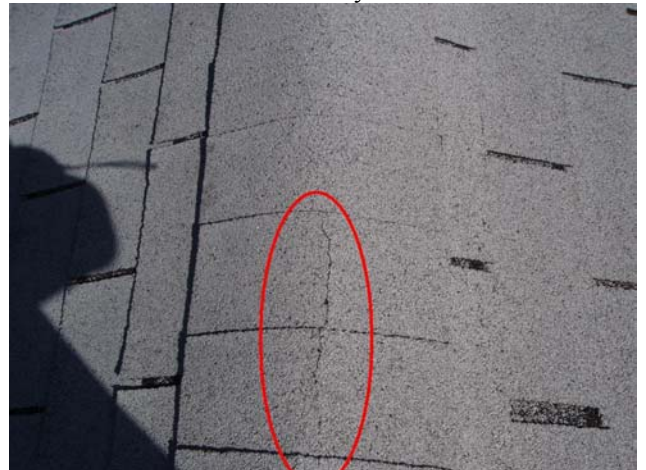
Sloped Roofing

- **Repair:** Minor repairs to the house roofing are needed at a few cracked ridge caps. Damaged or missing roofing material should be repaired. All roof penetrations should be examined and sealed as necessary.

- **Monitor, Repair:** The detached garage roofing is near the end of its life. Expect to replace the roof soon. Possible hail damage observed.

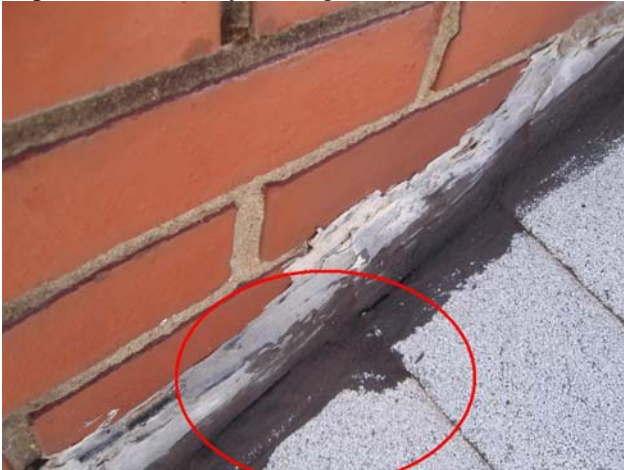
Flashings

- **Repair:** The chimney flashing should be caulked to avoid leaks.

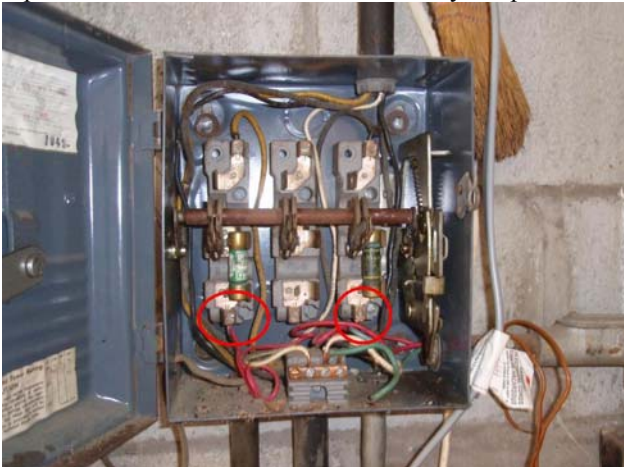
Auxiliary Panel(s)

- **Repair:** Circuits within the auxiliary panel in the garage that are doubled up (referred to as "double taps") should be separated. Each circuit should be served by a separate fuse or breaker.

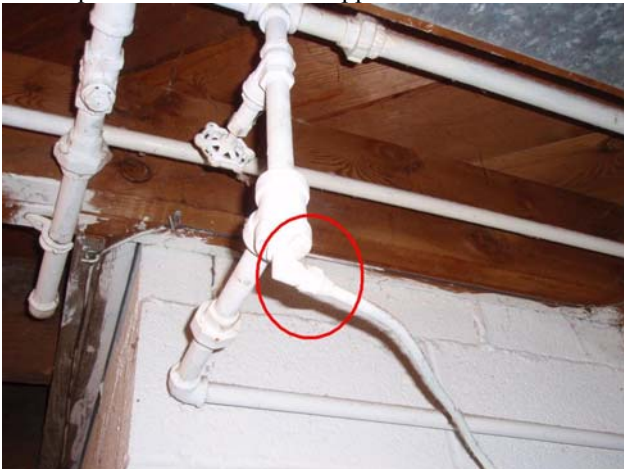
Gas Piping

- **Repair:** Copper tubing is no longer suitable for gas piping. It's recommended this unused piping in the basement near the fireplace be removed and capped off.
