Star Home Inspection Services

Home Inspection Report

3726 Madison Ave Kansas City, MO 64111

Inspection Date: 09/17/2010

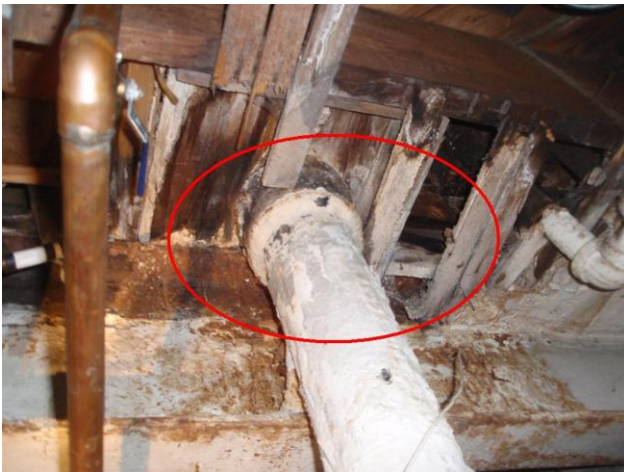
- **Monitor:** Minor unevenness was observed in the floor structure. This condition is common. It may be the result of the materials, framing design, installation methods and aging of the building. There was not evidence of need for immediate, costly repair.
- **Monitor:** Water stained subflooring (supporting layer of flooring atop floor joists and below finish flooring or carpeting) was found at the south and middle west area of the basement. This condition suggest previous leakage has occurred in these areas.

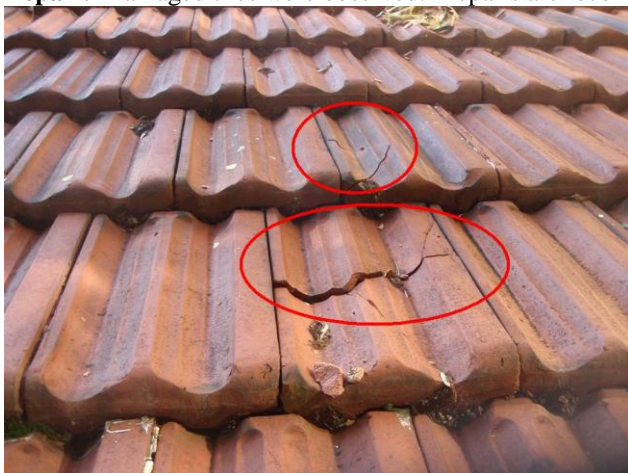
- **Repair:** Damaged tiles were observed. Repairs are recommended.

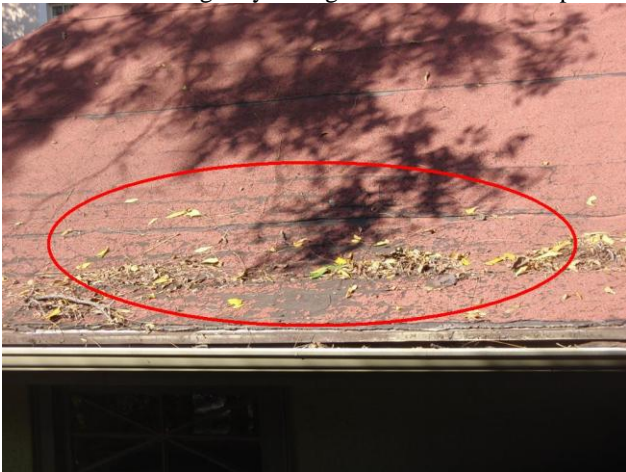
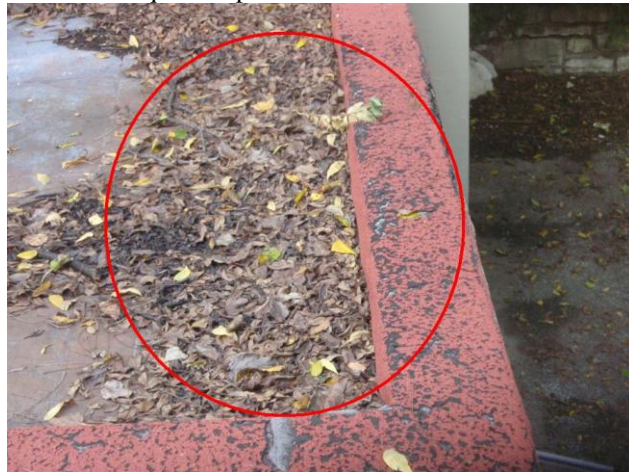
- **Repair:** The garage roofing is near the end of its life. Exposed sheathing is visible where the roofing is damaged. Damaged or missing roofing material should be repaired. Watch for leaks and expect to replace the roof soon. The flat roofing is in fair condition. Older roofs are, by their nature, a high maintenance roof. Annual inspection and repair should be anticipated. In addition, the older flashings should be monitored. In some cases, a deteriorated flashing can result in expensive repairs, because sections of the roofing have to be removed. As a rule of thumb, replacement of the entire roof covering may be logical if more than ten percent of the roof requires repair.

- It is recommended that the present layers of garage roofing materials be removed prior to re-roofing. This adds cost of demolition and debris removal to the re-roof cost.

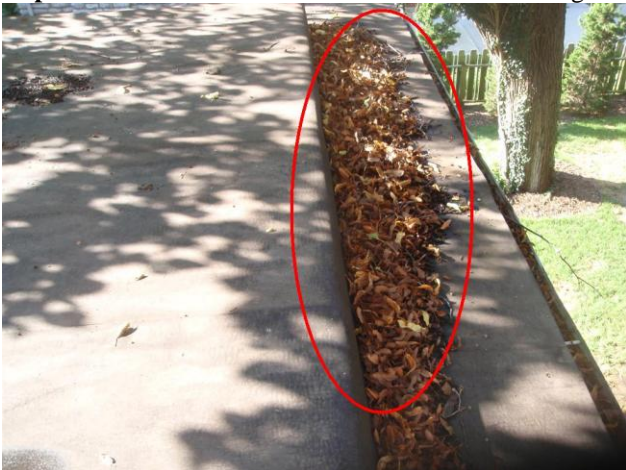
- **Improve:** Debris should be removed from the roofing to reduce risk of leaks and early roof wear.

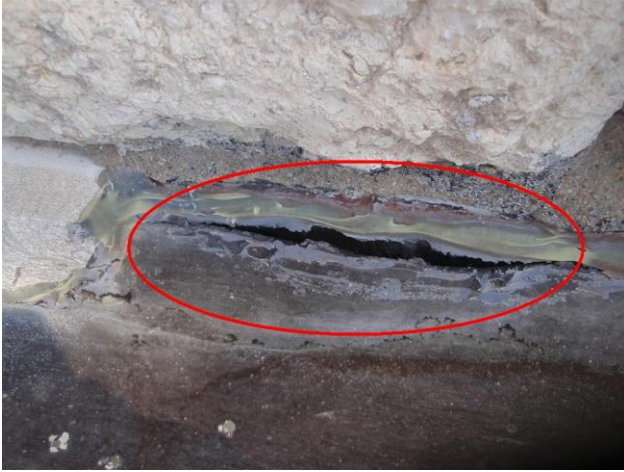
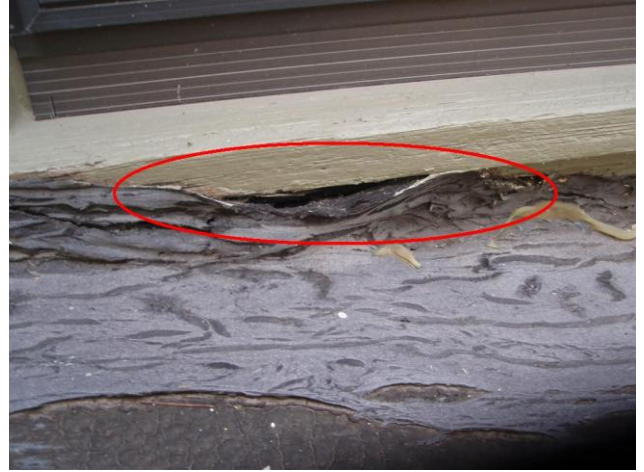
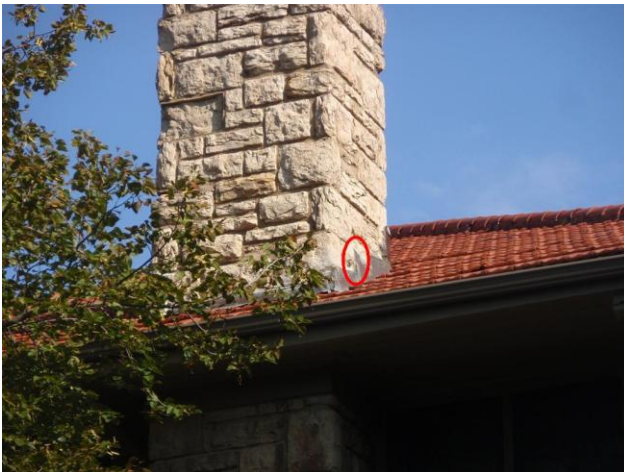
- **Repair:** The flashing should be caulked to avoid leaks (i.e. chimney flashing, south side flat roof and back flat roof where air conditioners are located.)

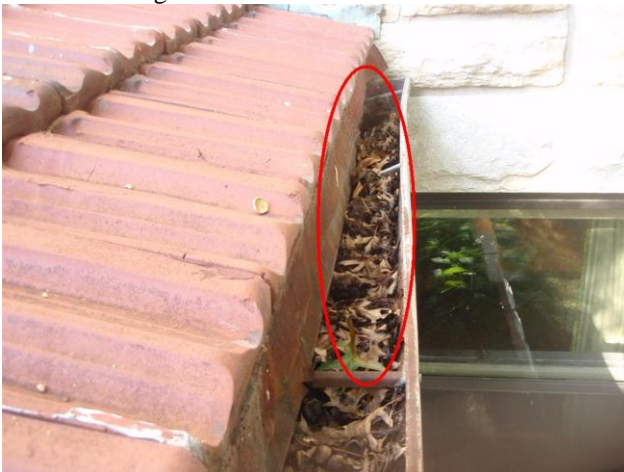
- **Repair:** The gutters require cleaning to avoid spilling roof runoff around the building – a potential source of water entry or water damage.

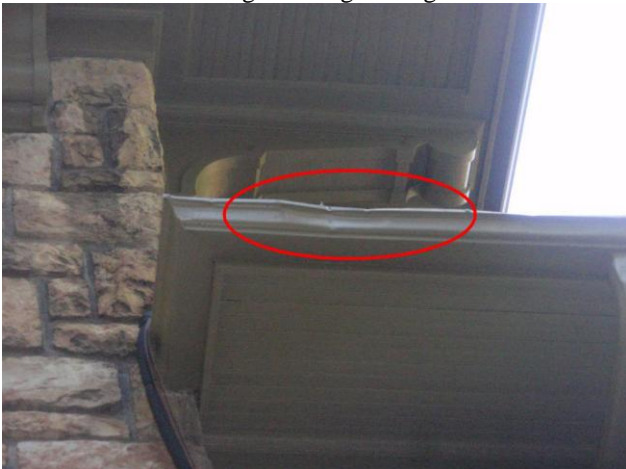
- **Note:** Cosmetic damage to the guttering was observed.

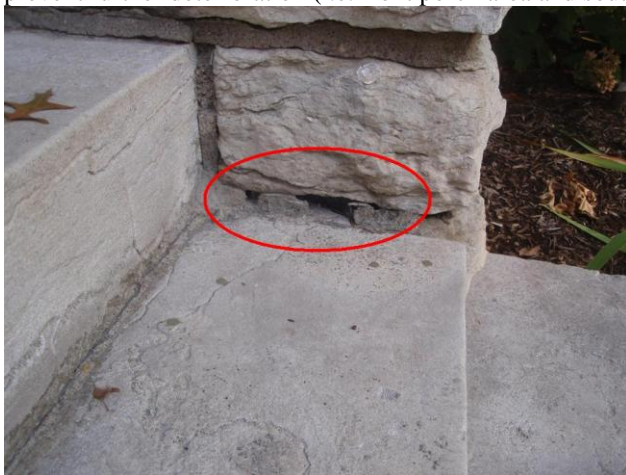
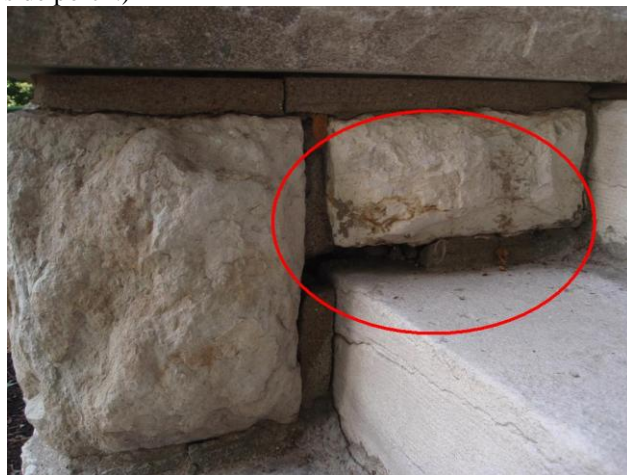
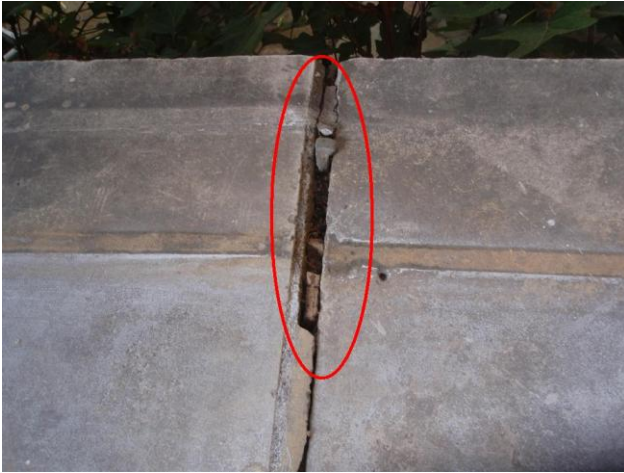
- **Repair:** The exterior stones should be re-pointed in localized areas (replacement of the mortar between the stones) to prevent further deterioration (i.e. front porch area and south side porch.)

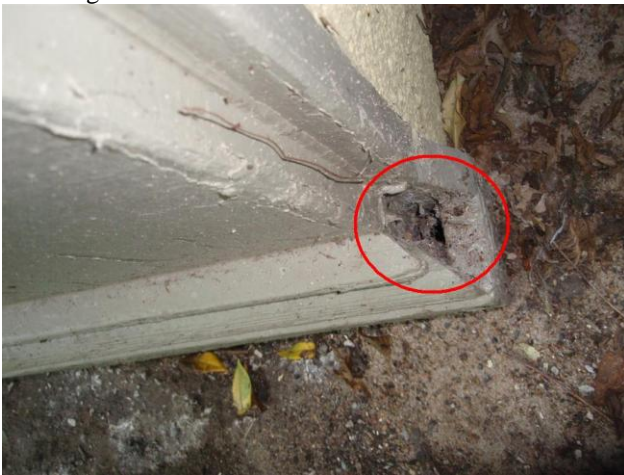
- **Repair:** Any openings in the exterior siding trim should be sealed. An example is at the northwest corner of the garage. Caulking is needed.

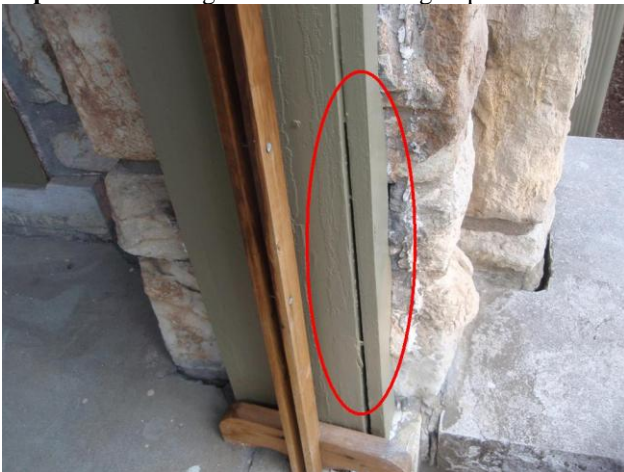
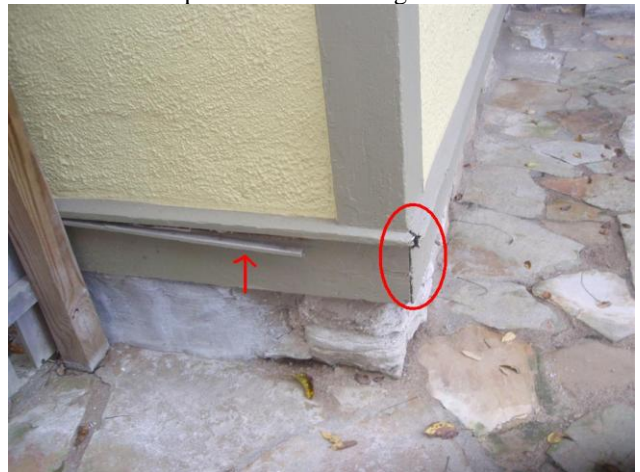
- **Repair, Safety Issue:** The birds nest should be removed from the north side light fixture to prevent insect infestation.
- **Repair:** The loose/damaged siding trim at the back of the home needs repair.
- **Repair:** The siding trim needs caulking improvements in localized areas to prevent water damage and rot.

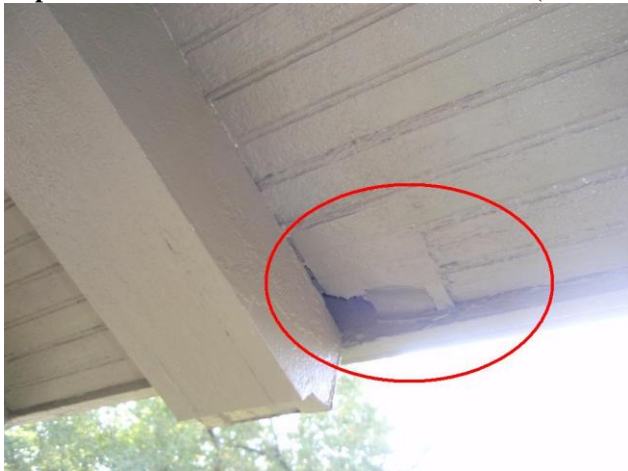
- **Repair:** Localized rot was observed in the soffit (i.e. soffit at front porch.) Repairs and painting is needed.

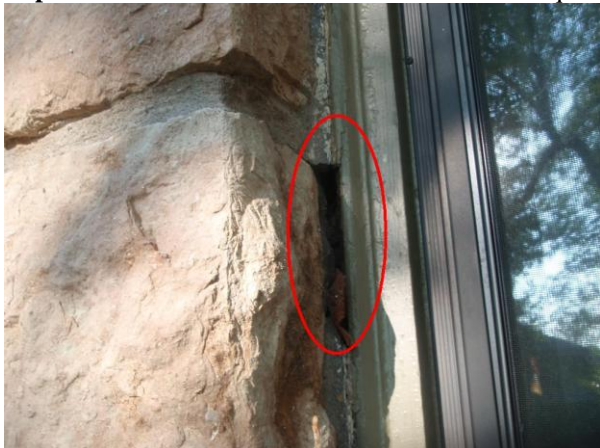
- **Repair:** The front northeast window frame/trim requires mortar and/or caulking.

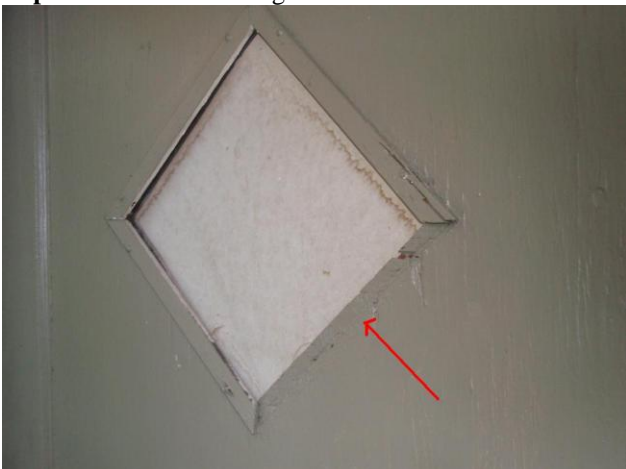
- **Repair:** Localized damage of the back door window trim/frame was observed.

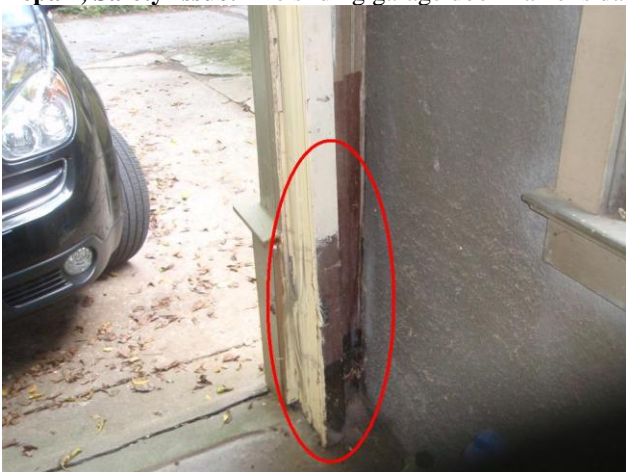
- **Repair:** The back door frame/ trim requires caulking.
- **Repair, Safety Issue:** The sliding garage door frame is damaged/loose and needs repair.

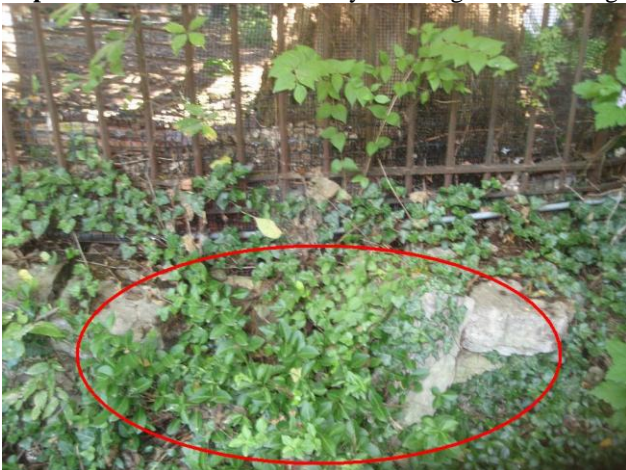
- **Monitor:** The driveway retaining wall shows evidence of movement. This condition should be monitored. It is impossible to determine the rate of movement during a one time visit to the house.
- **Repair:** The back west driveway retaining wall is damaged and needs repair.

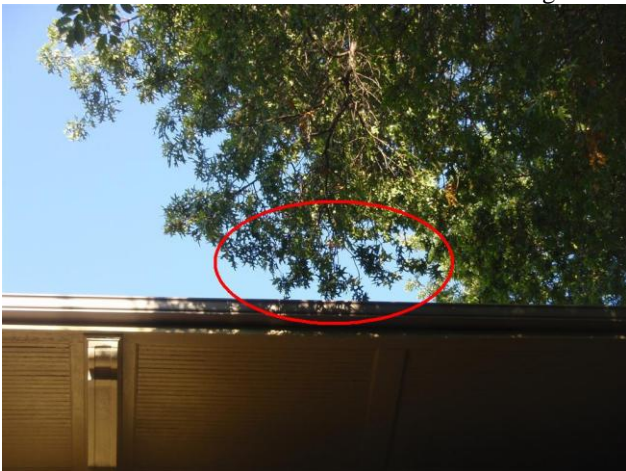
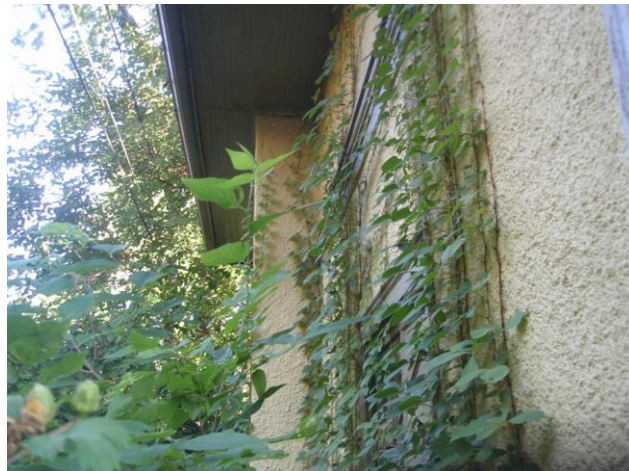
- **Repair:** Tree branches should be trimmed away from the house to avoid damage to the building.
- **Repair:** Shrubs, bushes and/or vines growing on exterior walls of the house and/or garage need to be trimmed away from the structure to reduce the risk of water damage and insect infestation.

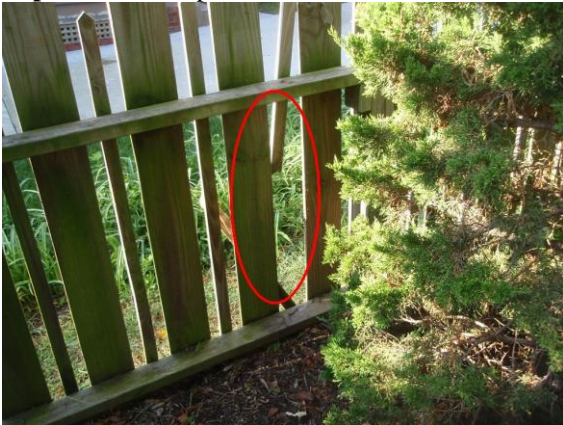
- **Repair:** Minor repairs are needed.
