Star Home Inspection Services

Home Inspection Report

3902 NE 51st Terr, Kansas City, MO 64119

Inspection Date: 4/3/2008

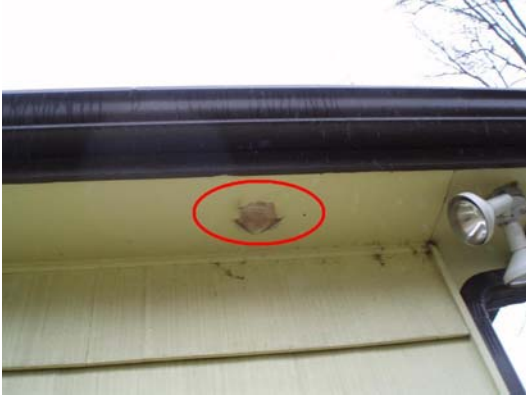
Exterior Eaves

- **Repair:** The soffit and fascia need paint in minor localized areas.

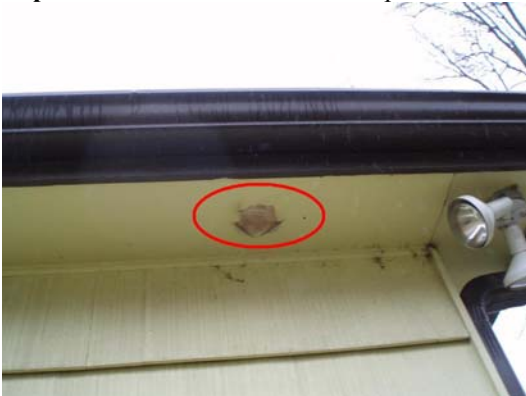
Exterior Eaves

- **Repair:** The soffit and fascia need paint in minor localized areas.

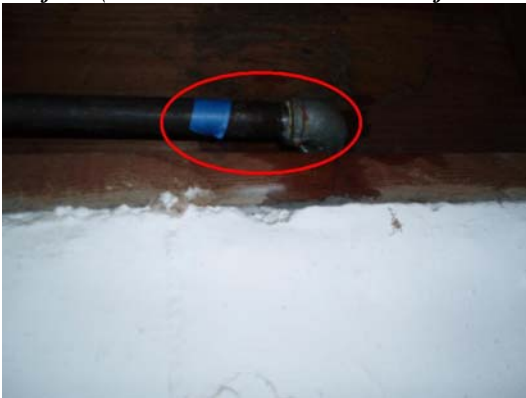
Gas Piping

- **Repair, Safety Issue:** *A gas leak was detected with a TIF 8800 gas/carbon monoxide detector and confirmed with soapy water. This is a serious safety concern. It is recommended that the gas utility, HVAC company or plumber be engaged as soon as possible to make the necessary repairs. The current occupants of the home should also be notified. (Located at northwest corner of basement ceiling marked with blue tape at elbow)*
