**Star
Home
Inspection Services**

Home Inspection Report

3910 Wyoming St Kansas City, MO 64111

Inspection Date: 01/05/2011

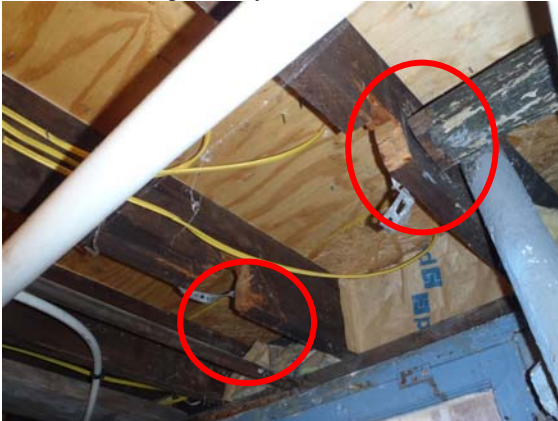
- **Monitor:** Minor unevenness was observed in the floor structure. This condition is common. It may be the result of the materials, framing design, installation methods and aging of the building. There was not evidence of need for immediate, costly repair.
- **Monitor:** Floor joists are notched and or cut (i.e. northwest corner of basement.) This weakens the joist and risks structural damage; if any further movement or cracking is observed repairs or additional support will be needed.

- **Monitor:** Repaired floor joists and subflooring (supporting layer of flooring atop floor joists and below finish flooring or carpeting) was found.
- **Monitor:** Additional metal support posts were observed in the basement.

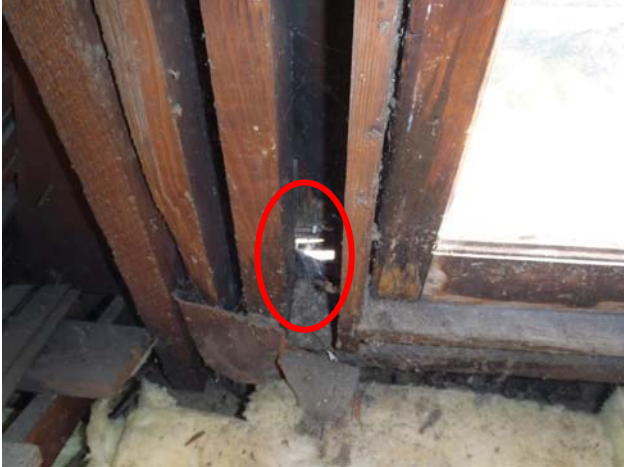
- **Repair:** While investigating the roof structure, outside light was visible near the framing around the attic windows. Any openings in the roof should be repaired to avoid leaks.

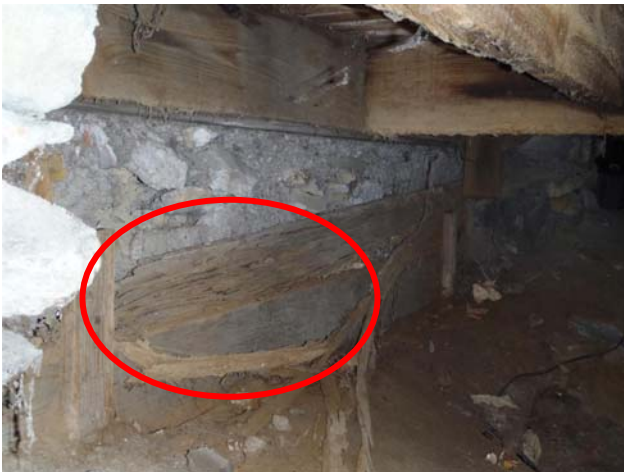
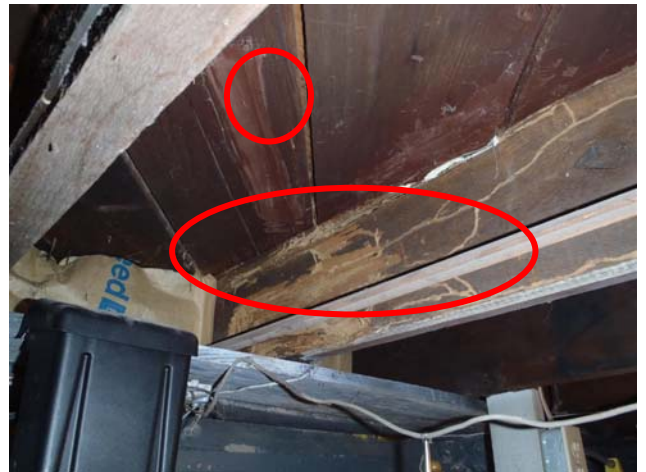
- **Repair:** Evidence of termite damage was observed at the wood retaining wall under the east side of the front porch, at the floor joists and subflooring at the northeast corner of the basement and there is risk of additional hidden damage since termites can do a substantial amount of damage. Evidence of previous termite treatment (drill marks) was observed at the north side of the home. Damaged wood should be repaired or replaced. Any wood soil contact should be eliminated.

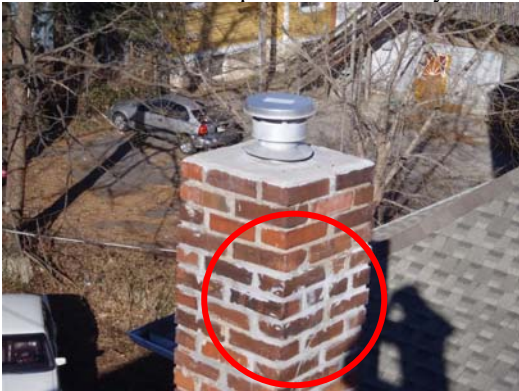
- **Monitor:** Previous repair to the masonry chimney was observed.

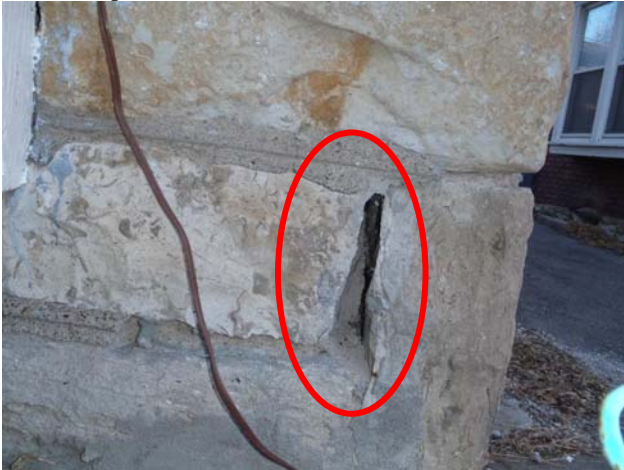
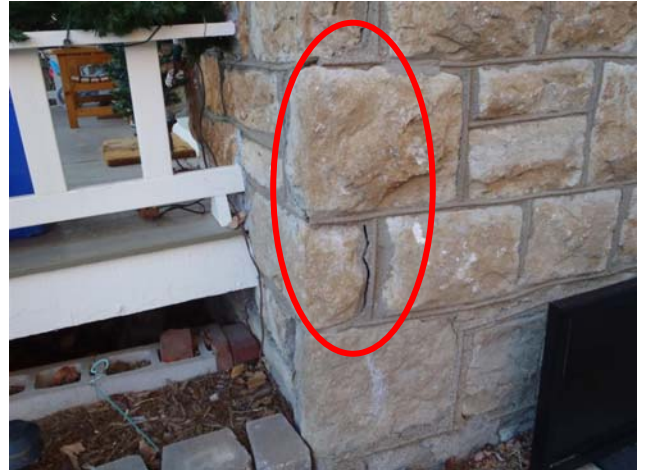
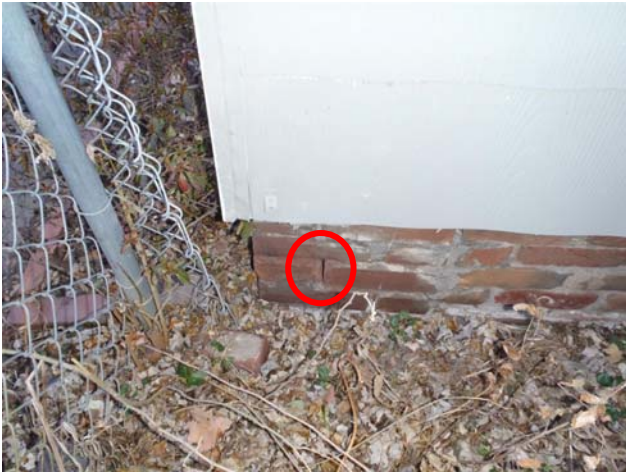
- **Repair:** The exterior stones and brickwork should be re-pointed (replacement of the mortar between the bricks & stones) to prevent further deterioration.

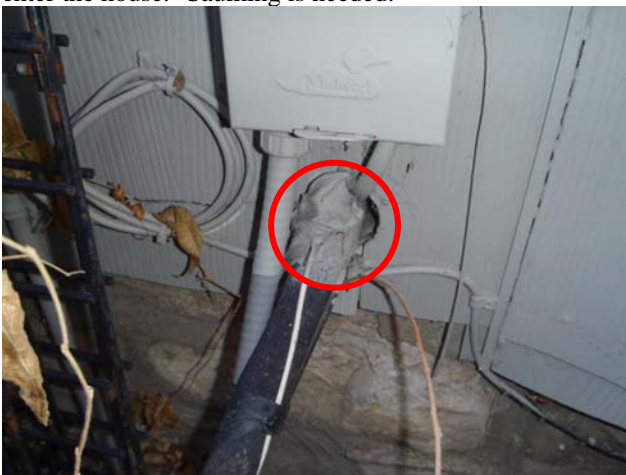
- **Repair:** Any openings in the exterior siding should be sealed. An example is where the air conditioner refrigerant lines enter the house. Caulking is needed.

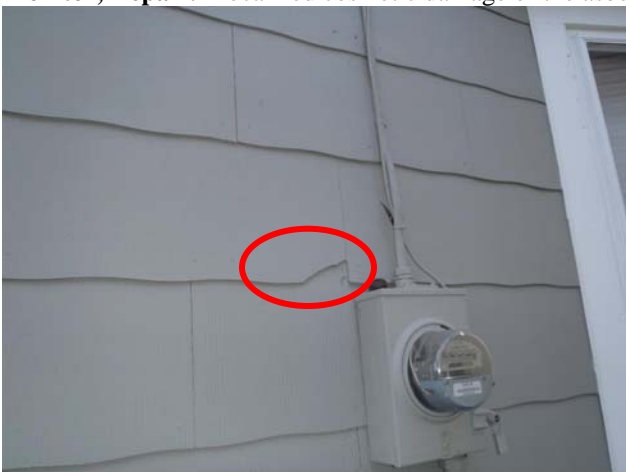
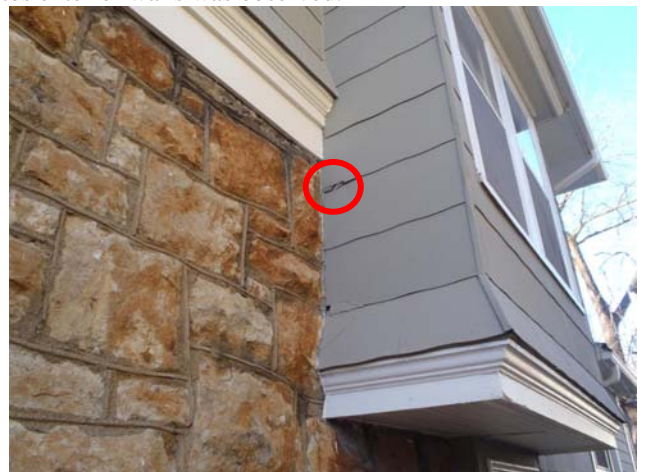
- **Monitor, Repair:** Localized cosmetic damage of the asbestos exterior walls was observed.

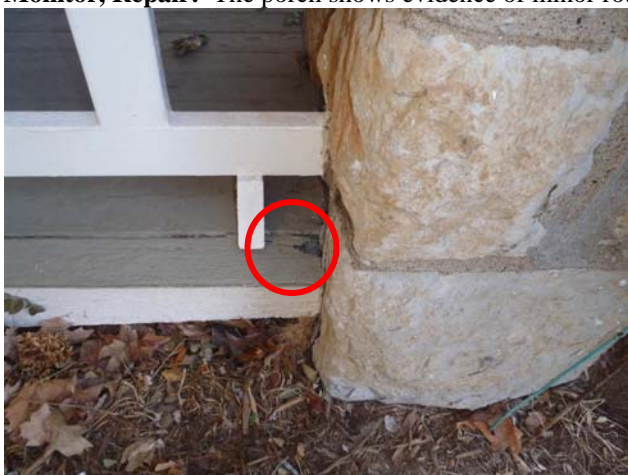
- **Monitor, Repair:** The porch shows evidence of minor rot. Repairs are discretionary.

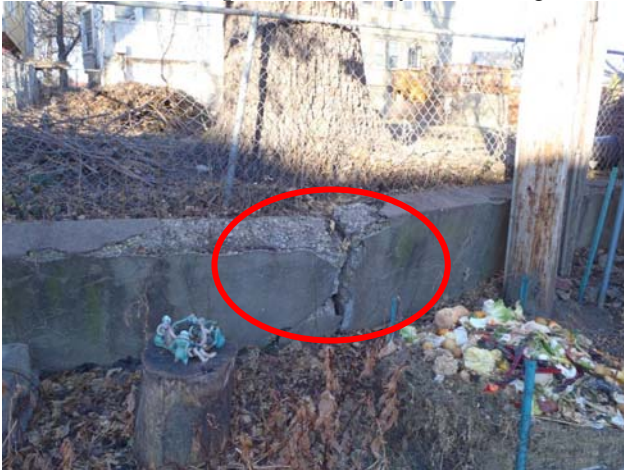
- **Major Concern, Repair:** The back yard retaining wall should be rebuilt.

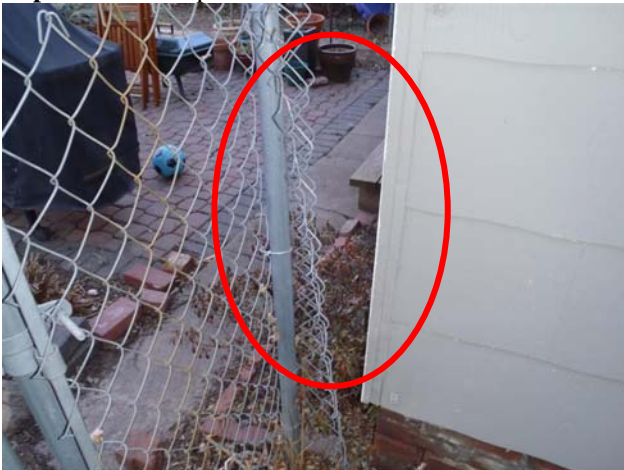
- **Repair:** Minor repairs are needed.

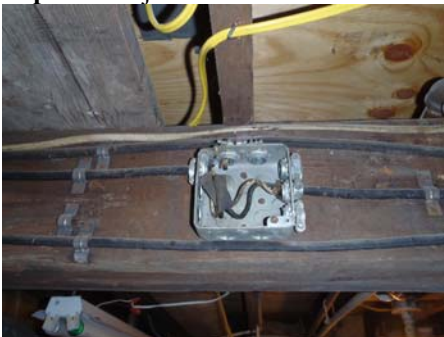
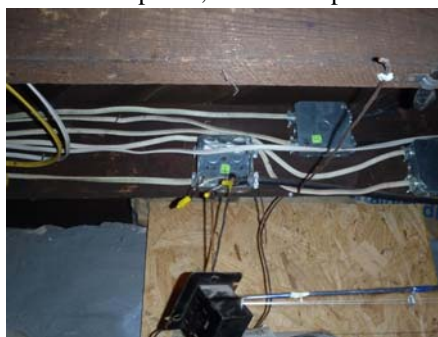
- **Repair:** All junction boxes should be fitted with cover plates, in order to protect the wire connections (i.e. basement.)

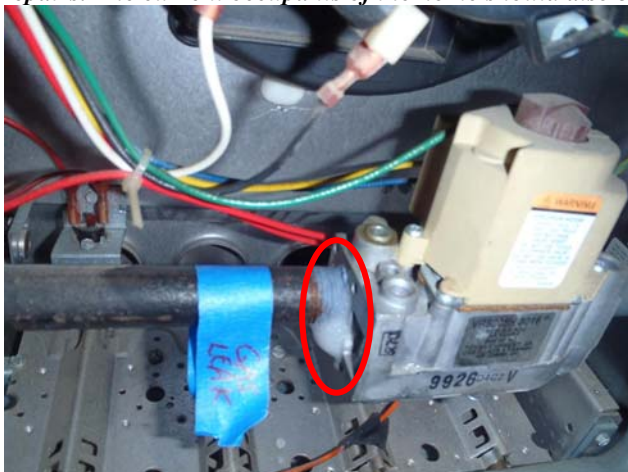
- **Repair, Safety Issue:** *A gas leak was detected with a TIF 8800 gas/carbon monoxide detector and confirmed with soapy water inside the furnace housing, marked "GAS LEAK" with blue tape. This is a serious safety concern. It is recommended that the gas utility, HVAC company or plumber be engaged as soon as possible to make the necessary repairs. The current occupants of the home should also be notified.*
