**Star
Home
Inspection Services**

Home Inspection Report

400 E 80th Terr, Kansas City, MO 64131

Inspection Date: 7/18/2008

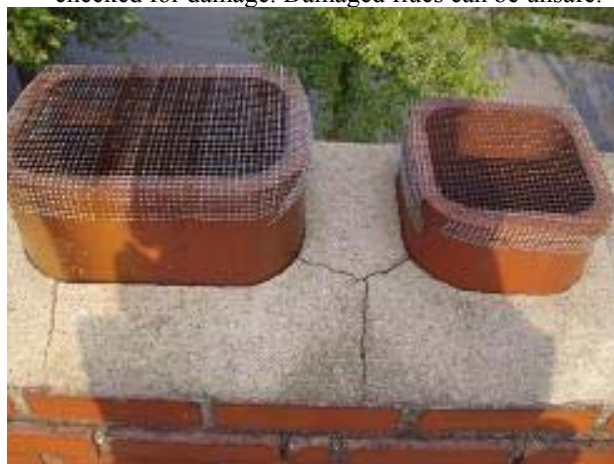
- **Repair:** The cap of the masonry chimney is cracked. These cracks should be sealed or caulked before winter to prevent damage from freezing water.
- **Recommend:** A rain cap and vermin screen should be installed on the masonry chimney and the chimney flue should be checked for damage. Damaged flues can be unsafe.

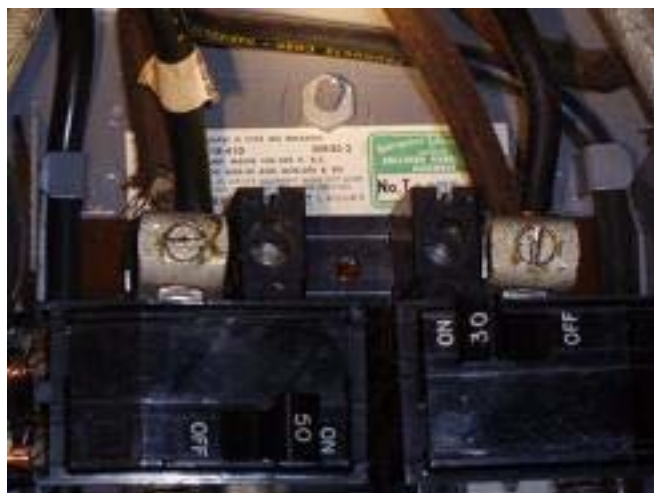
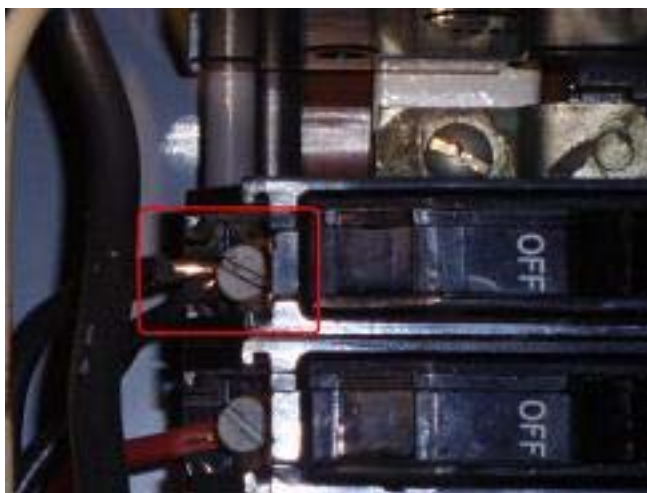
- **Repair:** The feed wire leading to the auxiliary panel should be protected by fuses or breakers in the main panel.
- **Repair:** It is recommended that the feed wire to the auxiliary panel be protected by a rigid conduit.
- **Repair:** Circuits within the auxiliary panel that are doubled up (referred to as "double taps") should be separated. Each circuit should be served by a separate fuse or breaker.

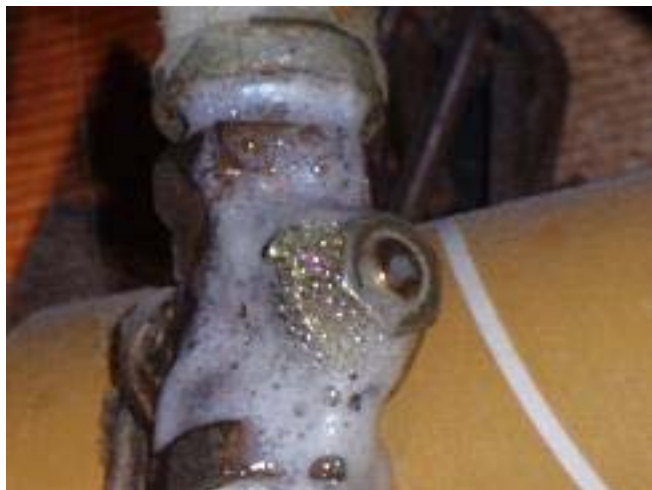
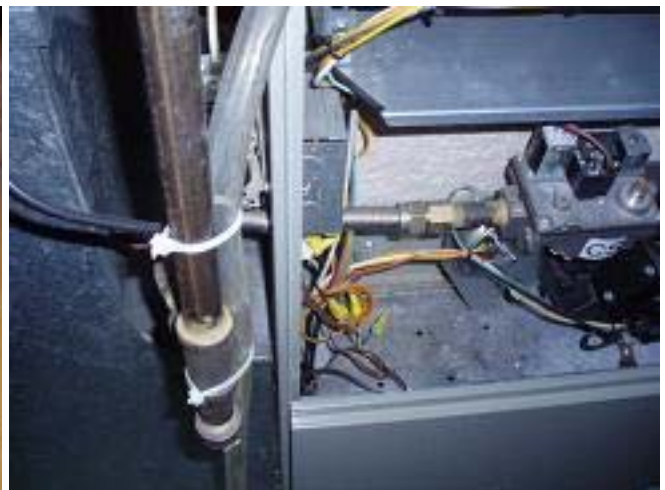
- **Repair, Safety Issue:** *A gas leak was detected at the valve leading to the water heater using a TUFF 8800 multi gas detector and soapy water. This is a serious safety concern. It is recommended that a plumber or the gas utility be engaged immediately. The current occupants of the home should be notified.*
- **Repair:** The appliance gas connection is unconventional (flexi line through furnace wall). This condition should be corrected for improved safety.
