Home Inspection Report

411 W 86th St, Kansas City, MO 64114

Inspection Date: 05/22/2009

Report Number: 05222009-1A

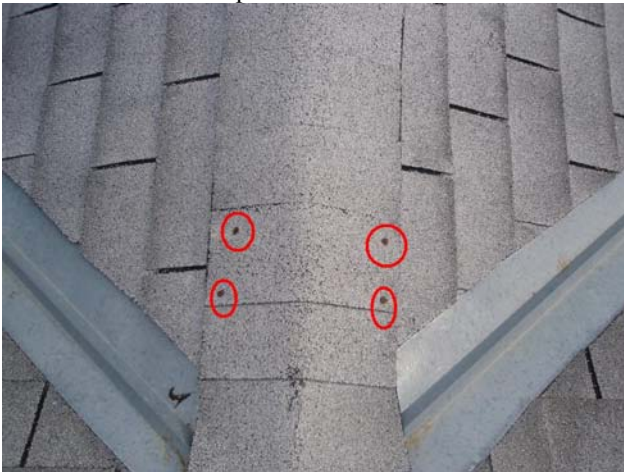
- **Repair:** Exposed nail heads were observed in the roofing shingles and/or ridge caps. All exposed nail heads should be caulked to reduce the potential of leaks.

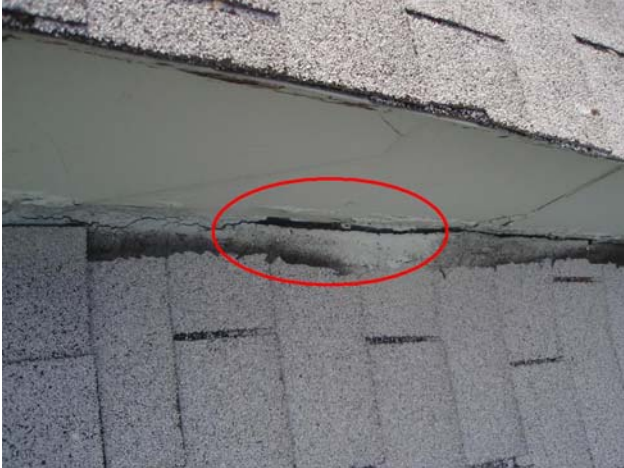
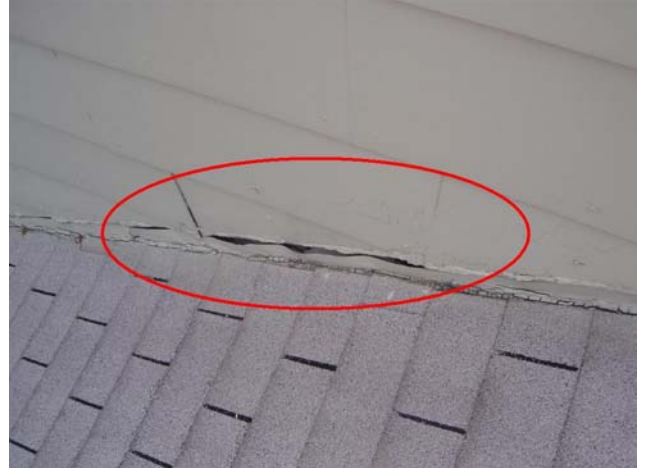
- **Repair:** The flashing at the garage siding near the house should be sealed/caulked to avoid leaks.

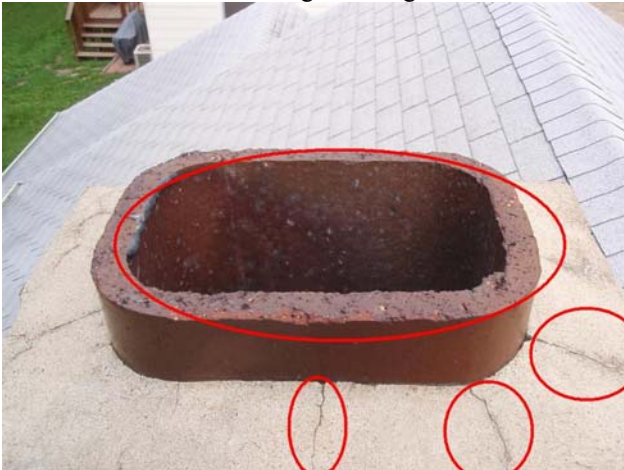
- **Repair:** The cap of the masonry chimney is cracked. These cracks should be sealed or caulked to prevent damage from freezing water.
- **Repair:** A rain cap and vermin screen should be installed on the masonry chimney prior to winter and the chimney flue should be checked for damage. Damaged flues can be unsafe.

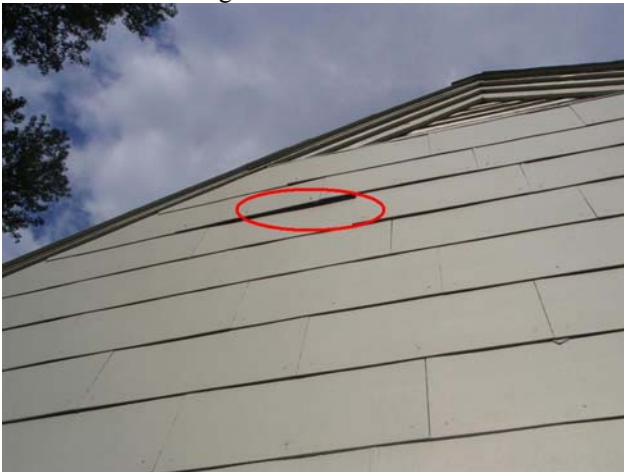
- **Monitor:** The siding is loose at the east side. This area should be monitored and secured as needed.

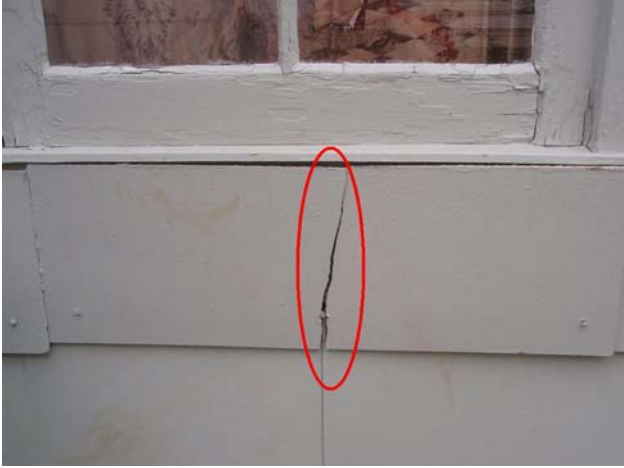
- **Monitor, Repair:** Localized minor damage was observed in the siding (example at west side). Following repair of the damaged areas (which should be combined with exterior painting/maintenance) proper maintenance of the siding and control of water from roof or surface runoff can avoid further damage.

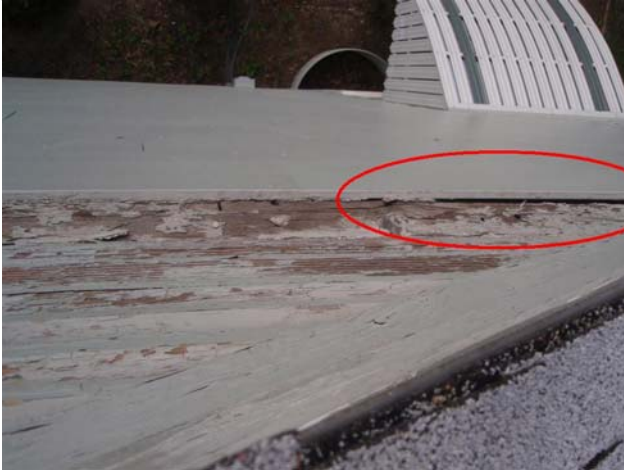
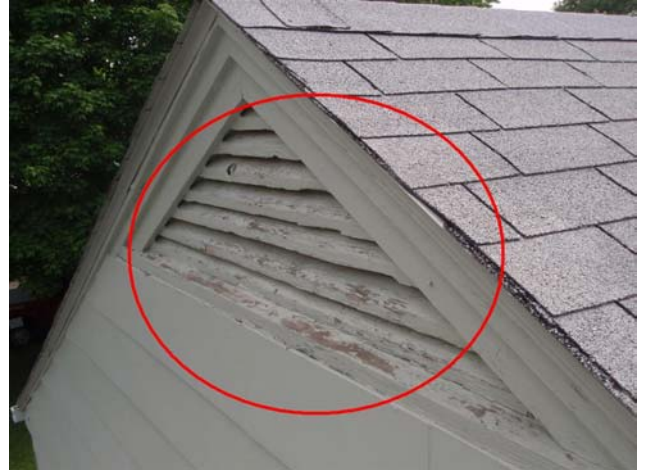
- **Repair:** The paint on the trim around the siding is peeling (examples at gable vents). These areas should be caulked and painted to prevent water damage and rot.

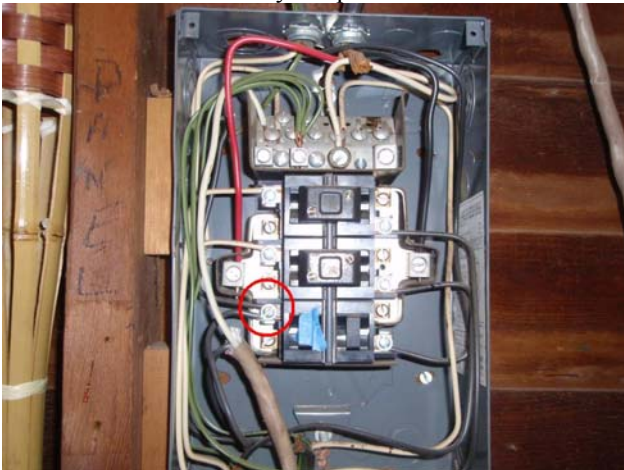
- **Repair:** Circuits within the auxiliary panel that are doubled up (referred to as "double taps") should be separated. Each circuit should be served by a separate fuse or breaker.

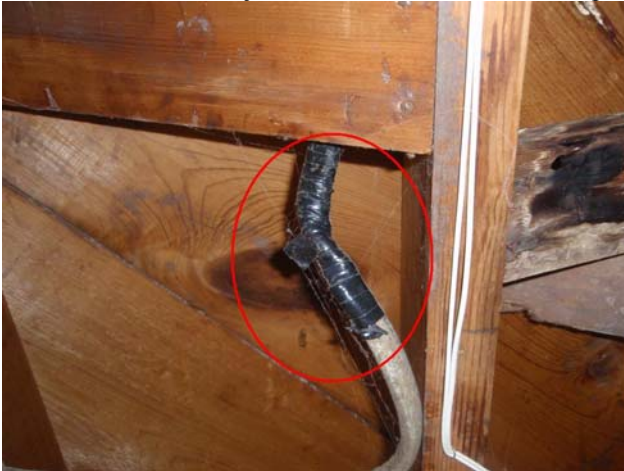
- **Repair:** Loose cable wiring in the basement should be secured.
- **Repair:** Improper electrical connections should be repaired (example at basement ceiling). All electrical connections should be made inside junction boxes fitted with cover plates.
