**Star
Home
Inspection Services**

Home Inspection Report

416 SE Battery Dr, Lees Summit, MO 64063

Inspection Date: 07/10/2009

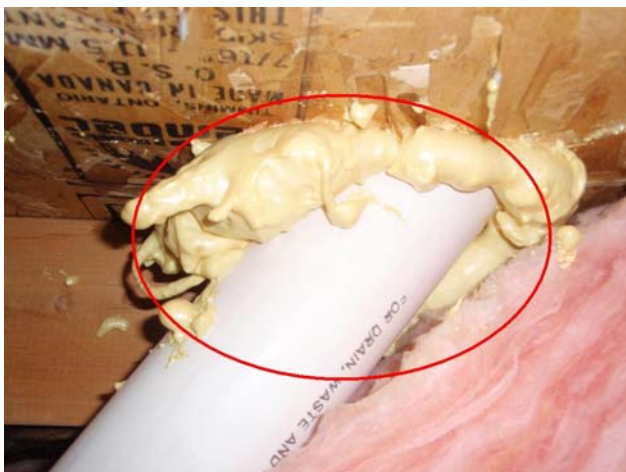
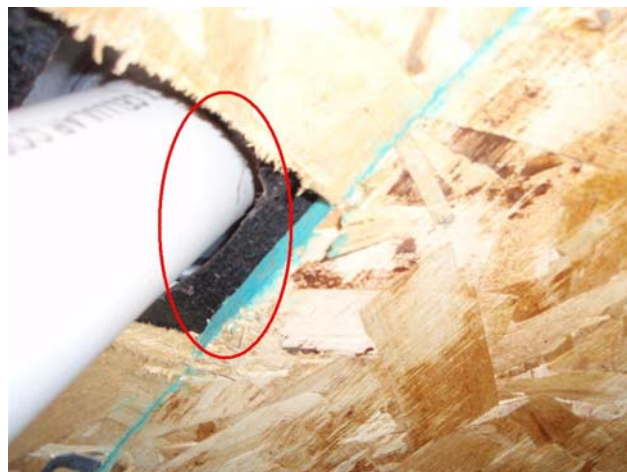
- **Monitor, Repair:** The plumbing vent flashing boot(s) is split making it vulnerable to leaks. It's recommended that the boot be caulked or the flashing replaced (light visible in attic at north plumbing vent boot and south plumbing vent boot was observed to be sealed improperly from the inside).

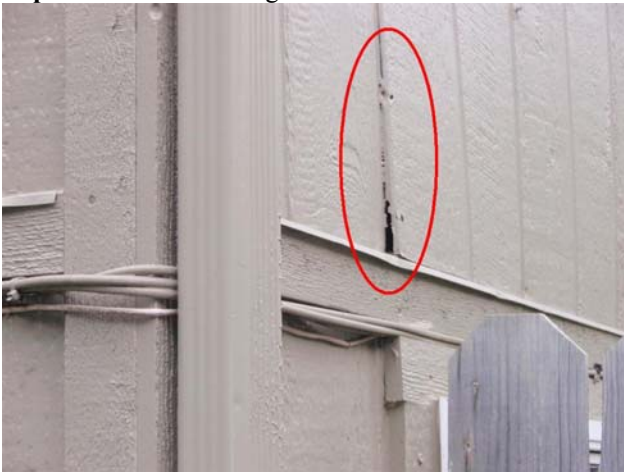
- **Repair:** The loose siding should be re-secured to avoid water and/or wind damage.

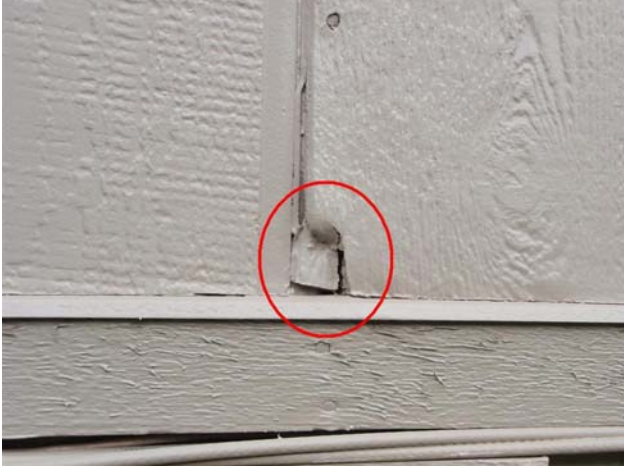
- **Repair:** Localized minor rot was observed in the siding at the lower corner of a sheet of siding on the south side. Following repair of the damaged areas (which should be combined with exterior painting/maintenance) proper maintenance of the siding and control of water from roof or surface runoff can avoid further damage.

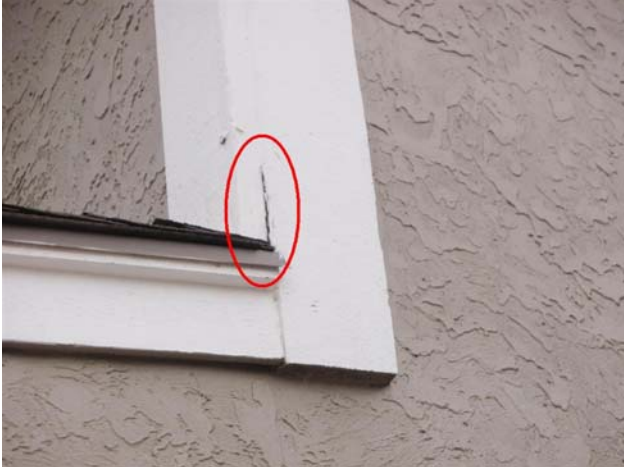
- **Repair:** The siding trim needs caulking improvements in localized areas to prevent water damage and rot.

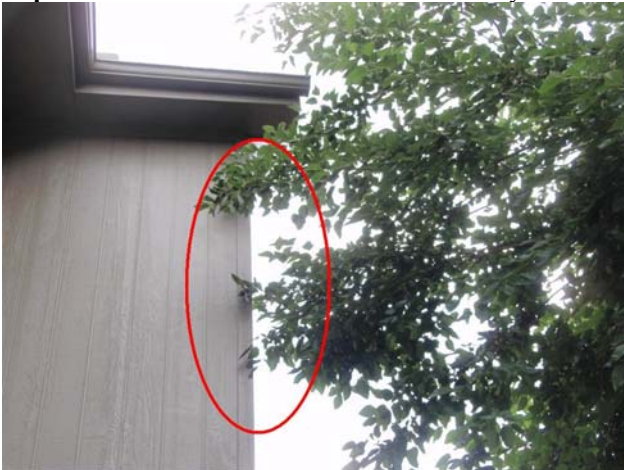
- **Repair:** Tree branches should be trimmed away from the house to avoid damage to the building.

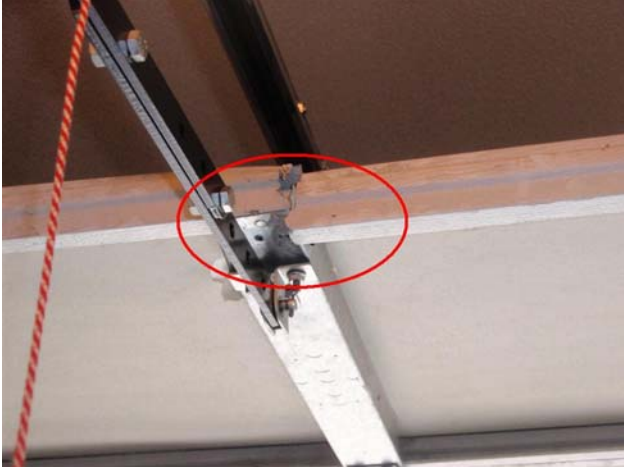
- **Repair, Safety Issue:** The south overhead garage door is damaged and needs repair.

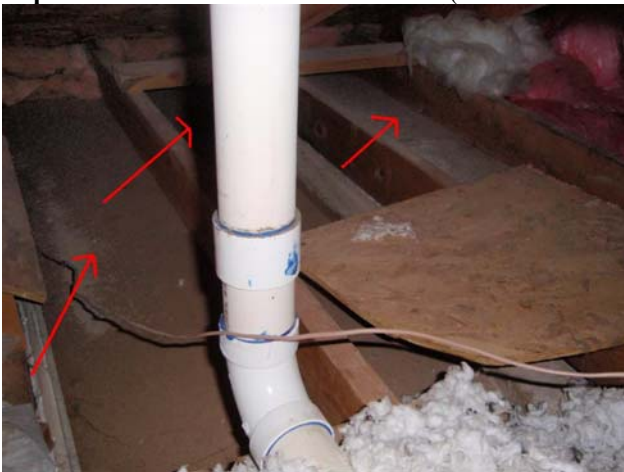
- **Repair:** Insulation should be evened out (small section at northwest side of attic missing insulation).

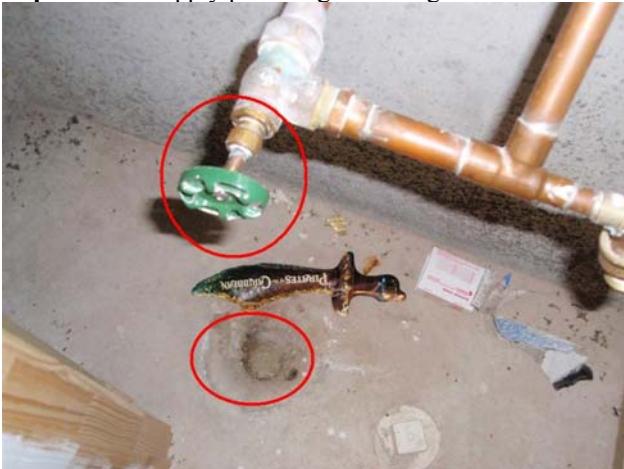
- **Monitor, Repair:** Low water pressure was observed when two or more faucets were in use. Suspect pressure regulator may need repairs or replacement.
- **Repair:** The supply plumbing is leaking at the main shutoff.
