Star Home Inspection Services

Home Inspection Report

416 SE Lana, Lees Summit, MO 64063

Inspection Date: 1/30/2008

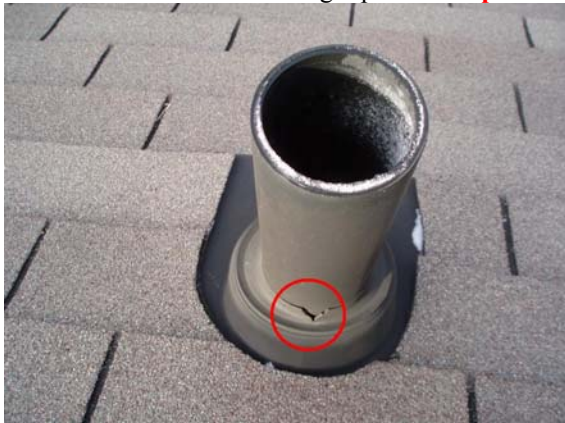
- Monitor, Repair:** The plumbing vent flashing boot is split making it vulnerable to leaks. It's recommended that the boot be caulked or the flashing replaced. **Repaired**
