# Star Home Inspection Services

## *Home Inspection Report*

**4203 Booth St, Kansas City, KS 66103**

**Report Number: 07292009-1A**

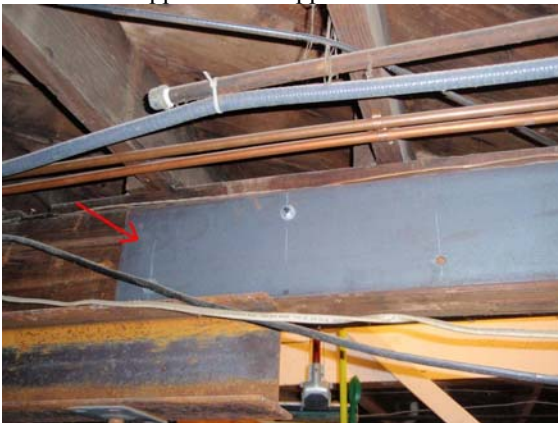
- **Monitor:** Minor unevenness was observed in the floor structure. This condition is common. It may be the result of the materials, framing design, installation methods and aging of the building. There was not evidence of need for immediate, costly repair.
- **Note:** The support main support beam in the basement has been reinforced with a steel plate.

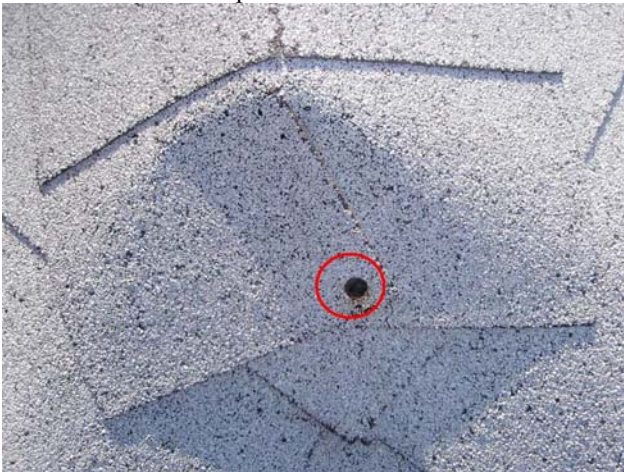
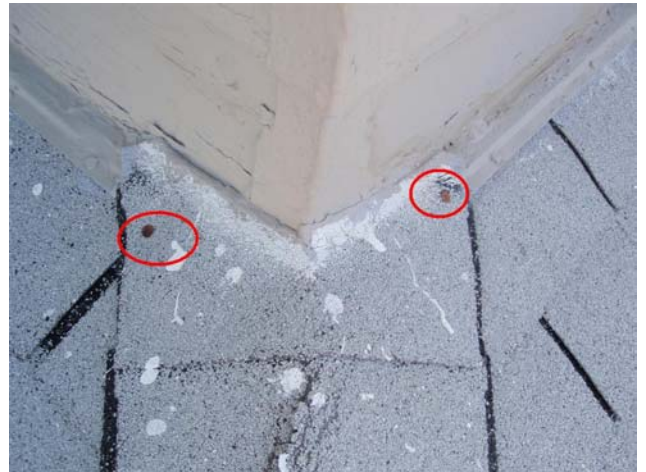
- **Repair:** Exposed nail heads were observed in the roofing shingles and/or ridge caps. All exposed nail heads should be caulked to reduce the potential of leaks.

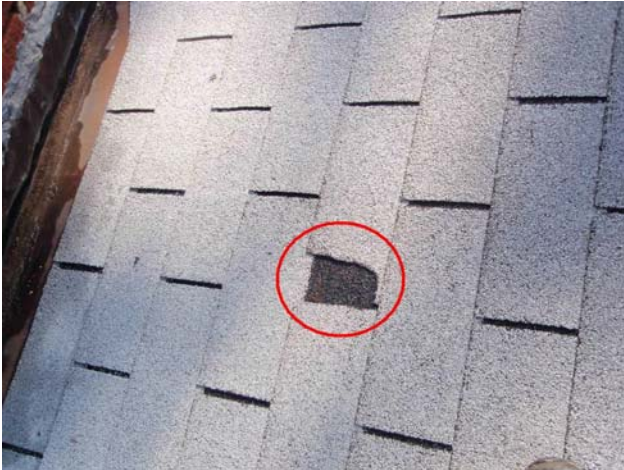
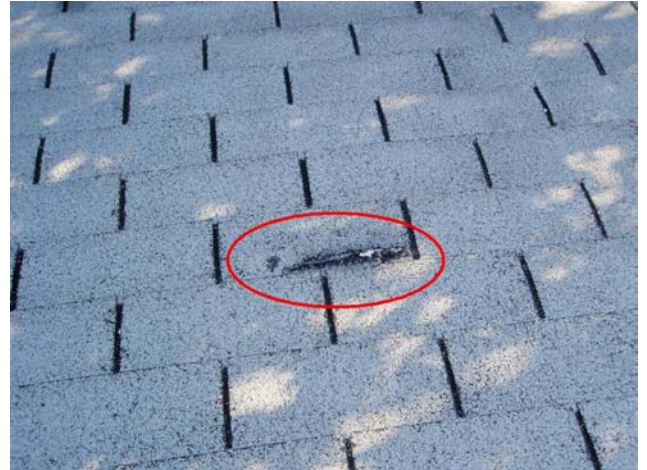
- **Monitor:** Two damaged tabs were observed. These areas should be monitored closely, especially after instances of high wind.

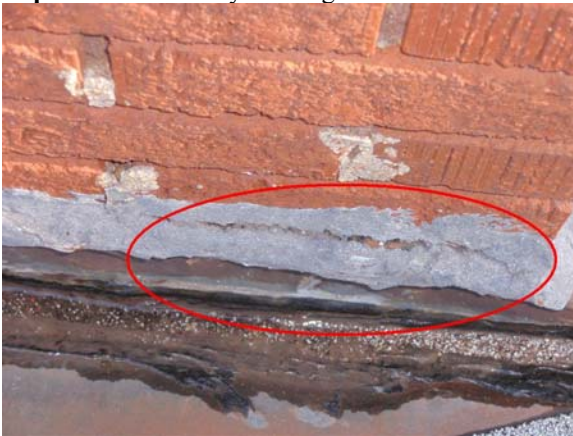
- **Repair:** The chimney flashing should be caulked to avoid leaks.

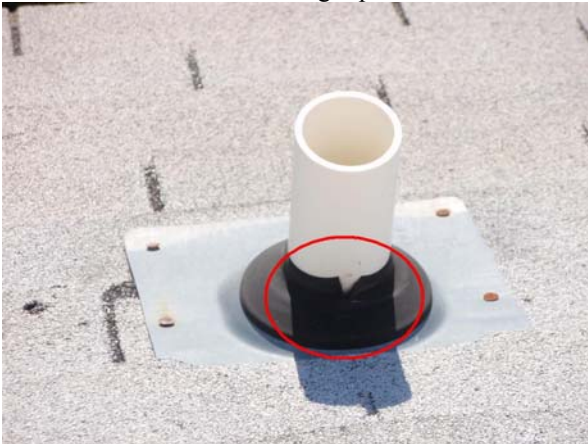
- **Monitor, Repair:** The plumbing vent flashing boot(s) is split making it vulnerable to leaks. It's recommended that the boot be caulked or the flashing replaced.

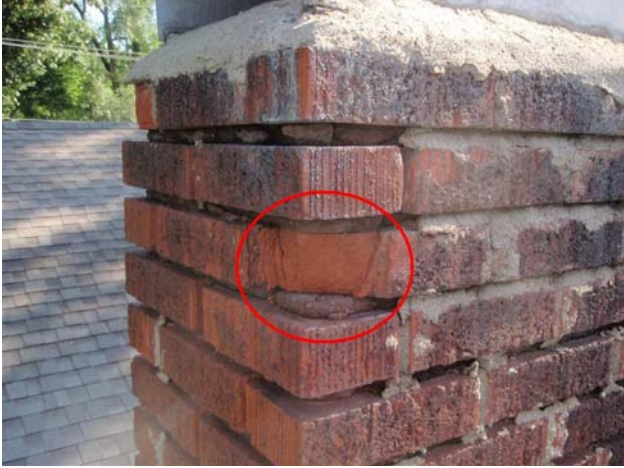
- **Monitor:** The masonry chimney shows evidence of spalling (surface deterioration of the masonry). Repair is not necessary at this time but this condition should be monitored.

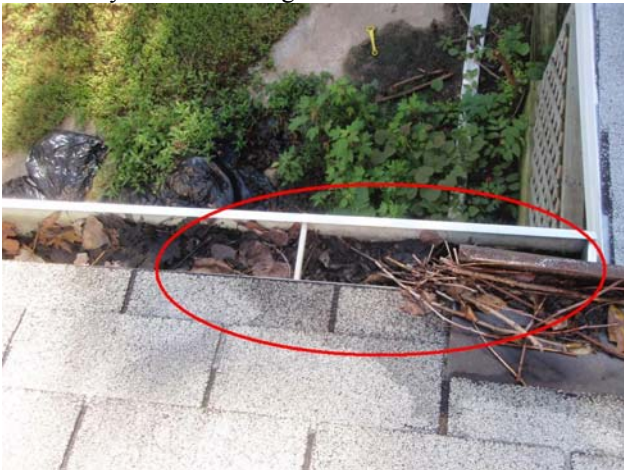
- **Repair:** The back porch gutter requires cleaning to avoid spilling roof runoff around the building – a potential source of water entry or water damage.

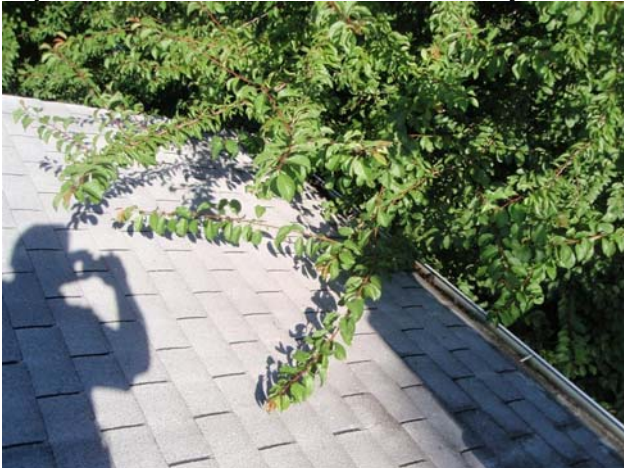
- **Repair:** Tree branches should be trimmed away from the house to avoid damage to the building.

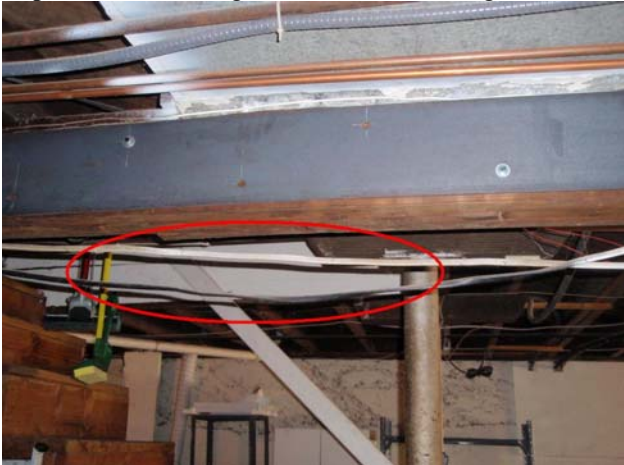
- **Repair:** Loose wiring at the basement ceiling should be secured.

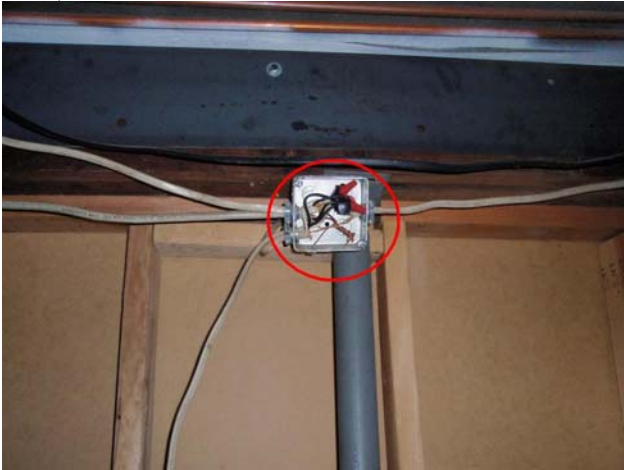
- **Repair:** All junction boxes should be fitted with cover plates, in order to protect the wire connections (i.e. furnace room).

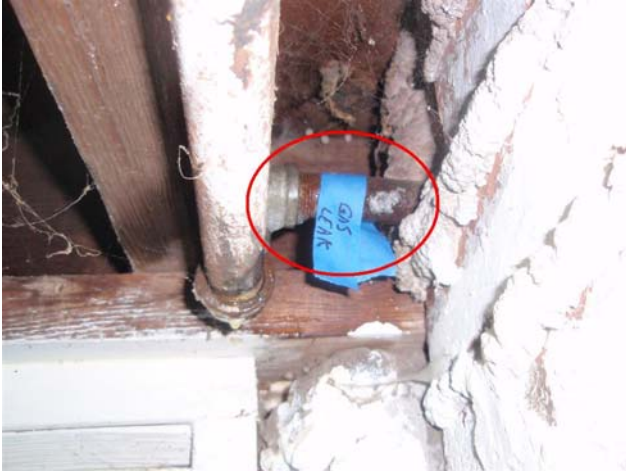
- **Repair, Safety Issue:** *A gas leak was detected with a TIF 8800 gas/carbon monoxide detector and confirmed with soapy water (marked "GAS LEAK" with blue tape at northwest corner of basement ceiling). This is a serious safety concern. It is recommended that the gas utility, HVAC company or plumber be engaged as soon as possible to make the necessary repairs. The current occupants of the home should also be notified.*
