Star Home Inspection Services

Home Inspection Report

427 E Prairie St, Olathe, KS 66061

Report Number: 11282008-1A

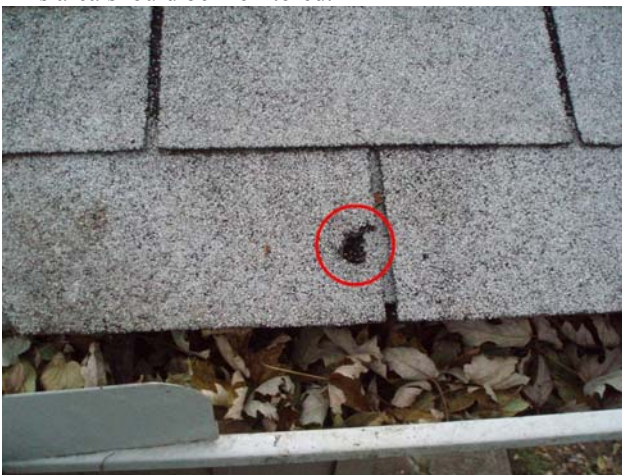
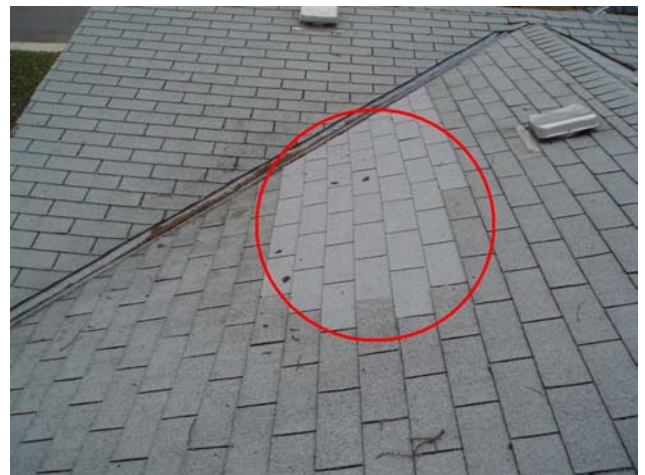
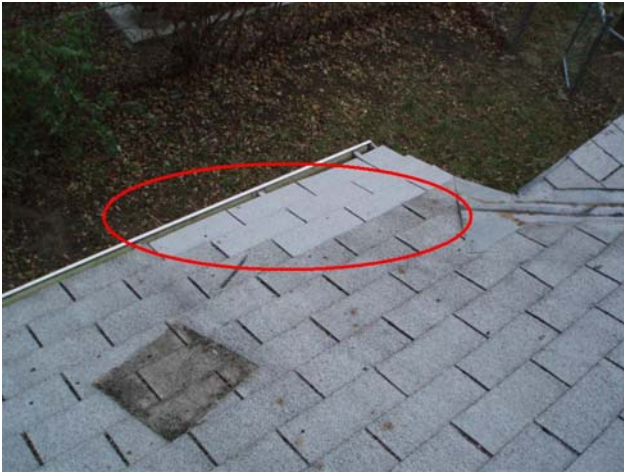
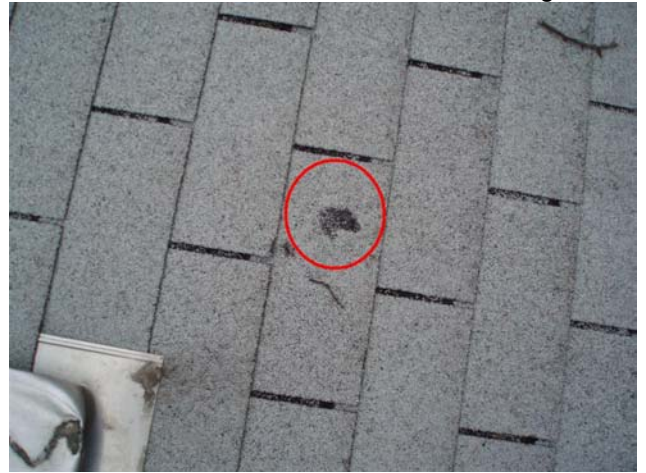
Sloped Roofing

- **Repair:** Minor repairs to the roofing are needed. Damaged or missing roofing material should be repaired. All roof penetrations should be examined and sealed as necessary. The roofing is in fair condition. We did not see evidence of active leaks nor need for immediate major repair. Older roofs are, by their nature, a high maintenance roof. Annual inspection and repair should be anticipated. In addition, the older flashings should be monitored. In some cases, a deteriorated flashing can result in expensive repairs, because sections of the roofing have to be removed. As a rule of thumb, replacement of the entire roof covering may be logical if more than ten percent of the roof requires repair.
- **Monitor:** Prior repairs to the roofing are evident. This would suggest that problems have been experienced in the past. This area should be monitored.

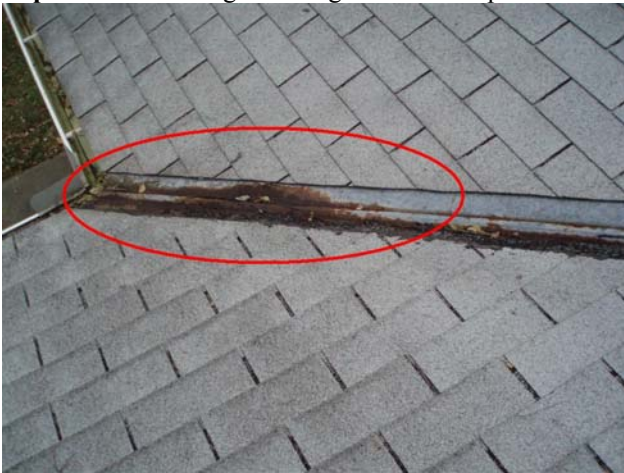
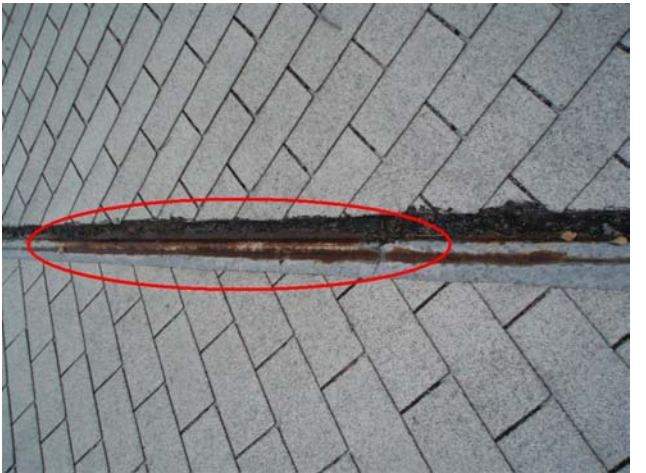
Flashings

- **Monitor:** The flashing is old and should be monitored. If leaks occur it may be possible to patch leaky flashing; otherwise replacement will be needed.
- **Repair:** The flashing is rusting. It should be painted to extend its life.

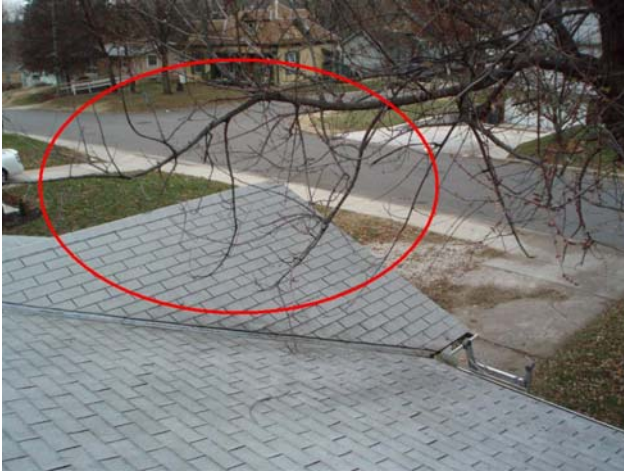
Landscaping

- **Repair:** Shrubs, bushes and/or vines growing on exterior walls need to be trimmed away from the structure to reduce the risk of water damage and insect infestation. Tree should be trimmed back away from roof.

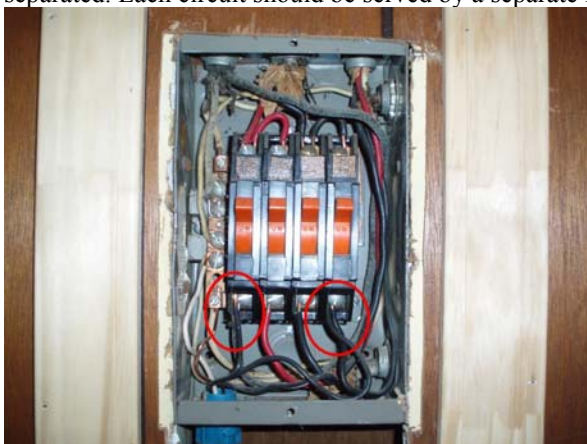
Main Panel

- **Major Concern, Repair:** The panel has a smaller rating than the size of the incoming service. It should be replaced with a panel that is suitable to the size of the incoming service.
- **Repair:** Circuits within the main distribution panel that are doubled up (referred to as "double taps") should be separated. Each circuit should be served by a separate fuse or breaker.

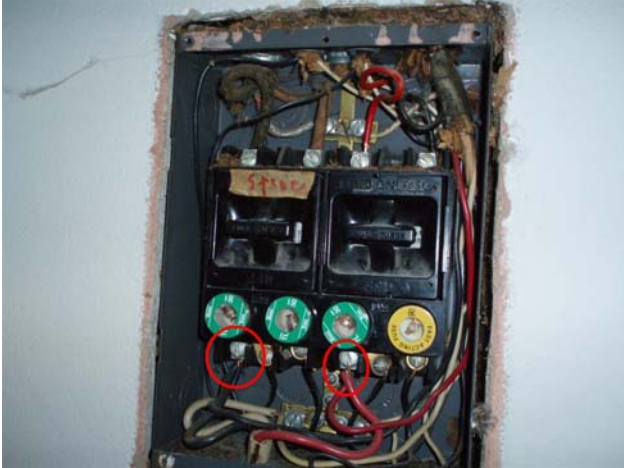
Auxiliary Panel(s)

- **Repair:** Circuits within the auxiliary panel that are doubled up (referred to as “double taps”) should be separated. Each circuit should be served by a separate fuse or breaker.

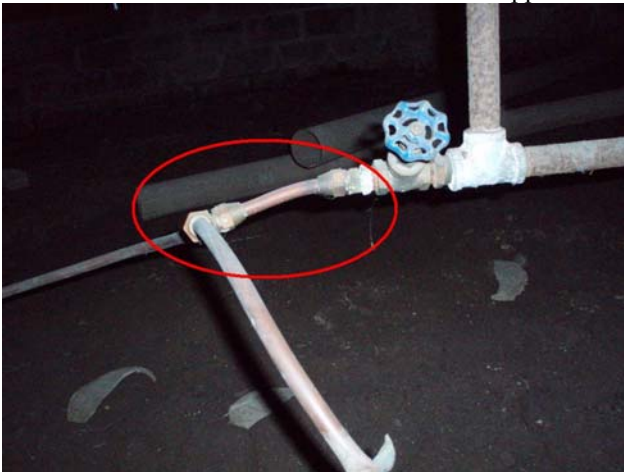
Gas Piping

- **Repair:** Copper tubing is no longer suitable for gas piping. It's recommended this pipe in the crawl space be replaced with one of suitable material or removed and capped off.
