**Star
Home
Inspection Services**

Home Inspection Report

4305 NE 59th Terr, Kansas City, MO 64119

Inspection Date: 09/12/2009

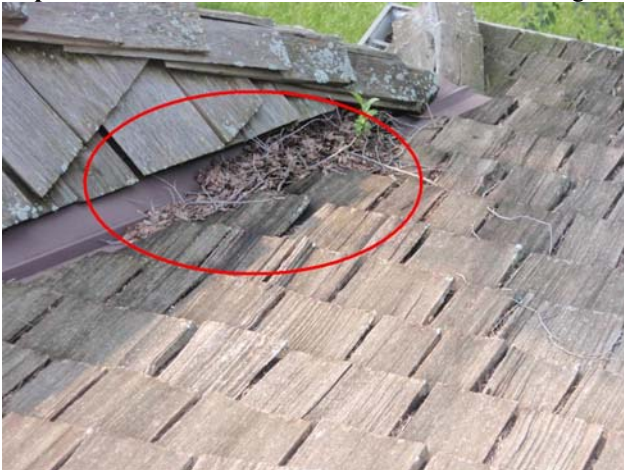
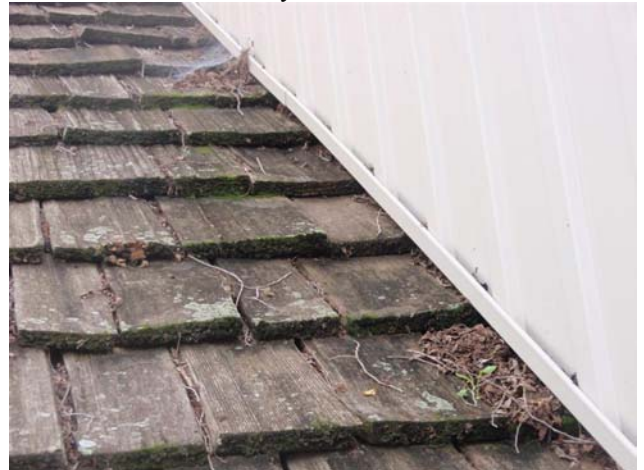
- **Monitor:** The life expectancy of wood roofs is generally 15 to 20 years. This will depend on several factors such as the quality of shingle or shake, the slope of the roof (steeper is better), the amount of exposed shingle, and the amount of sun or shade. As with all roofs, annual maintenance is needed. Cracked, curled, or displaced shingles or shakes should be repaired. As a rule of thumb, replacement of the entire roof covering may be logical if more than ten percent of the wood roof requires repair. The roofing shows evidence of moss and organic build up in shaded areas. This condition may reduce the life expectancy of the roofing. Trimming or removing trees could improve this condition.
- **Improve:** Debris should be removed from the roofing to reduce risk of leaks and early roof wear.

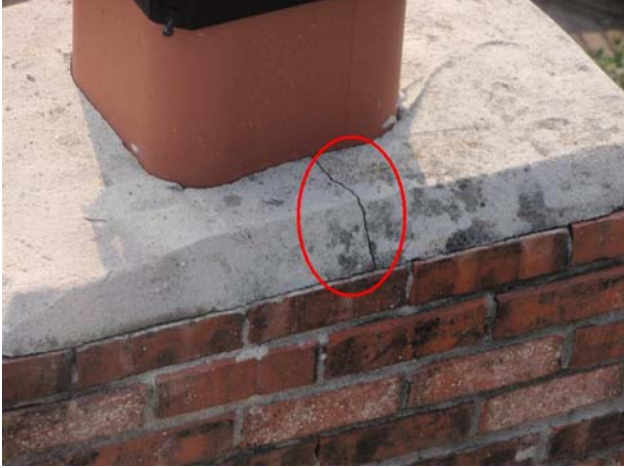
- **Repair:** The cap of the masonry chimney is cracked. These cracks should be sealed or caulked to prevent damage from freezing water.

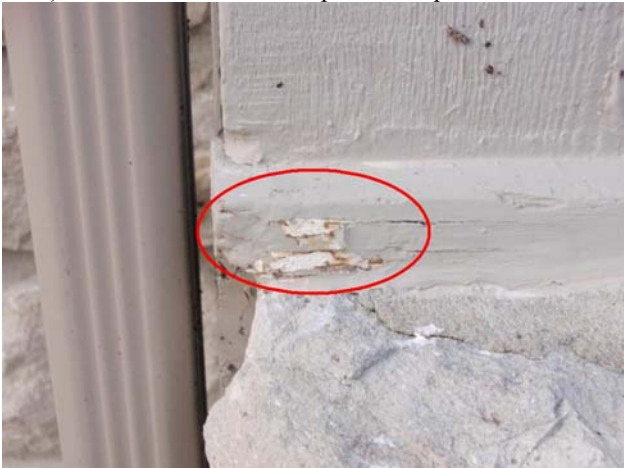
- **Repair:** The paint on the trim around the siding was observed to have minor peeling (i.e. at siding trim near garage door). These areas should be painted to prevent water damage and rot.

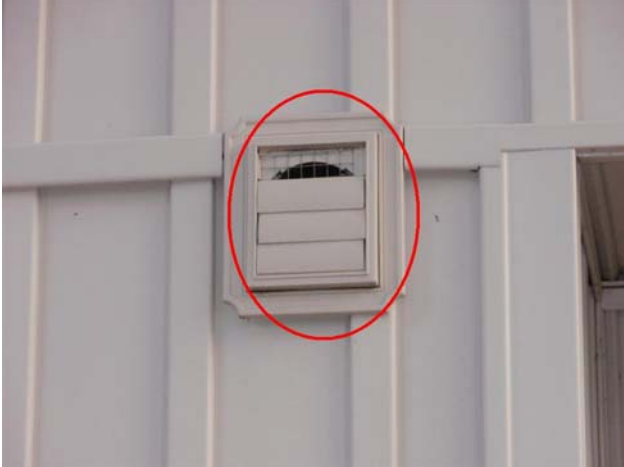
- **Improve:** Missing louver to the vent cover was observed.

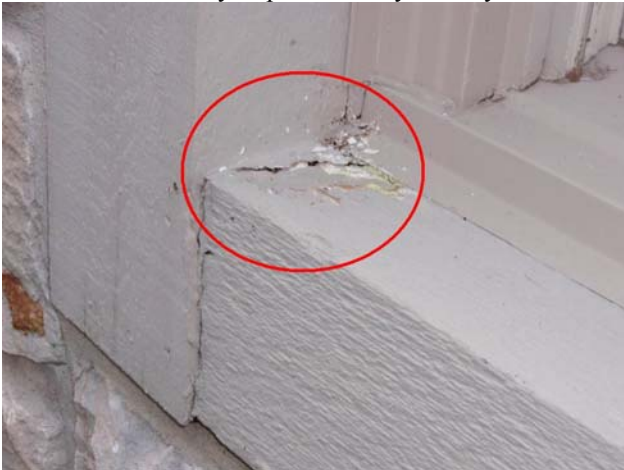
- **Repair:** Localized evidence of rot was visible on window trim/frame (i.e. front window trim corner). Repair to the window frame can usually be accomplished by a skilled carpenter. It's recommended that a thorough "inventory" be taken by a competent window repair technician to ascertain exactly how many areas will need to be repaired or replaced. Further evaluation by a specialist may identify additional areas that require servicing.

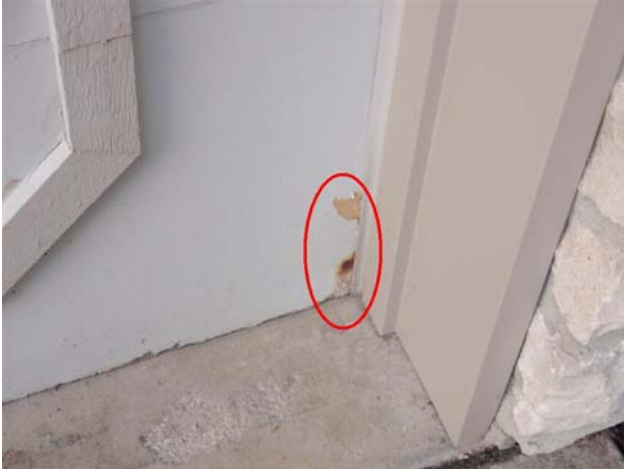
- **Repair:** The paint on the overhead door, frame/ trim is peeling and requires painting and caulking.

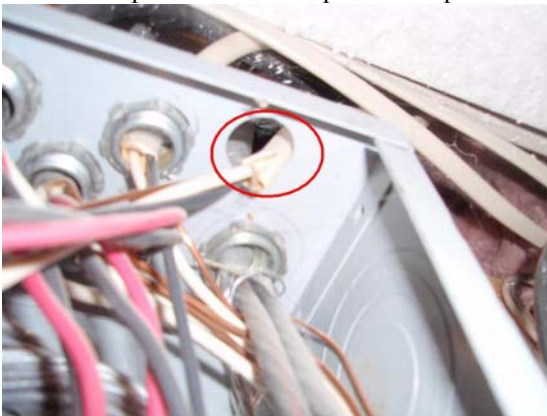
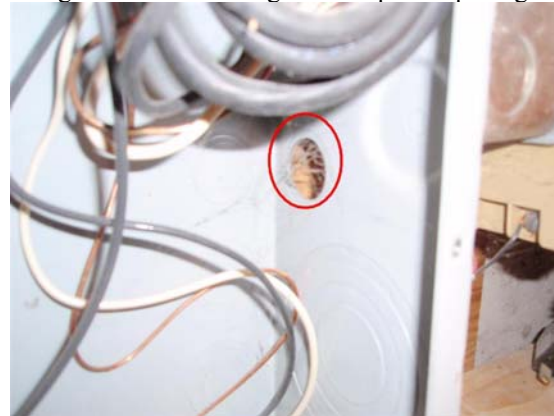
- **Repair:** Any openings in the main panel should be covered.
- **Repair:** Cable clamps (sometimes referred to as bushings or grommets) are required where wiring passes into the main distribution panel. Cable clamps serve to protect the wiring from the metal edges of the panel openings.

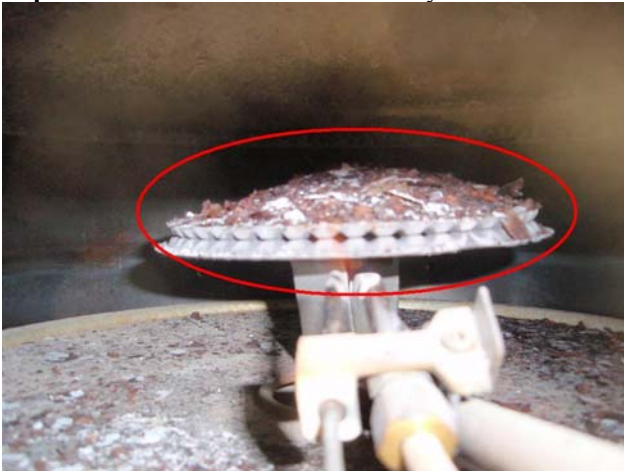
- **Monitor:** Water heaters have a typical life expectancy of 7 to 12 years. The existing unit is approaching or has exceeded this age range. One cannot predict with certainty when replacement will become necessary.
- **Repair:** The water heater burner is dirty. It should be cleaned and adjusted.

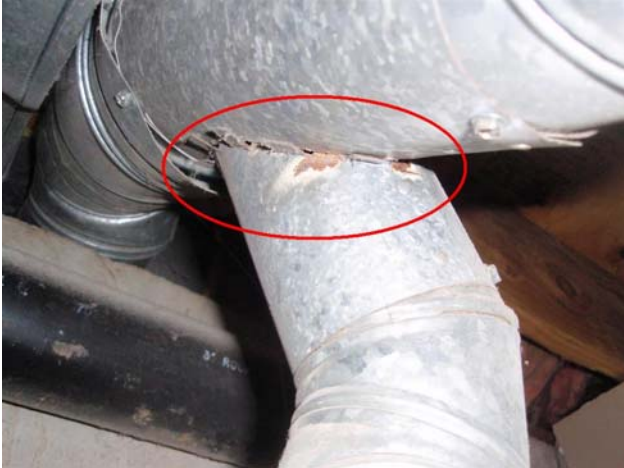
- **Repair, Safety Issue:** For enhanced safety, it is recommended that the connections of the water heater venting system be improved.
