**Star
Home
Inspection Services**

Home Inspection Report

4312 Eaton, Kansas City, KS 66103

Inspection Date: 11/18/2008

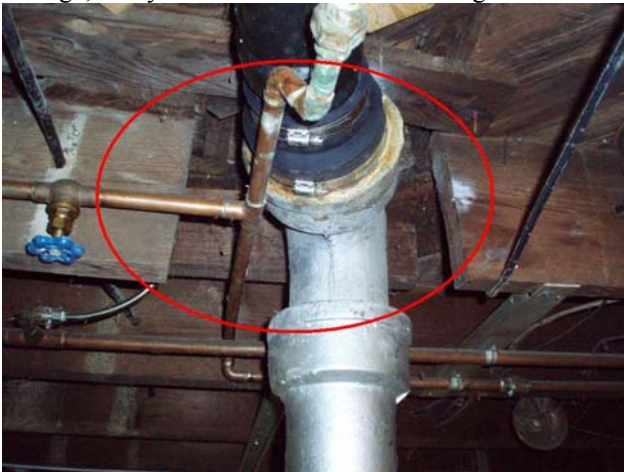
- **Monitor:** Minor unevenness was observed in the floor structure. This condition is common. It may be the result of the materials, framing design, installation methods and aging of the building. There was not evidence of need for immediate, costly repair.
- **Monitor:** Floor joists are notched and or cut under bathroom waste piping. This weakens the joist and risks structural damage; if any further movement or cracking is observed repairs or additional support will be needed.

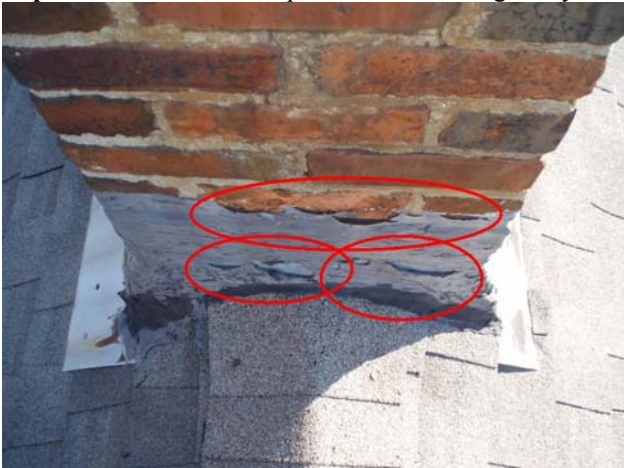
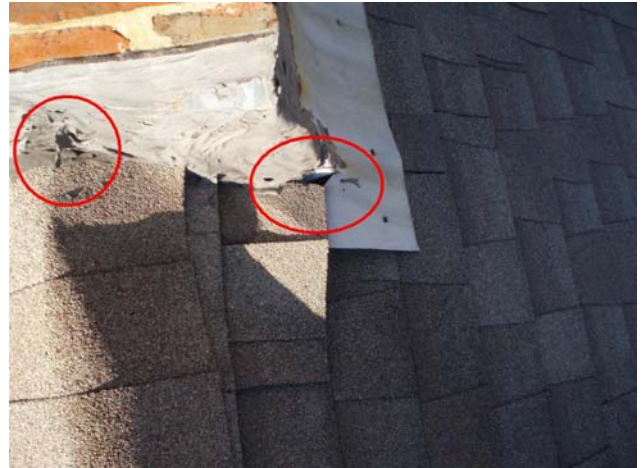
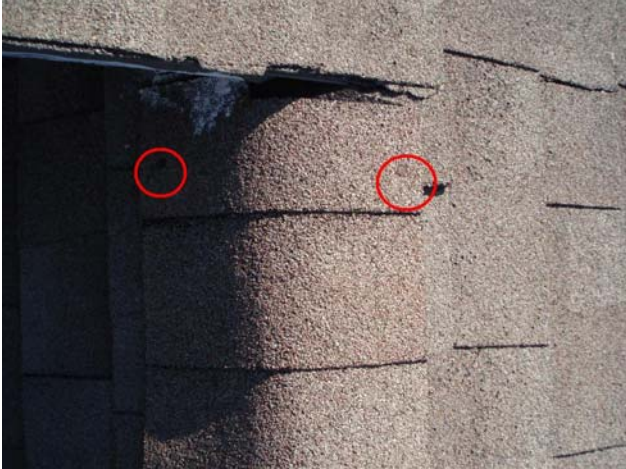
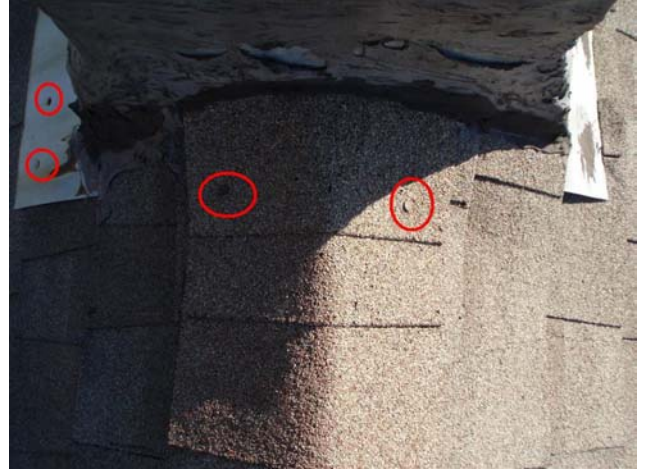
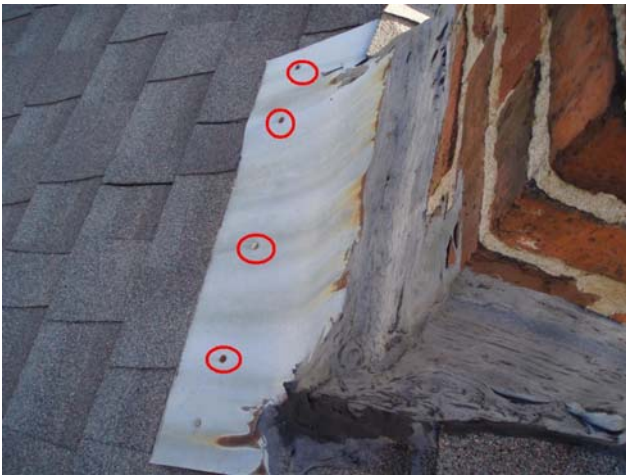
Flashings

- **Monitor, Repair:** The chimney flashing is vulnerable and should be carefully monitored for leaks.
- **Repair:** Nail heads are exposed at the flashing. They should be sealed to reduce risk of leaks.

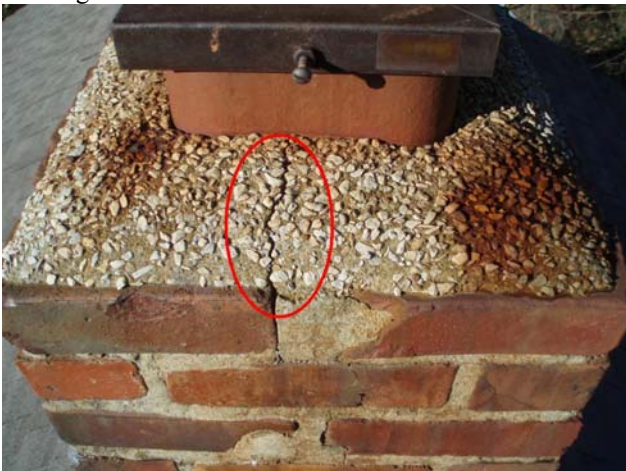
Chimneys

- **Repair:** The cap of the masonry chimney is cracked. These cracks should be sealed or caulked to prevent damage from freezing water.

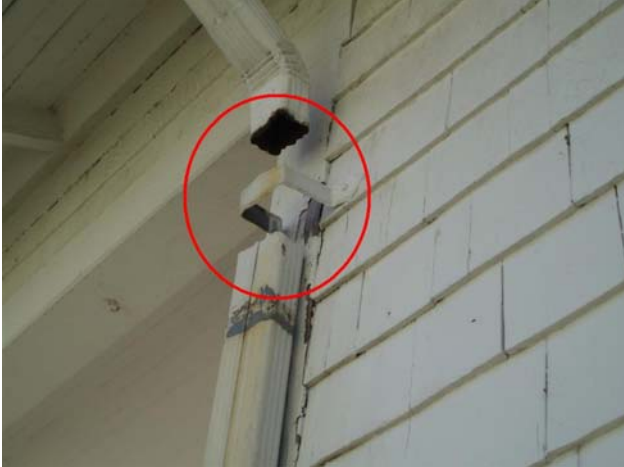
Gutters & Downspouts

- **Repair:** The old galvanized gutters and downspouts should be replaced. There does not appear to be a sufficient number of downspouts and gutters. If practical, additional downspouts should be installed to avoid spilling roof runoff around the building – a potential source of water entry or water damage.

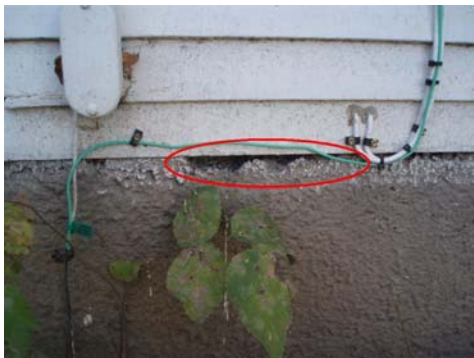
- **Monitor, Repair:** Localized damage of the exterior siding was noted. Seal openings at siding to prevent water entry.

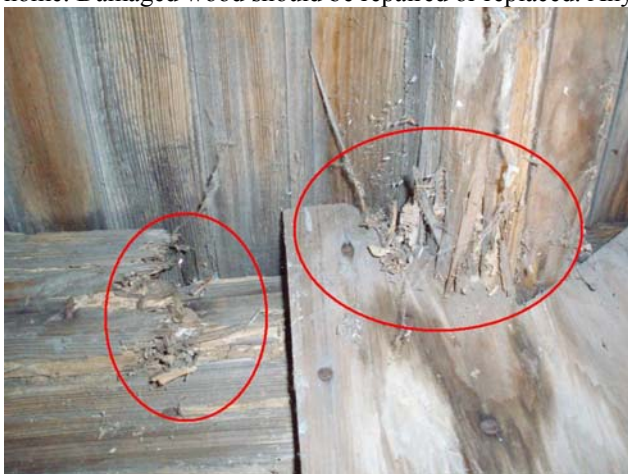
Wood Boring Insects

- **Repair:** Evidence of termite damage was observed (example under the front porch stairs and porch floor joists) and there is risk of additional hidden damage since termites can do a substantial amount of damage. If the property has not already been treated, a licensed pest control specialist should be engaged to eliminate further termite activity within the home. Damaged wood should be repaired or replaced. Any wood soil contact should be eliminated.

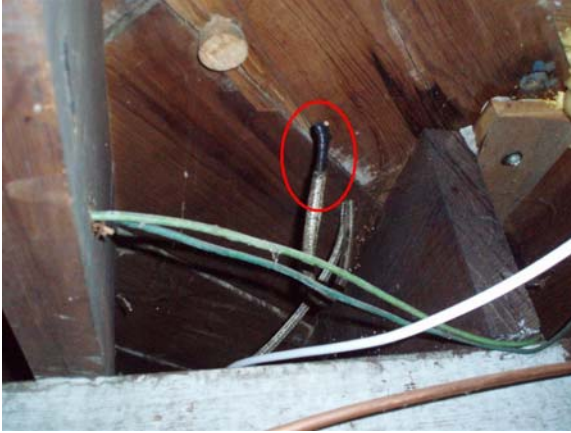
Distribution Wiring

- **Repair:** Improper electrical connections should be repaired (example at basement ceiling). All electrical connections should be made inside junction boxes fitted with cover plates.

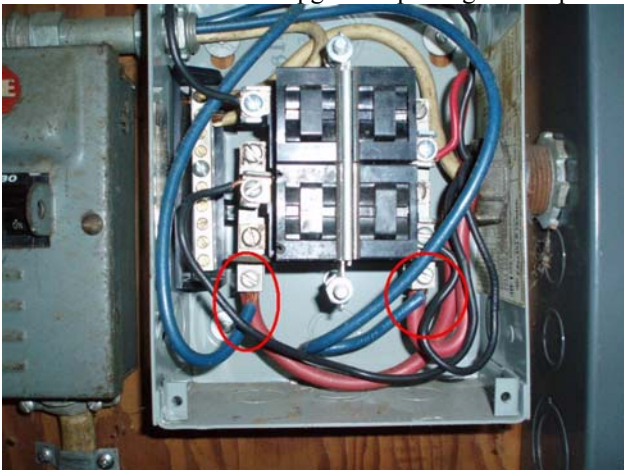
Main/Auxiliary Panel(s)

- **Repair:** Circuits within the auxiliary panel that are doubled up (referred to as “double taps”) should be separated. Each circuit should be served by a separate fuse or breaker. Upgrades to the electrical system have included adding subpanels, it is recommended that an upgrade replacing the subpanels and main panel with a single main panel be made.
