Star Home Inspection Services

Home Inspection Report

437 E 72nd St , Kansas City, MO 64131

Inspection Date: 4/14/2009

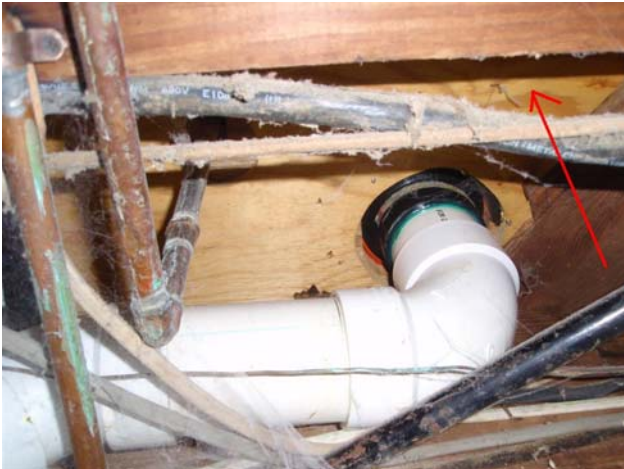
- **Monitor:** Repaired subflooring (supporting layer of flooring atop floor joists and below finish flooring or carpeting) was observed below the kitchen bathroom. The installation appears to be satisfactory.

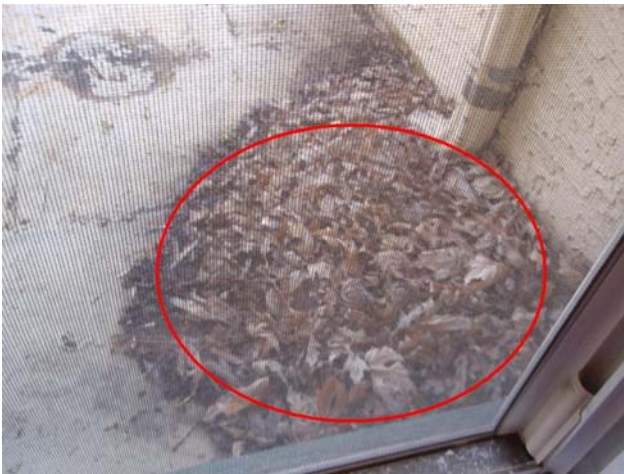
- **Improve:** It is recommended that the debris (leaves) be removed from the flat roof area outside the east upstairs bedroom window. **Repaired**

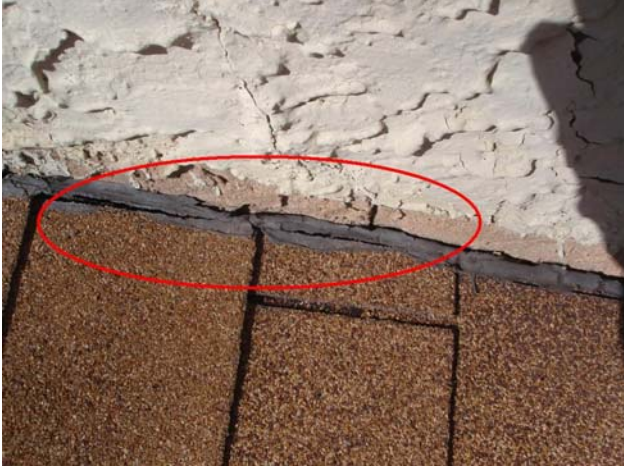
- **Repair:** The deteriorated, cracked or damaged caulking at back porch roof should be caulked where roofing meets siding to avoid leaks.

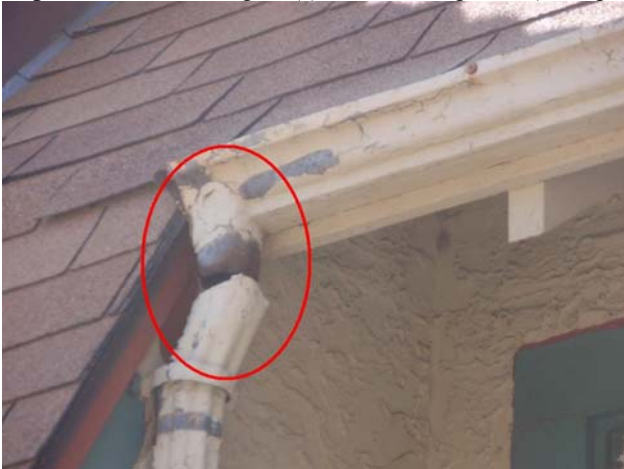
- **Repair:** The gutters require cleaning to avoid spilling roof runoff around the building – a potential source of water entry or water damage.
- **Repair:** The downspout(s) should discharge water at least five (5) feet from the house. Storm water should be encouraged to flow away from the building at the point of discharge (example at front northeast corner).
- **Repair:** Loose downspout(s) should be repaired (example at east side second floor window). **Repaired**

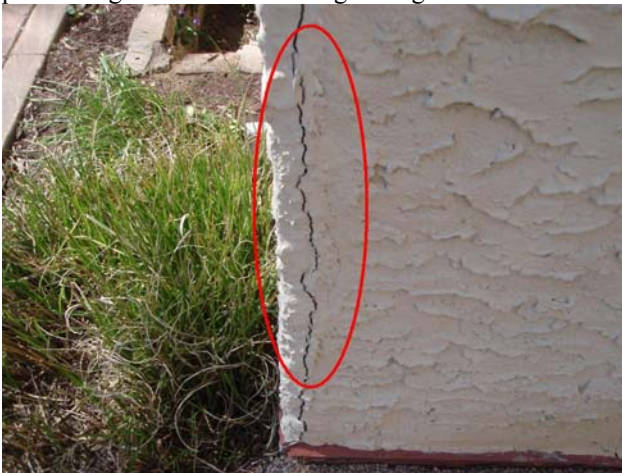
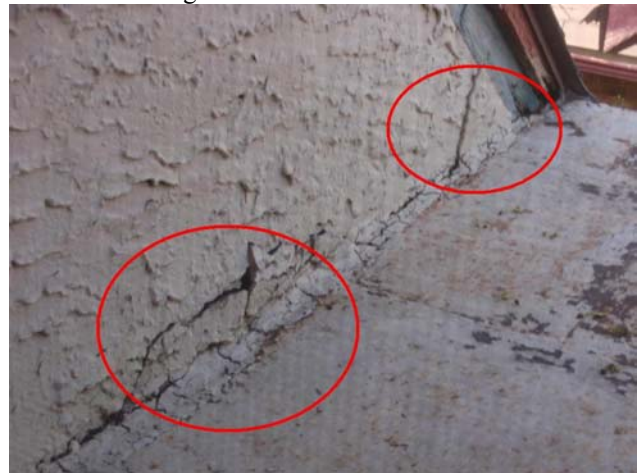
- **Repair:** The paint on the trim around the siding is peeling. These areas should be painted to prevent water damage and rot.
- **Repair:** Cracks were observed in the exterior stucco walls these cracks should be repaired to prevent water from penetrating the wall and causing damage. There is extra risk of hidden damage in such areas.

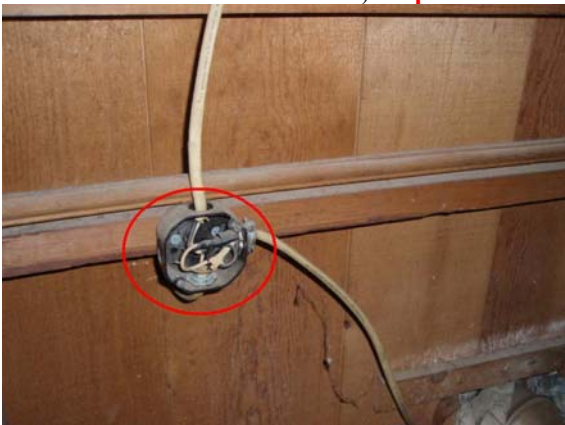
- **Repair:** All junction boxes should be fitted with cover plates, in order to protect the wire connections (example in unfinished basement near furnace). **Repaired**

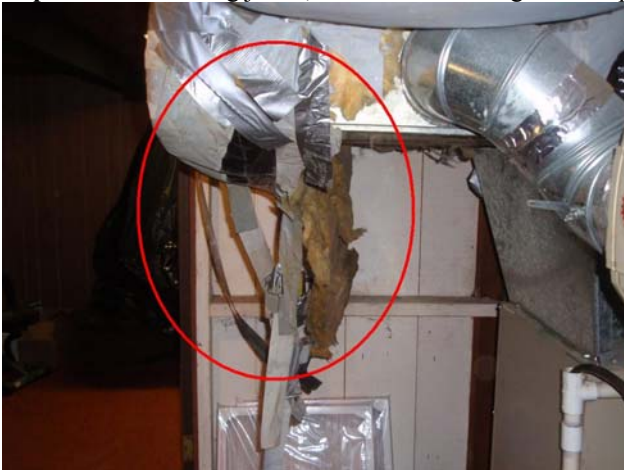
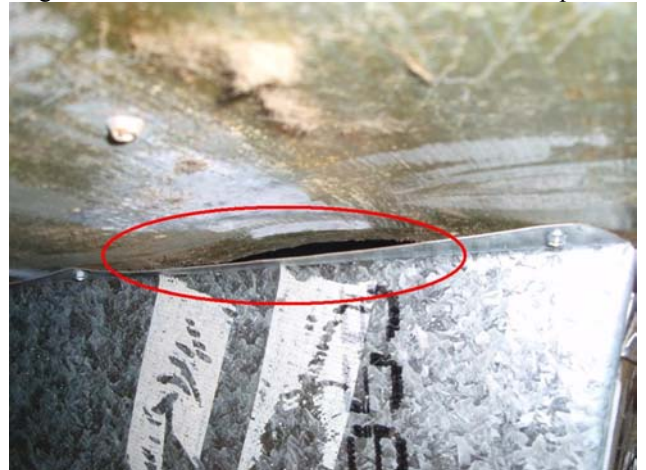
- **Repair:** Loose fitting joints, insulation covering and/or openings in the ductwork near the furnace should be improved.

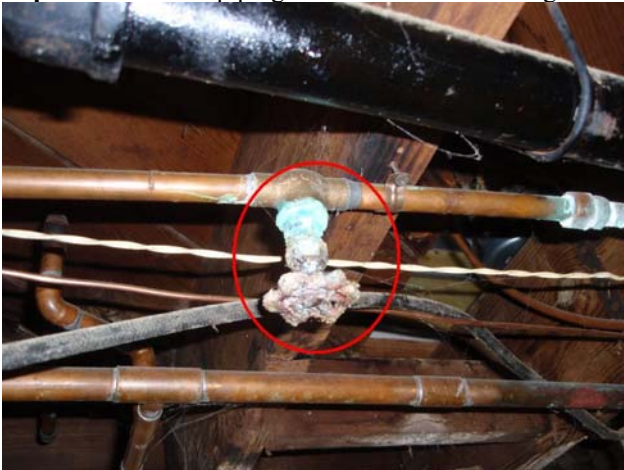
- **Repair:** The water piping shut off handle at ceiling above basement sink is leaking.
