**Star
Home
Inspection Services**

Home Inspection Report

4412 Vermont Ave Kansas City, MO 64133

Inspection Date: 04/06/2010

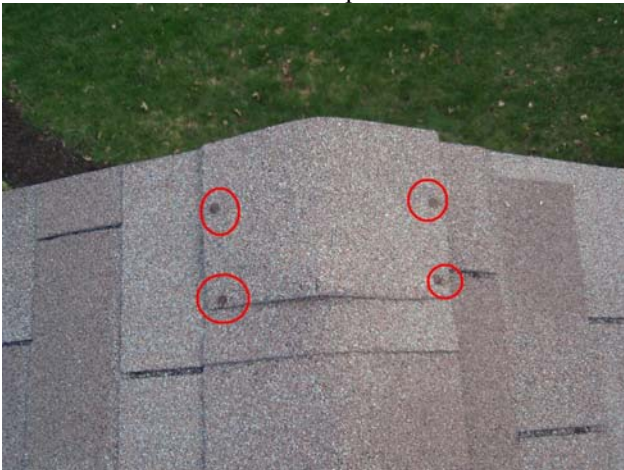
- **Recommend:** Exposed nail heads were observed in the roofing shingles and/or ridge caps. All exposed nail heads should be caulked to reduce the potential of leaks.

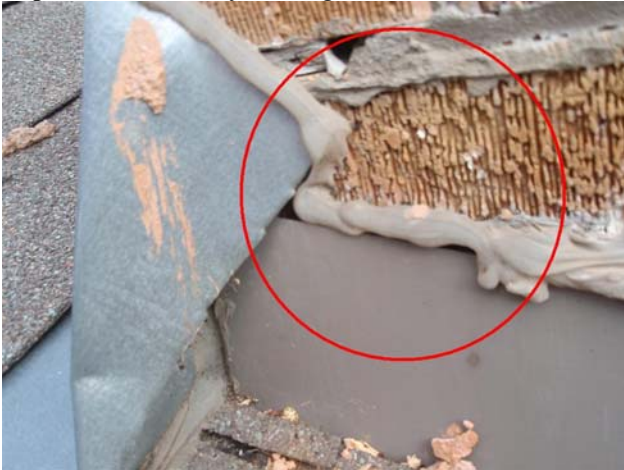
- **Repair:** The chimney flashing should be caulked to avoid leaks.

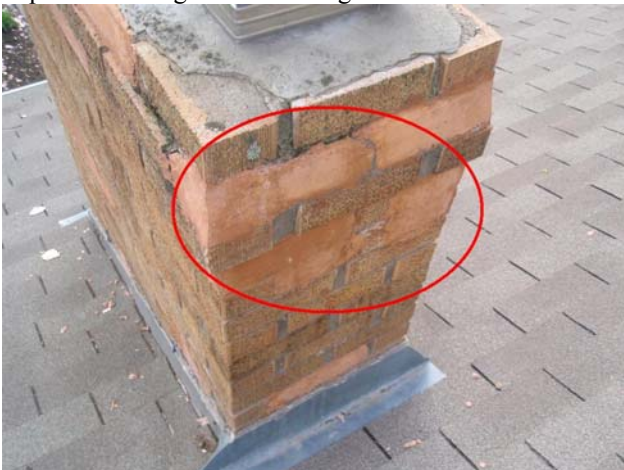
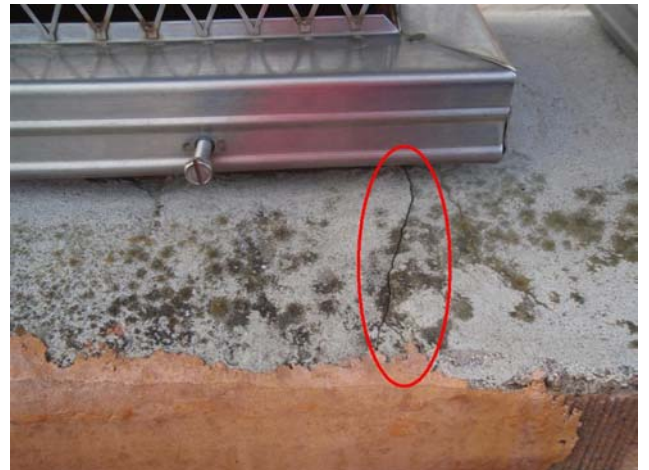
- **Monitor:** The masonry chimney shows evidence of repaired spalling (surface deterioration of the masonry).
- **Monitor, Repair:** The cap of the masonry chimney is cracked. These cracks should be sealed or caulked before winter to prevent damage from freezing water.

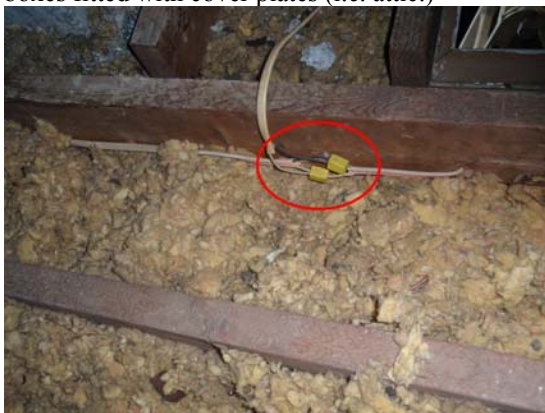
- **Repair:** Improper electrical connections should be repaired. All electrical connections should be made inside junction boxes fitted with cover plates (i.e. attic.)

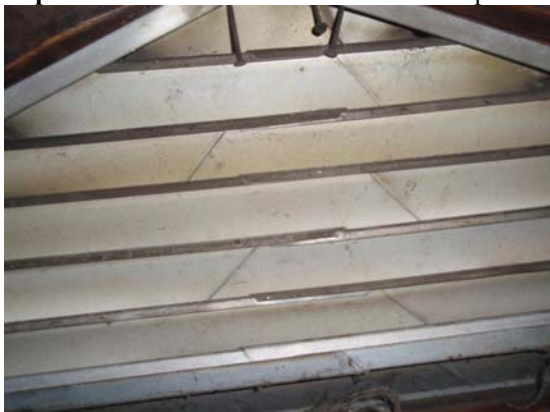
- **Repair:** Gable vents should be screened to prevent insect and vermin entry.
