**Star  
Home  
Inspection Services**

*Home Inspection Report*

**4462 Adams St, Kansas City, KS 66103**

**Inspection Date: 09/11/2009**

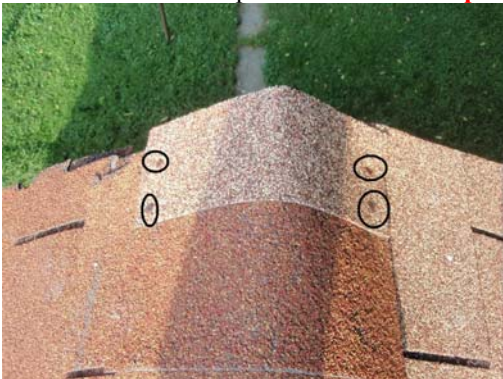
- **Repair:** Exposed nail heads were observed in the roofing shingles and/or ridge caps. All exposed nail heads should be caulked to reduce the potential of leaks. **Repaired**

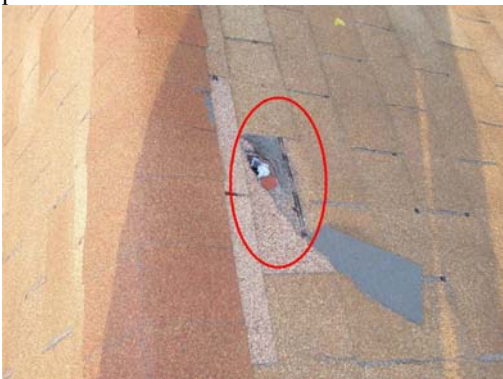
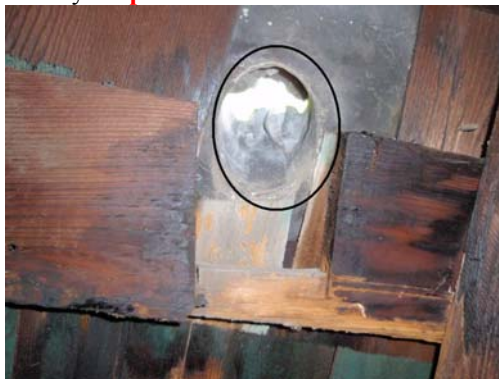
Attic view

- **Repair:** Minor repairs to the roofing are needed. Damaged or missing roofing material should be repaired. All roof penetrations should be examined and sealed as necessary. **Repaired**

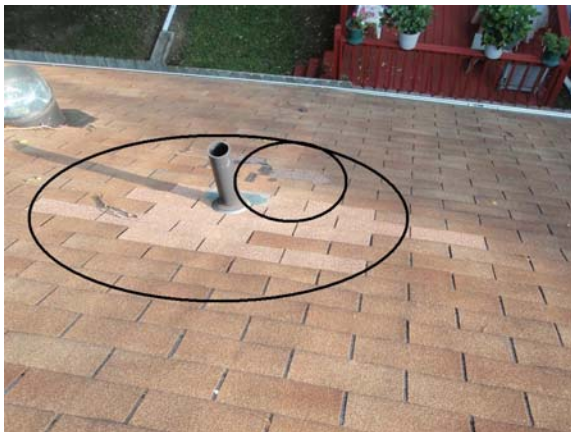
- **Monitor:** Prior repairs to the roofing are evident. This would suggest that problems have been experienced in the past. This area should be monitored.

- It is recommended that the present layers of roofing materials be removed prior to re-roofing. This adds cost of demolition and debris removal to the re-roof cost.

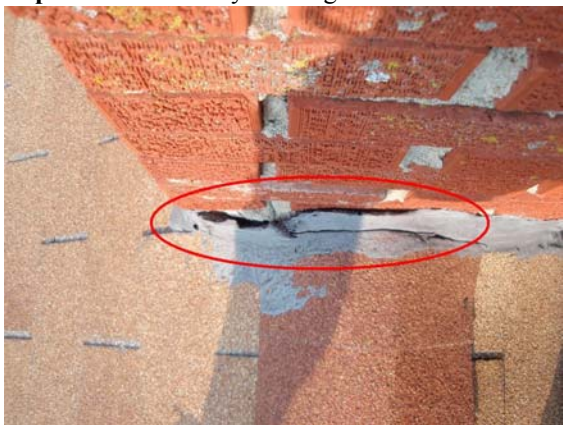
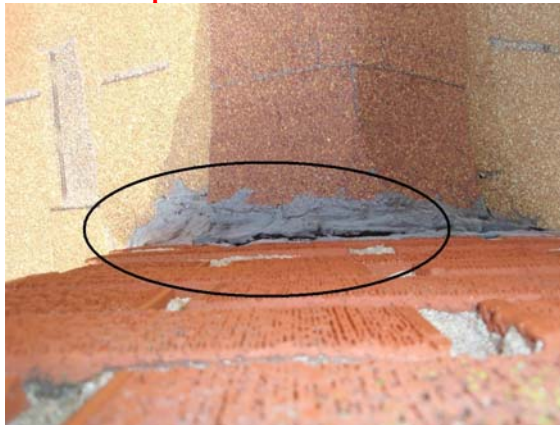
- **Repair:** The chimney flashing should be caulked to avoid leaks. **Repaired**

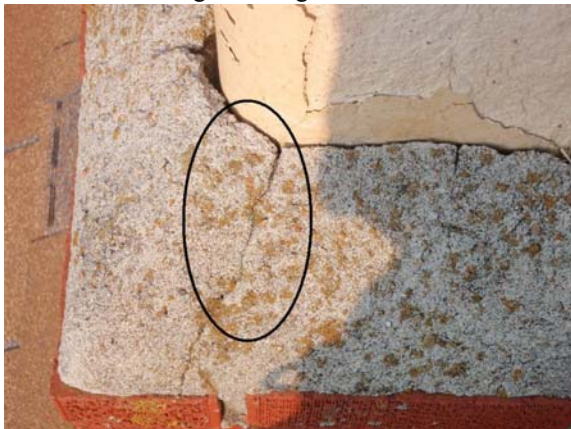
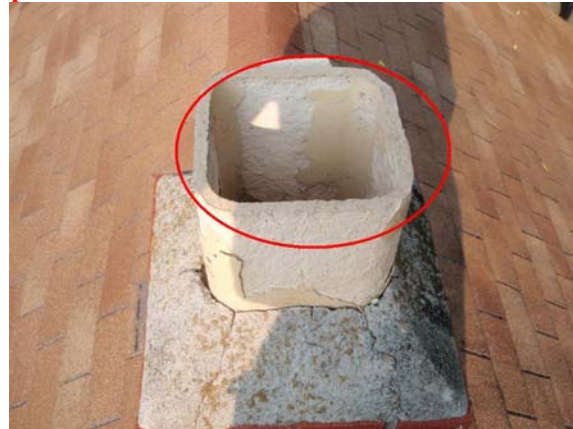
- **Repair:** The cap of the masonry chimney is cracked. These cracks should be sealed or caulked before winter to prevent damage from freezing water. **Repaired**
- **Repair:** A rain cap and vermin screen should be installed on the masonry chimney and the chimney flue should be checked for damage. Damaged flues can be unsafe. **Repaired**

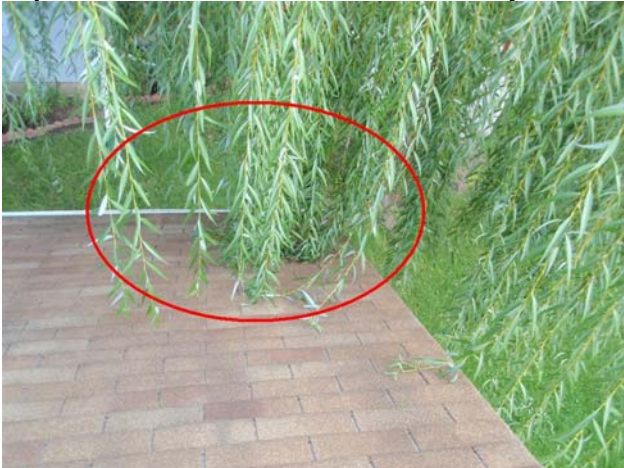
- **Repair:** Tree branches should be trimmed away from the house to avoid damage to the building. **Repaired**

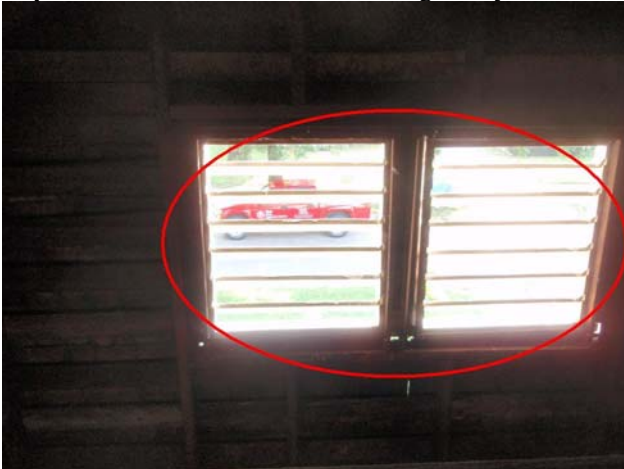
- **Repair:** Gable vent screens are missing. They should be repaired or replaced to prevent vermin activity. **Repaired**

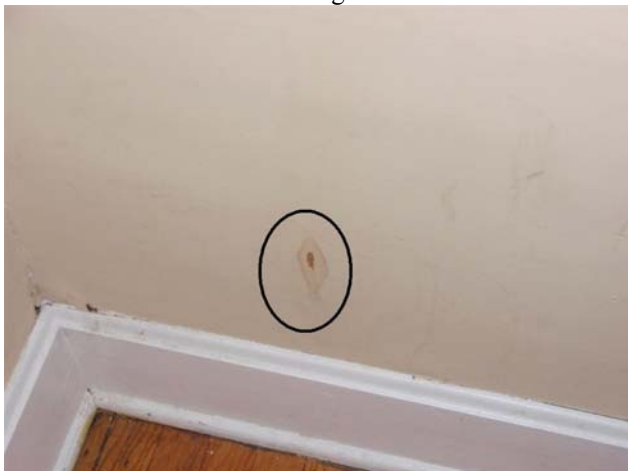
- **Monitor:** Minor water staining was noted at the northeast bedroom closet wall.
