**Star
Home
Inspection Services**

Home Inspection Report

4536 NW Bramble Trail, Lees Summit, MO 64064

Report Number: 12052008-1A

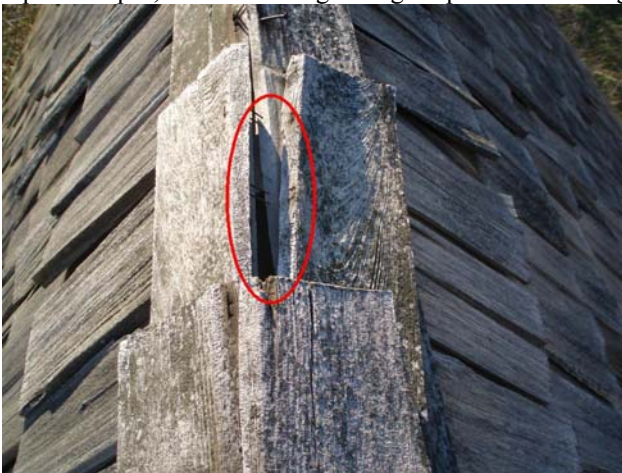
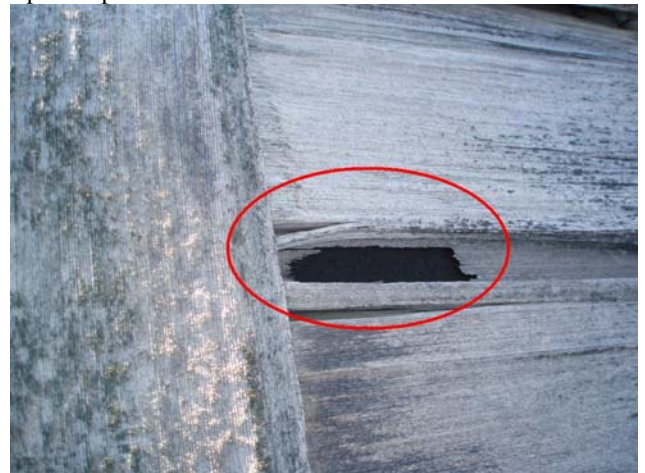
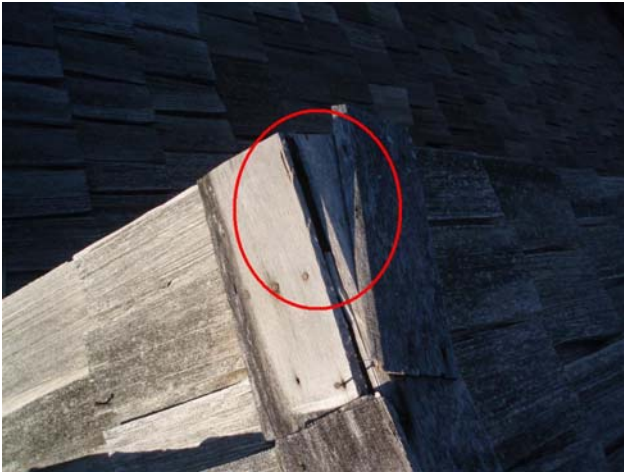
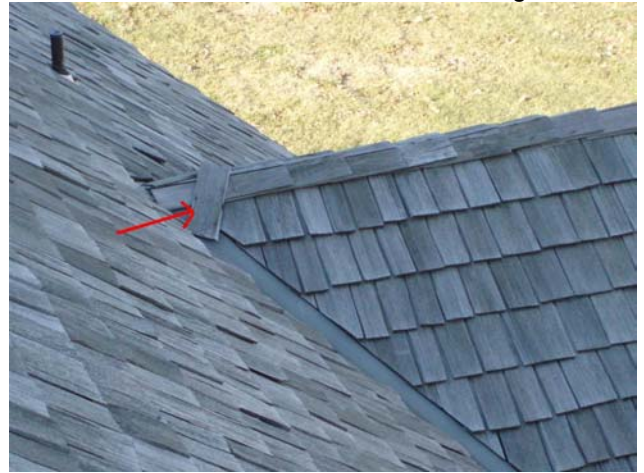
Sloped Roofing

- **Repair:** Minor repairs to the roofing are needed. Damaged or missing roofing material should be repaired. All roof penetrations should be examined and sealed as necessary. The life expectancy of wood roofs is generally 15 to 20 years. This will depend on several factors such as the quality of shingle or shake, the slope of the roof (steeper is better), the amount of exposed shingle, and the amount of sun or shade. As with all roofs, annual maintenance is needed. Cracked, curled, or displaced shingles or shakes should be repaired. As a rule of thumb, replacement of the entire roof covering may be logical if more than ten percent of the wood roof requires repair.
- **Repair:** Exposed sheathing is visible where the roofing is damaged. Damaged or missing roofing material should be repaired. Split, loose or damaged ridge caps of the roofing require repair.

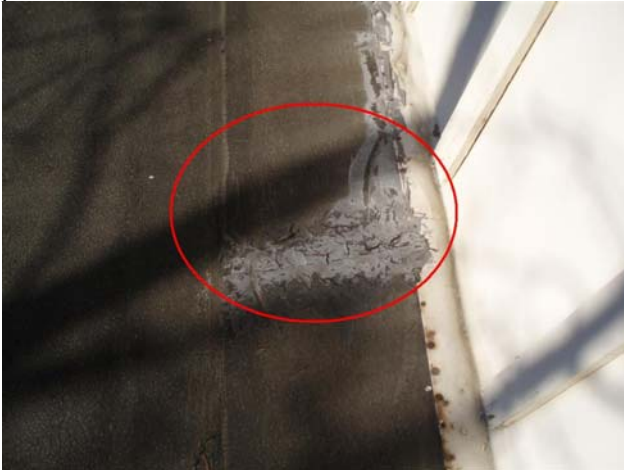
Flat Roofing

- **Note:** Rolled roofing (over back sunroom) is prone to leaking and requires close monitoring and higher than normal maintenance.
- **Monitor:** Prior repairs to the rolled roofing are evident. This would suggest that problems have been experienced in the past. This area should be monitored.

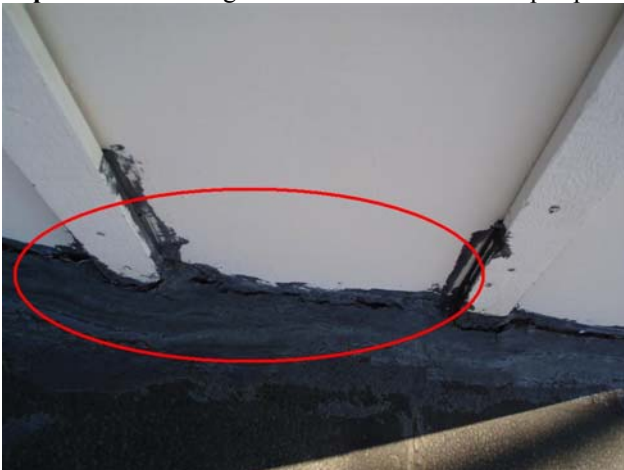
Flashings

- **Repair:** The flashing at back roof where roof steps up from one level to next should be caulked to avoid leaks.

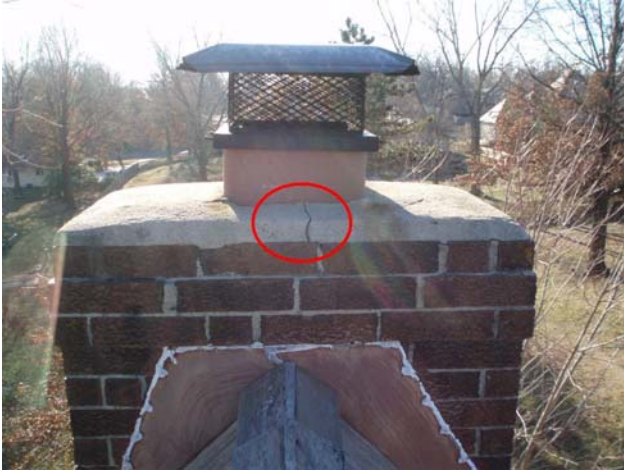
Chimneys

- **Repair:** The cap of the masonry chimney is cracked. These cracks should be sealed or caulked to prevent damage from freezing water.

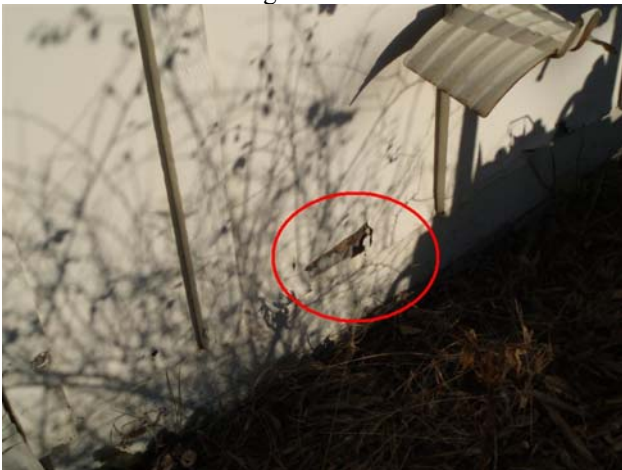
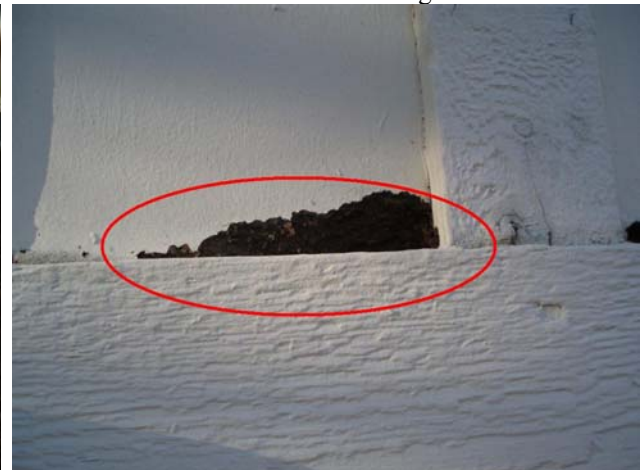
- **Repair:** Localized rot/damage was observed in the siding (examples at lower edge in back and siding at garage side). Following repair of the damaged areas (which should be combined with exterior painting/maintenance) proper maintenance of the siding and control of water from roof or surface runoff can avoid further damage.

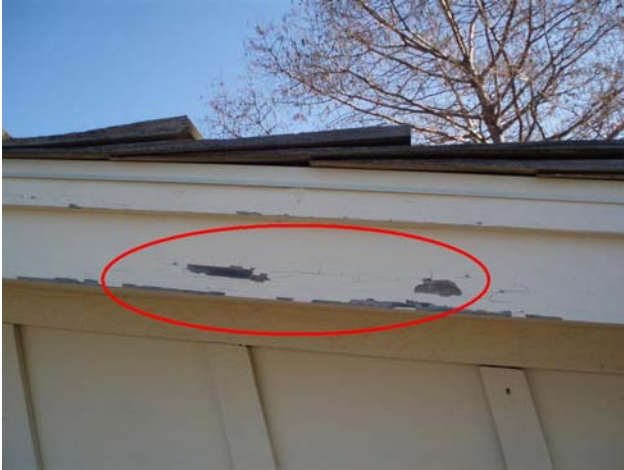
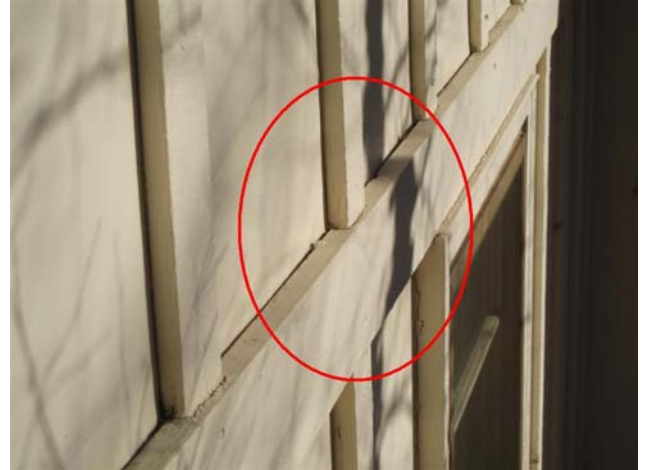
- **Repair:** The paint on the trim around the siding and eave where roof steps up from one level to the next in back is peeling in localized areas. These areas should be painted to prevent water damage and rot. All gaps at siding trim should be sealed.

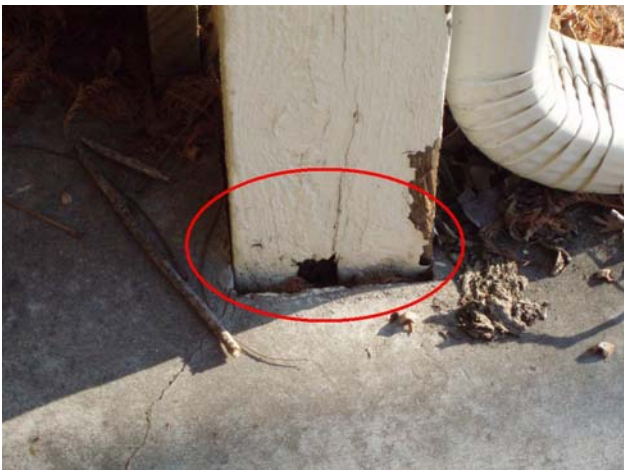
Deck

- **Monitor:** The deck steps show evidence of rot. Localized repairs could be undertaken.
- **Repair, Safety Issue:** The openings in the deck/step railing are large enough to allow a child to fall through. It is recommended that this be corrected for improved child safety.
- **Repair:** The support post for the deck is rotted. They should be repaired or replaced to avoid further damage to the structure.

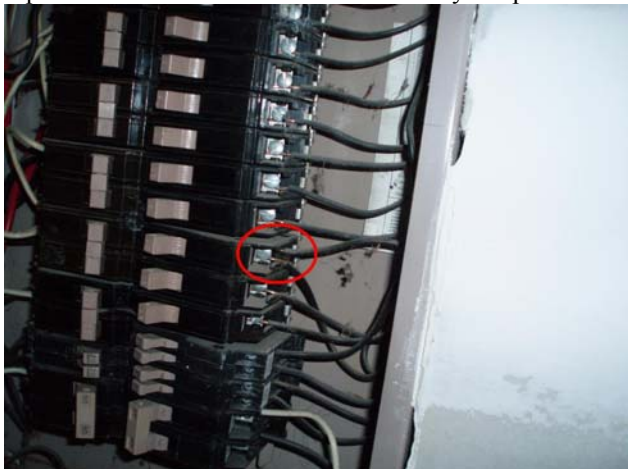
Main Panel

- **Repair:** Circuits within the main distribution panel that are doubled up (referred to as "double taps") should be separated. Each circuit should be served by a separate fuse or breaker.

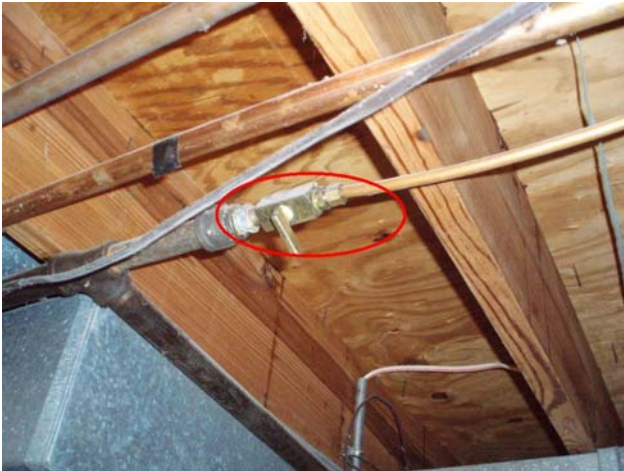
Gas Piping

- **Repair:** Copper tubing is no longer suitable for gas piping. It's recommended this pipe be replaced with one of suitable material.
